**FACILITY COMPLIANCE INSPECTION REPORT**  
**Division of Waste Management**  
**Solid Waste Section**

**Date of Site Inspection:** 2 February 2012      **Date of Last Inspection:** 19 August 2011

ARS-Beaufort County Transfer Station  
500 Flanders Filters Road  
Washington, NC

07-03T, 020212

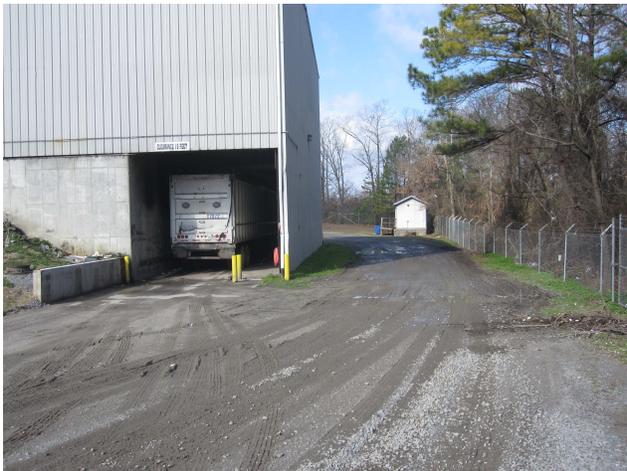
Access to trailer loading bay

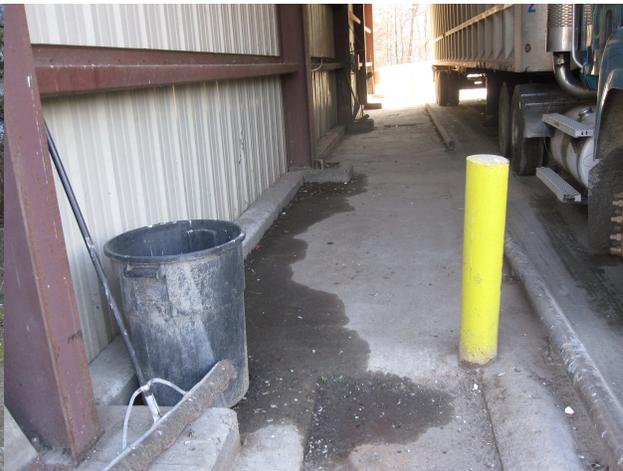
- 14) No windblown debris was noted outside of the perimeter fence and windblown debris along the inside of the fence was minimal.
  - 15) The trailer loading area is cleaned of any waste overflow as trailers are removed from the bays for transfer and at the end of each workday.

Well managed trailer loading bay

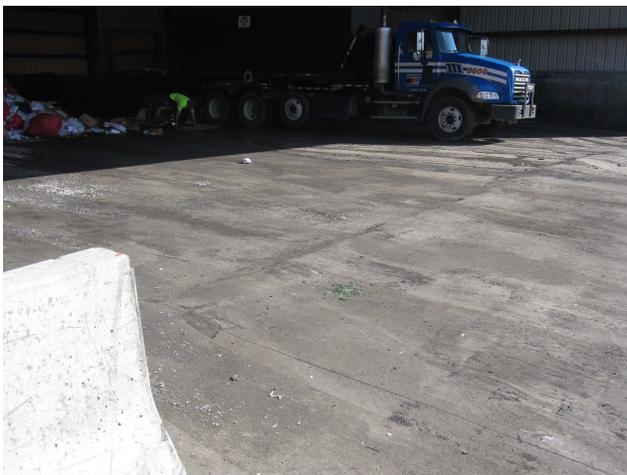
- 19) The tipping floor is cleaned and washed down daily and the interior walls are pressure washed quarterly.
  - 20) The facility is protected by highly visible, safety bollards at the entrance to the tipping floor, and at the trailer loading bay entrance and exit.

Well managed tipping floor
