FACILITY COMPLIANCE INSPECTION REPORT
Division of Waste Management
Solid Waste Section

Date of Site Inspection: 23 August 2011 **Date of Last Inspection:** 3 May 2011

Carteret County/CRSWMA Transfer Facility
 800 Hibbs Road
 Newport, NC

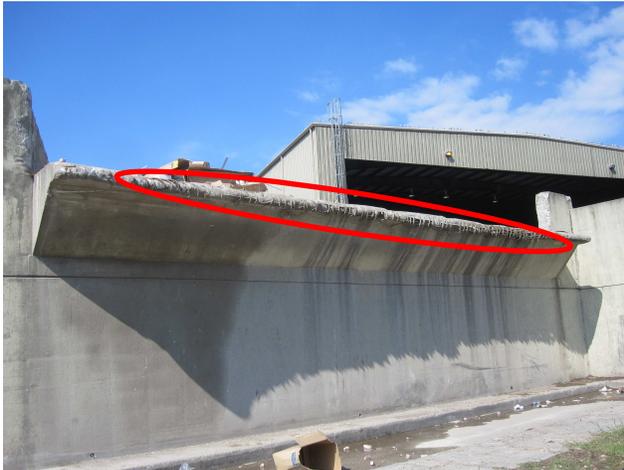
- 16) Recyclable metals and unacceptable waste streams are removed from the facility daily.
 - 17) Areas of excessive wear were noted in various areas on the tipping floor; exposed re-bar was noted at the loading bay edge of the tipping floor. *Plans for maintenance/repair of the worn and eroded areas of the tipping floor should be initiated as soon as possible.

C&D loading area, note worn concrete lip w/exposed re-bar

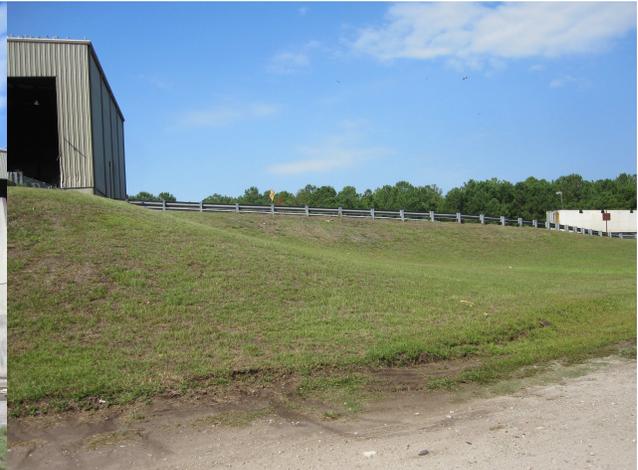
- 21) Access around the facility is generally stable.
 - 22) Windblown debris is collected and returned to the transfer station daily. No windblown debris was noted as leaving the facility.

Stable access around the transfer facility with no erosion noted

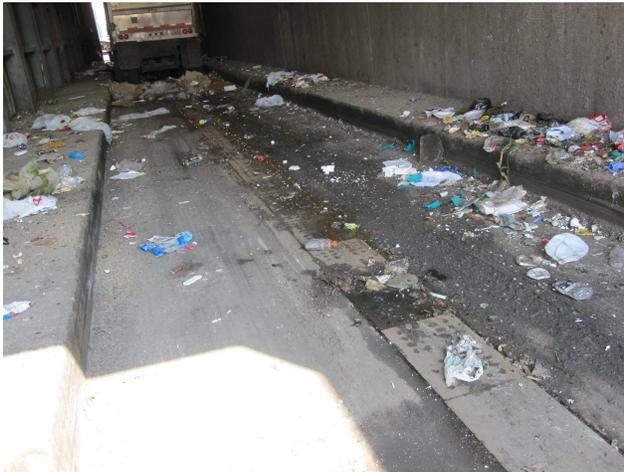
Trailer loading bay

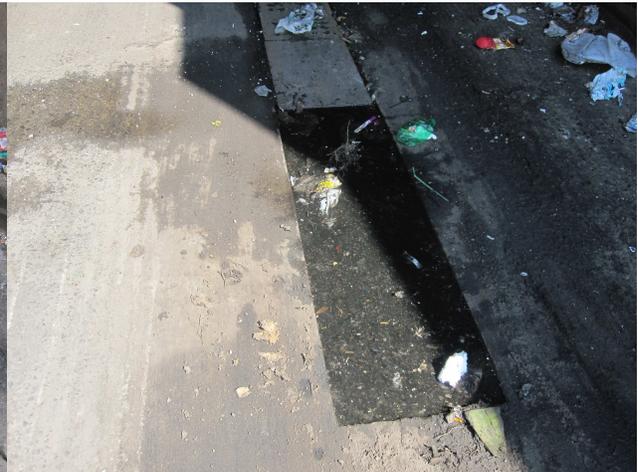
- 18) Although no leachate or standing liquids were noted in the trailer loading bay, the leachate drain was noted as being partially blocked with sediment. *To provide for positive drainage and collection of leachate, please ensure that all drains are kept clear of sediments and debris.

Leachate collection drain -note accumulated sediments
