FACILITY COMPLIANCE INSPECTION REPORT
Division of Waste Management
Solid Waste Section

Date of Site Inspection: 31 January 2012 **Date of Last Inspection:** 5 May 2011

MCAS Cherry Point Transfer Facility
 Mockingbird Road
 MCAS Cherry Point, NC 28533

Comprehensive audit

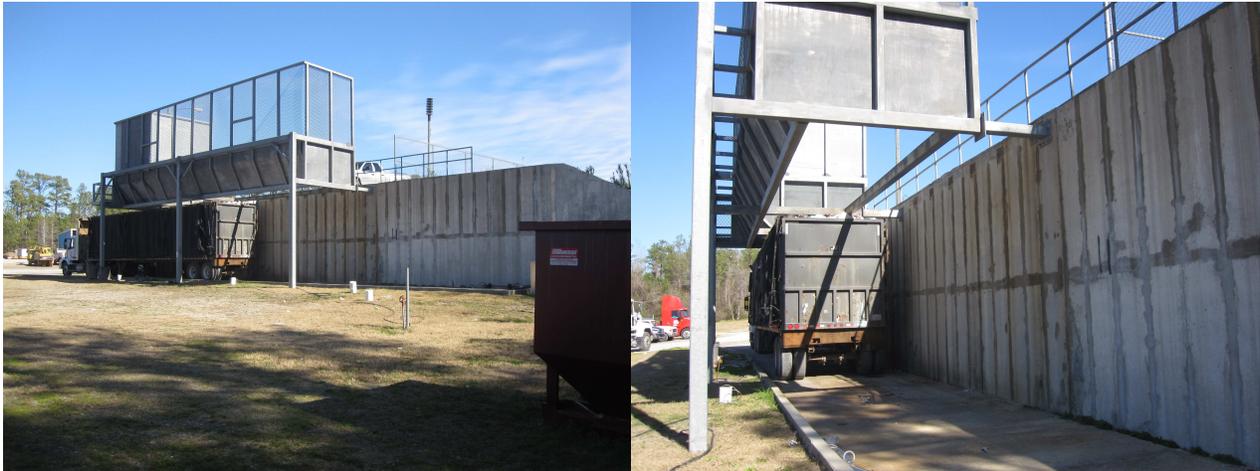
Hopper and trailer loading area

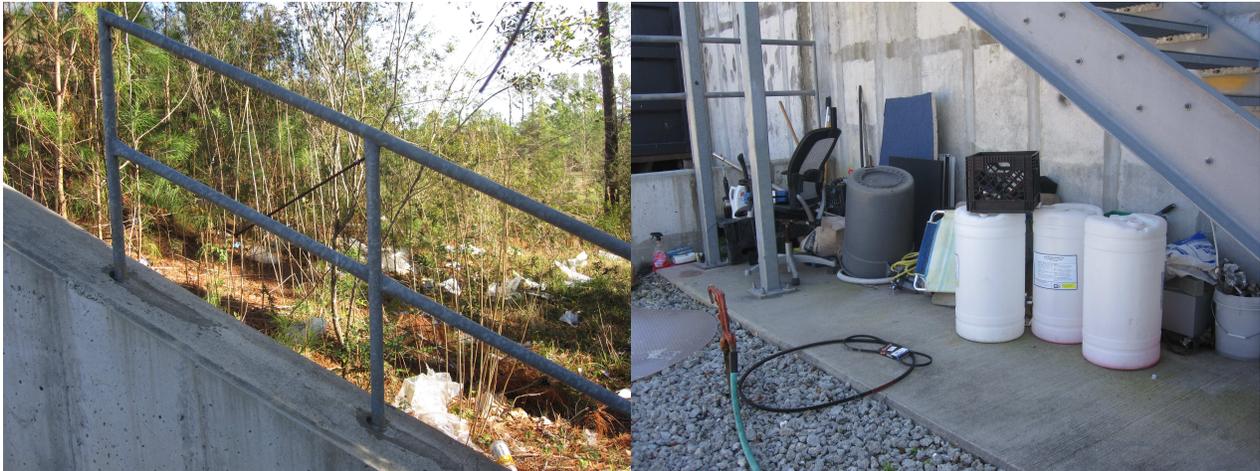
Brush and woody vegetation and windblown litter on back sideslope

Scavenged material stored under access steps

- 16) Overall, the trailer loading area and windblown debris are being well maintained at this time; however windblown debris was noted on the outside of the perimeter security fence and on the back sideslope. *Please ensure that all windblown debris both inside and outside the perimeter fence is collected and disposed in the MSW trailer at the end of each workday.

- 17) Scavenged materials are being stored under the loading bay access steps. *Scavenging is not allowed at permitted solid waste management facilities. Any recyclable materials removed from the waste stream should be placed in an appropriate receptacle and taken to a facility managed for the recycling of such materials.

- 24) Brush and woody vegetation have been allowed to grow on the back sideslope of the facility. *Please remove all brush and woody vegetation from this area and maintain the grass cover crop to prevent erosion.
