Re: Phase II Expansion CQA Letter Report  
Fort Bragg C&D Landfill  
Permit No. 26-08

**Attachment A**  
**Phase II Construction Photographs**

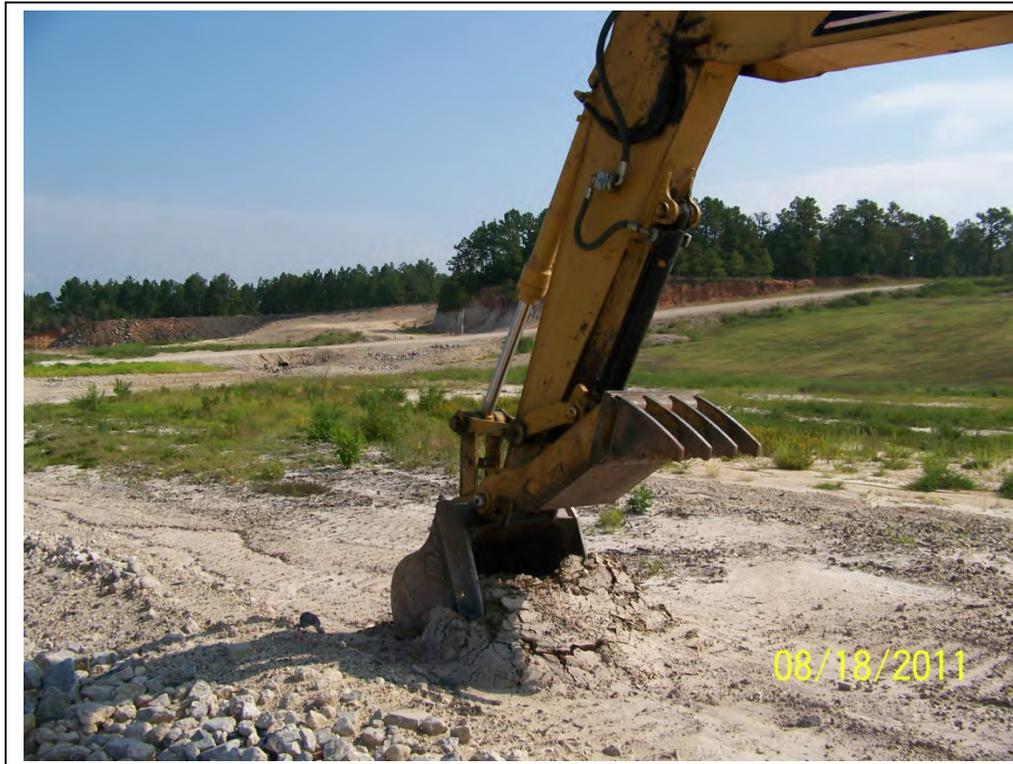
Photo No.	01
<i>Description:</i> August 18, 2011	
Excavating test pit to determine if waste was present beneath access road in Phase II.	
<i>Comments:</i>	
None.

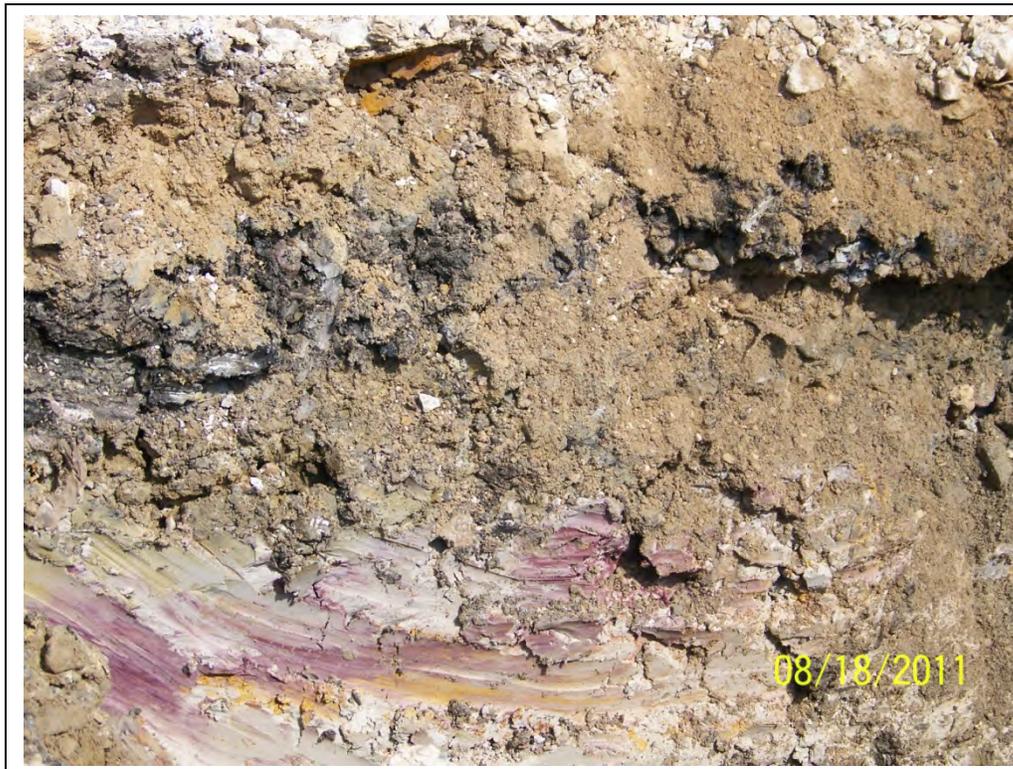
Photo No.	02
<i>Description:</i> August 18, 2011	
Test pit beneath access road in Phase II.	
<i>Comments:</i>	
Test pit indicates access road is underlain by undisturbed clayey soil. No waste found.

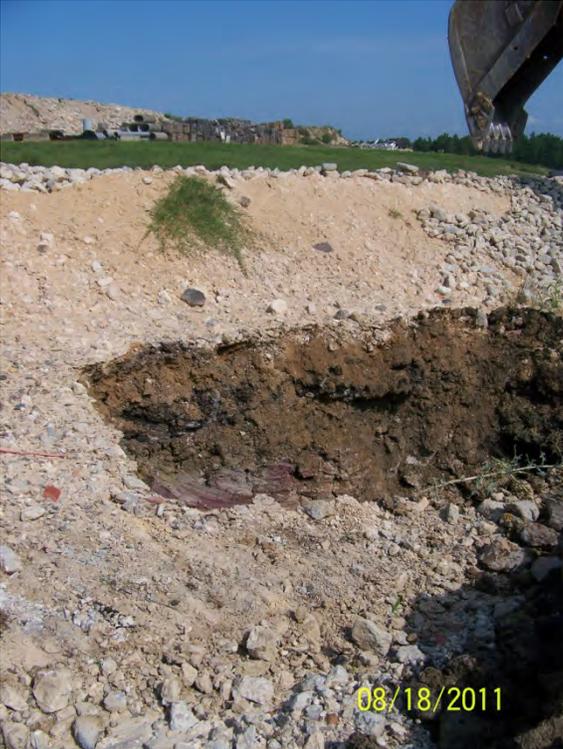
Photo No.	03
	<i>Description:</i> August 18, 2011	
	Test pit beneath access road in Phase II.	
	<i>Comments:</i>	
		Test pit indicates access road is underlain by undisturbed clayey soil. No waste found.

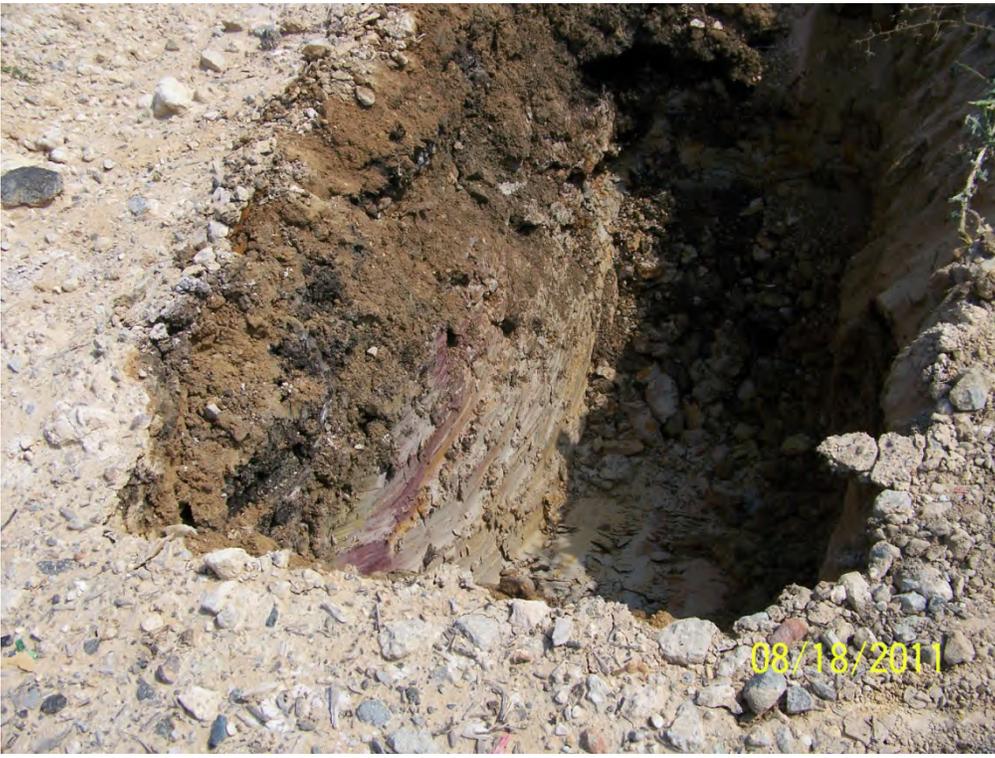
Photo No.	04
	<i>Description:</i> August 18, 2011	
	Test pit beneath access road in Phase II.	
	<i>Comments:</i>	
		Test pit indicates access road is underlain by undisturbed clayey soil. No waste found.

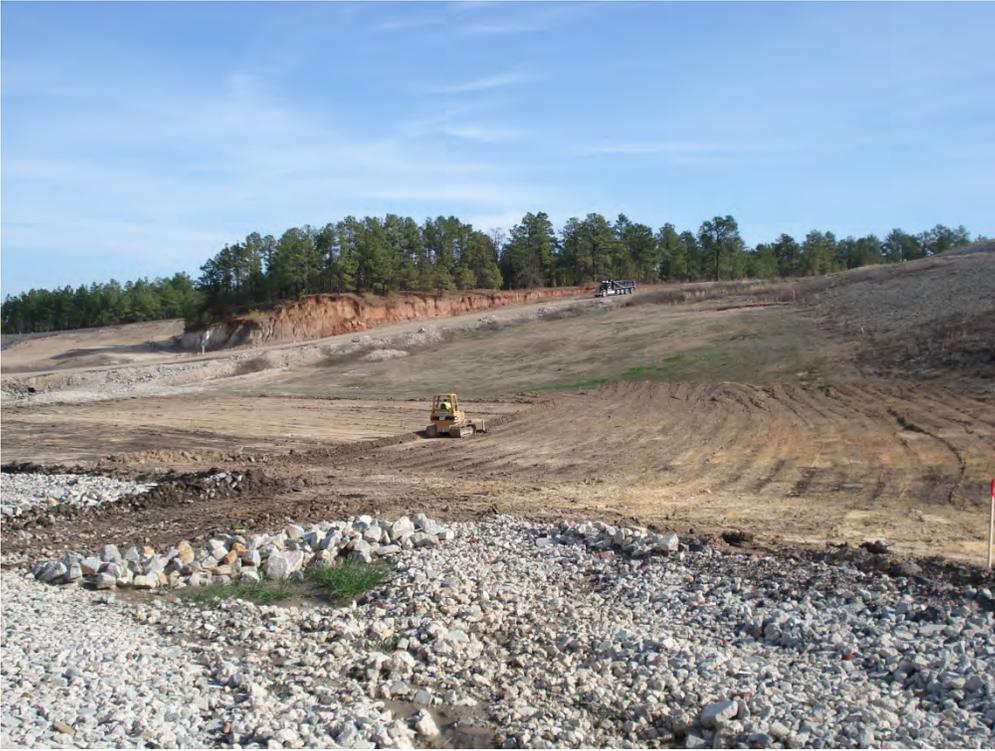
Photo No.	05
	<i>Description:</i> February 7, 2012	
	Stripping vegetation and organic soils from Phase II subgrade/basegrade.	
	<i>Comments:</i>	
		None.

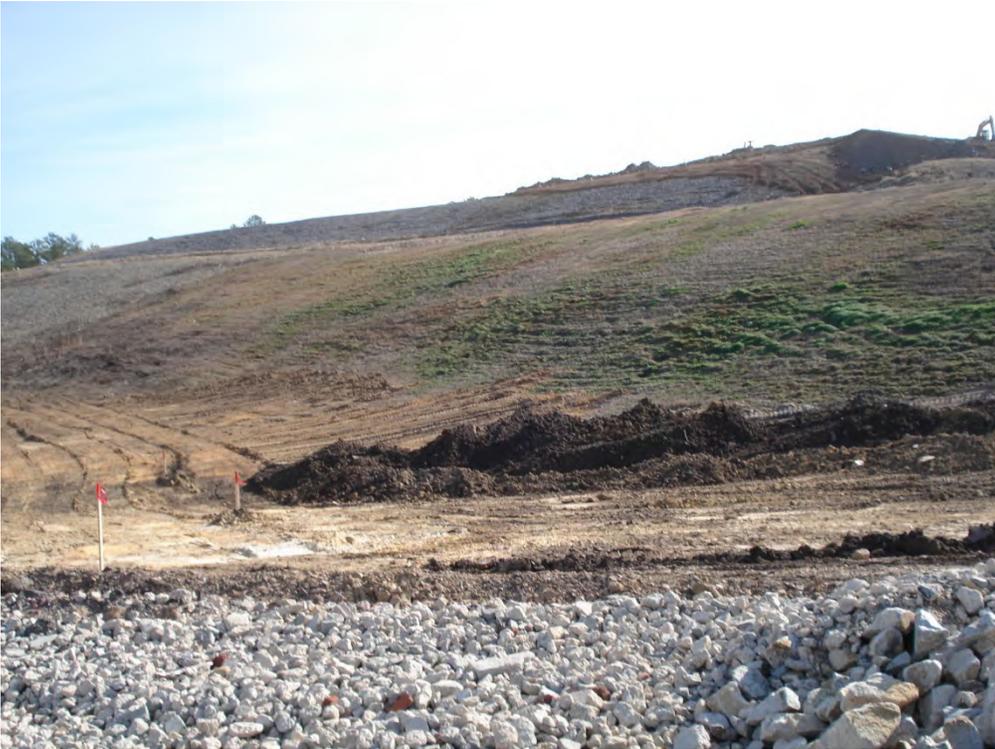
Photo No.	06
	<i>Description:</i> February 7, 2012	
	Stripping vegetation and organic soils from Phase II subgrade/basegrade.	
	<i>Comments:</i>	
		None.

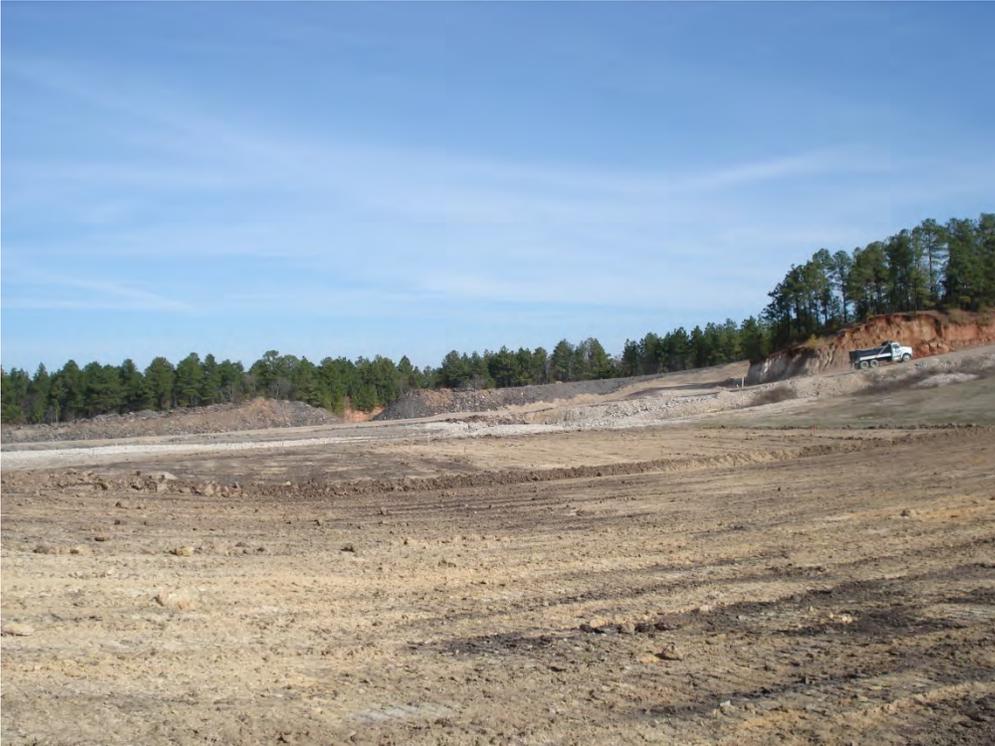
Photo No.	07
	<i>Description:</i> February 7, 2012	
	Stripping vegetation and organic soils from Phase II subgrade/basegrade.	
	<i>Comments:</i>	
		None.

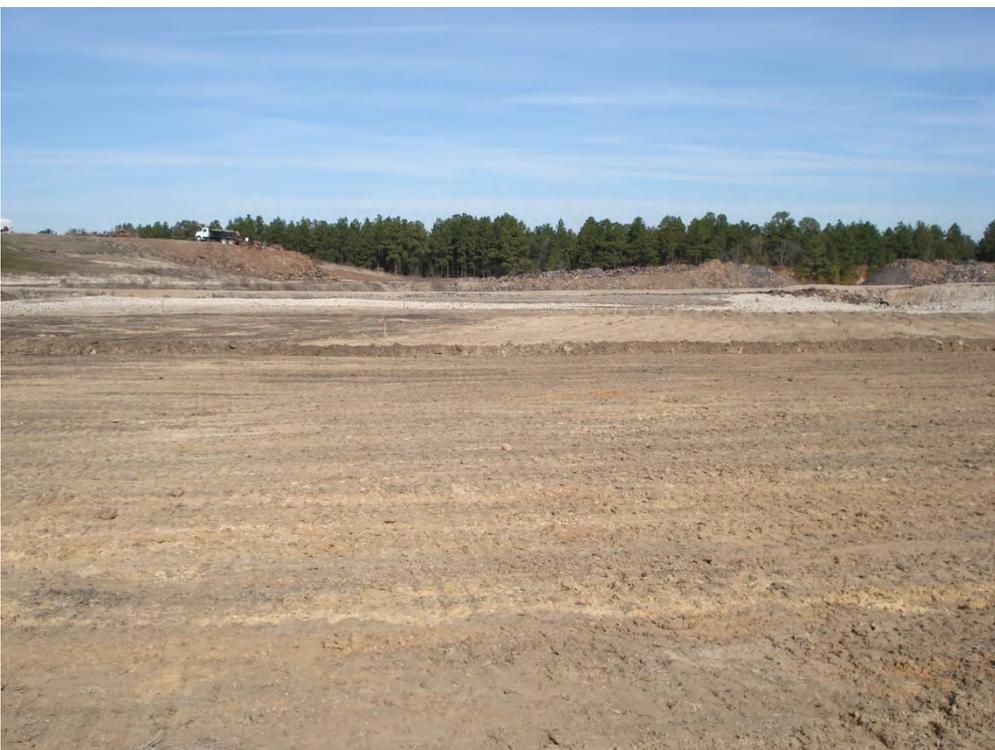
Photo No.	08
	<i>Description:</i> February 7, 2012	
	Stripping vegetation and organic soils from Phase II subgrade/basegrade.	
	<i>Comments:</i>	
		None.

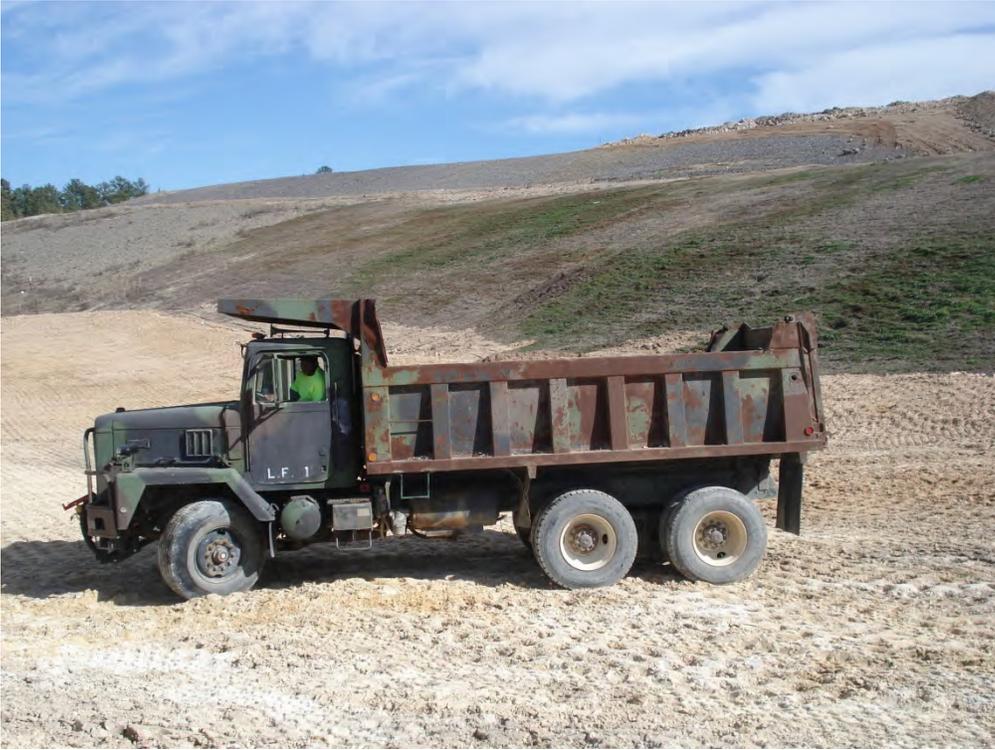
Photo No.	09
	<i>Description:</i> February 13, 2012	
	Proofrolling Phase II compacted subgrade/basegrade.	
	<i>Comments:</i>	
		Tandem dump truck loaded with approximately 6 tons of crusher-run stone.

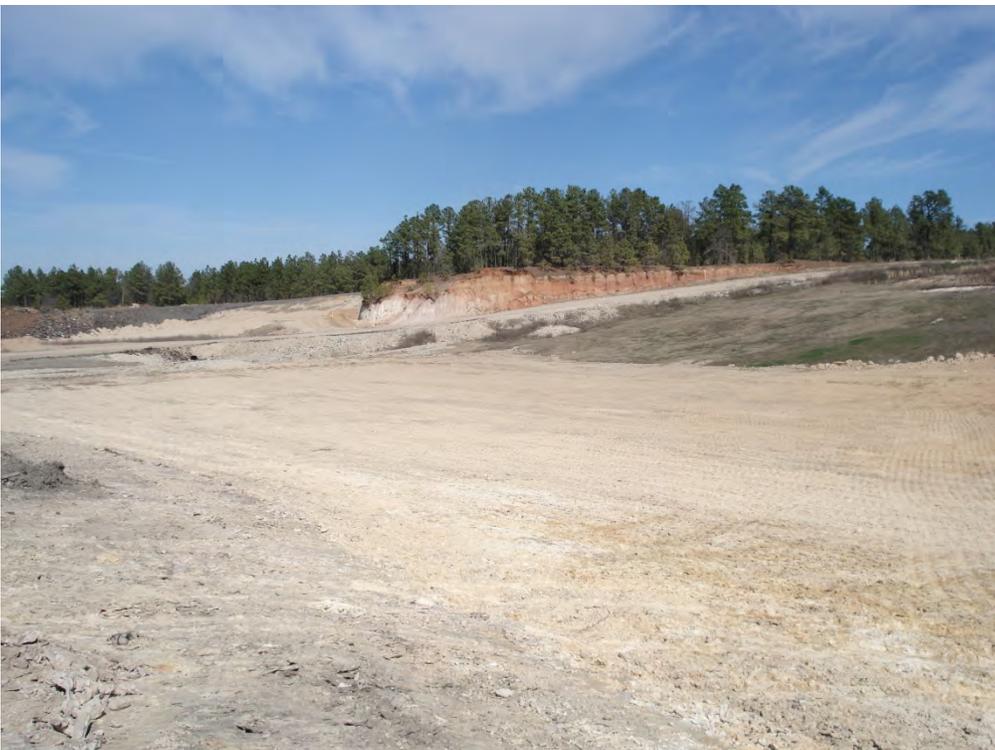
Photo No.	10
	<i>Description:</i> February 13, 2012	
	Compacted Phase II subgrade/basegrade.	
	<i>Comments:</i>	
		None.

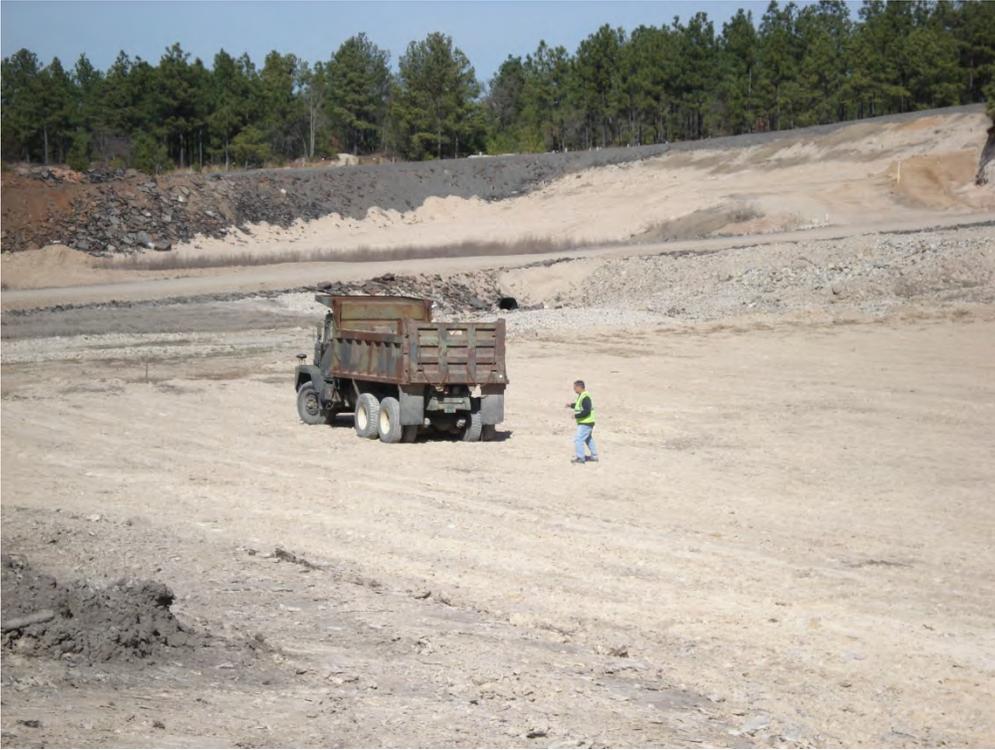
Photo No.	11
	Description: February 13, 2012	
	Proofrolling Phase II compacted subgrade/basegrade.	
	Comments:	
		CQC observing proofroll.

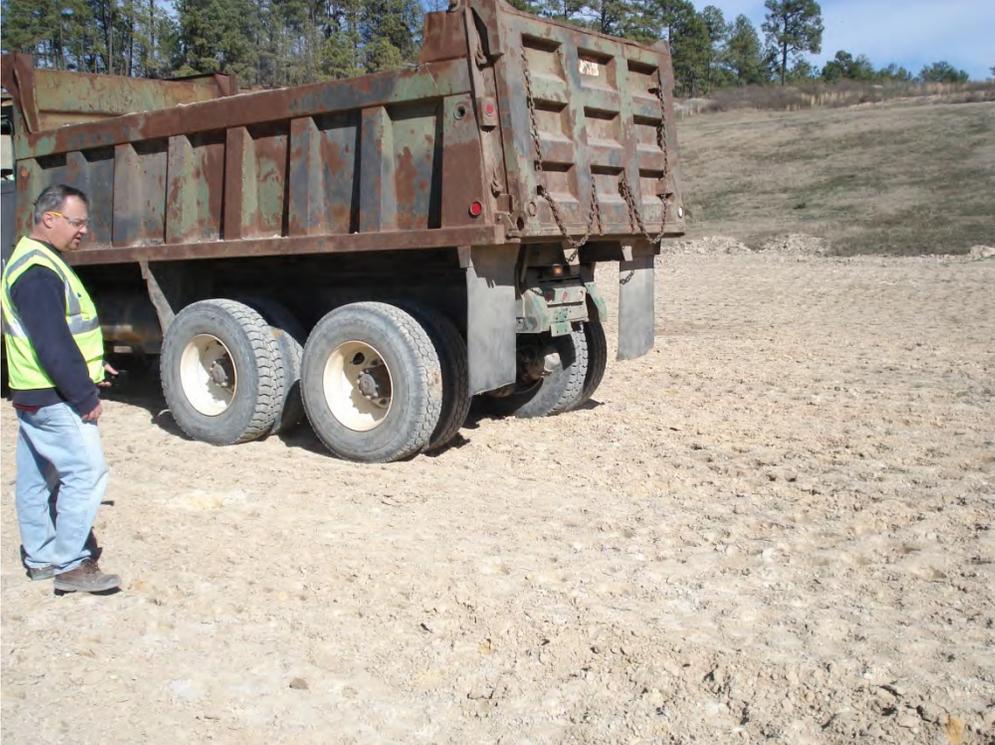
Photo No.	12
	Description: February 13, 2012	
	Proofrolling Phase II compacted subgrade/basegrade.	
	Comments:	
		CQC observing proofroll.

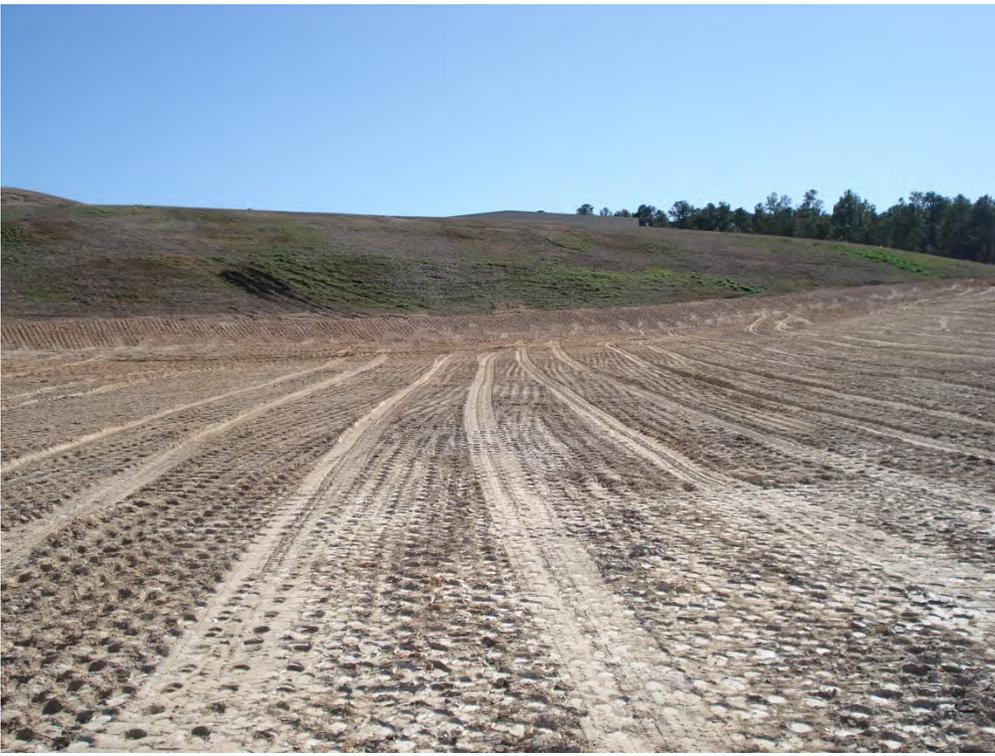
Photo No.	13
	<i>Description:</i> February 13, 2012	
	Phase II compacted subgrade/basegrade after proofrolling.	
	<i>Comments:</i>	
		None.

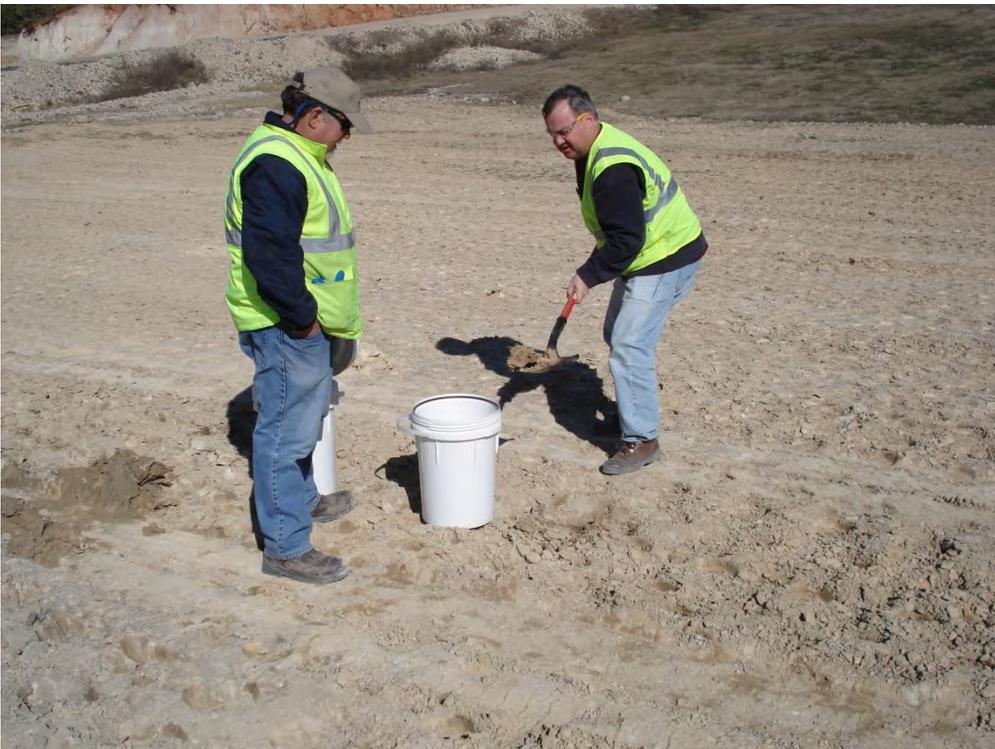
Photo No.	14
	<i>Description:</i> February 13, 2012	
	Obtaining CQC sample of Phase II subgrade/basegrade material for classification testing.	
	<i>Comments:</i>	
		None.

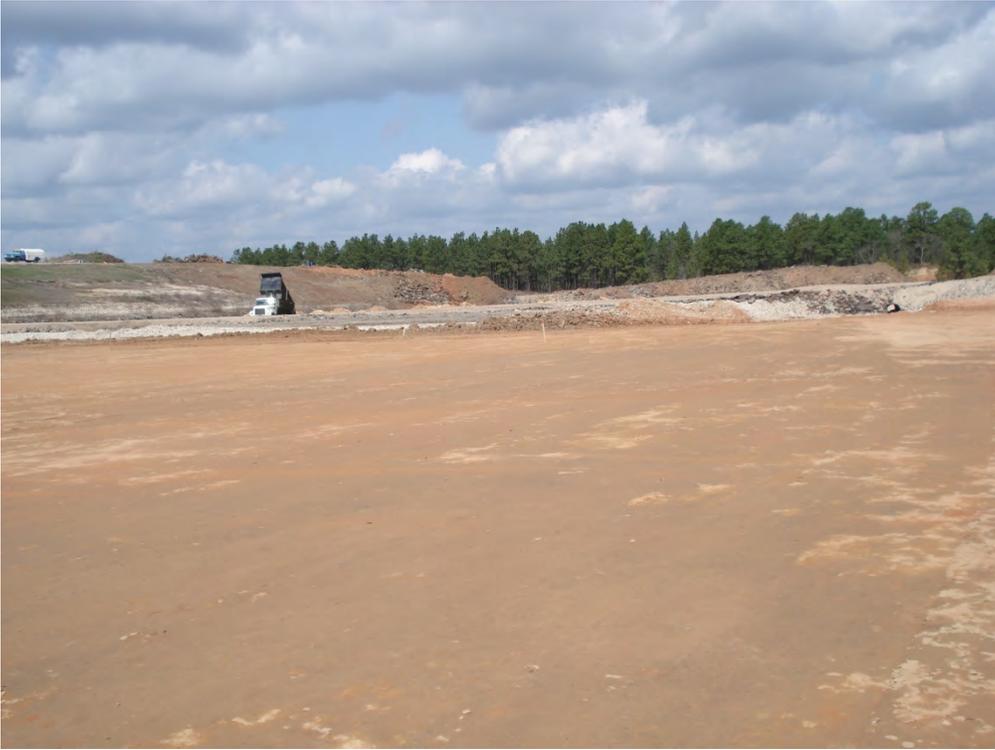
Photo No.	15
	<i>Description:</i> March 1, 2012	
	Phase II basegrade after placement of compacted clayey fill in low areas.	
	<i>Comments:</i>	
		Red soil is fill.

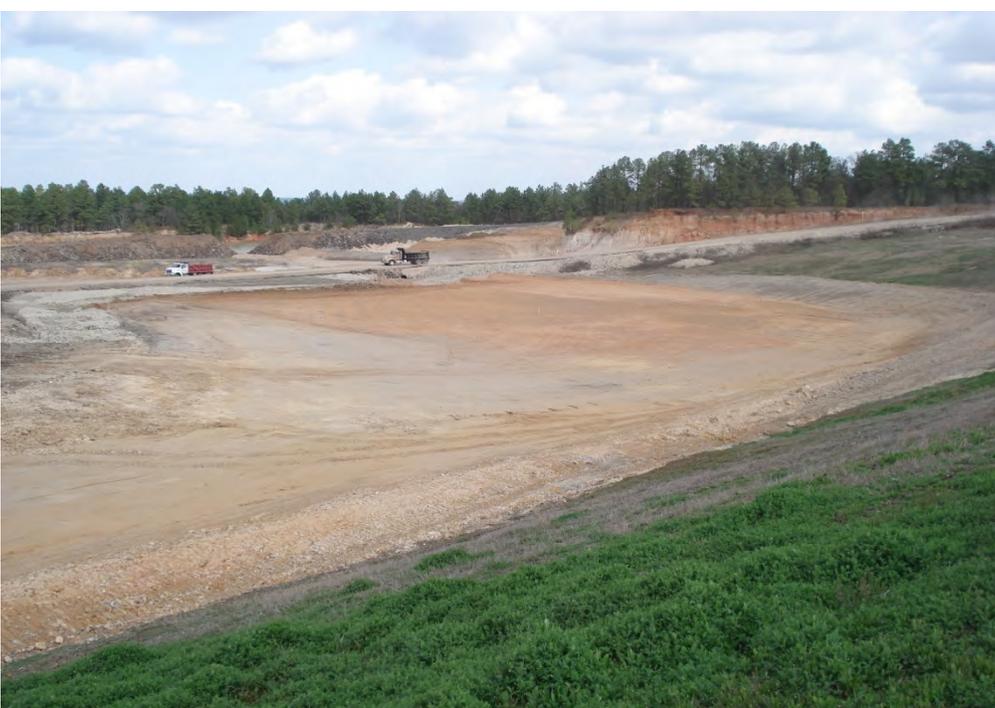
Photo No.	16
	<i>Description:</i> March 1, 2012	
	Phase II basegrade after placement of compacted clayey fill in low areas.	
	<i>Comments:</i>

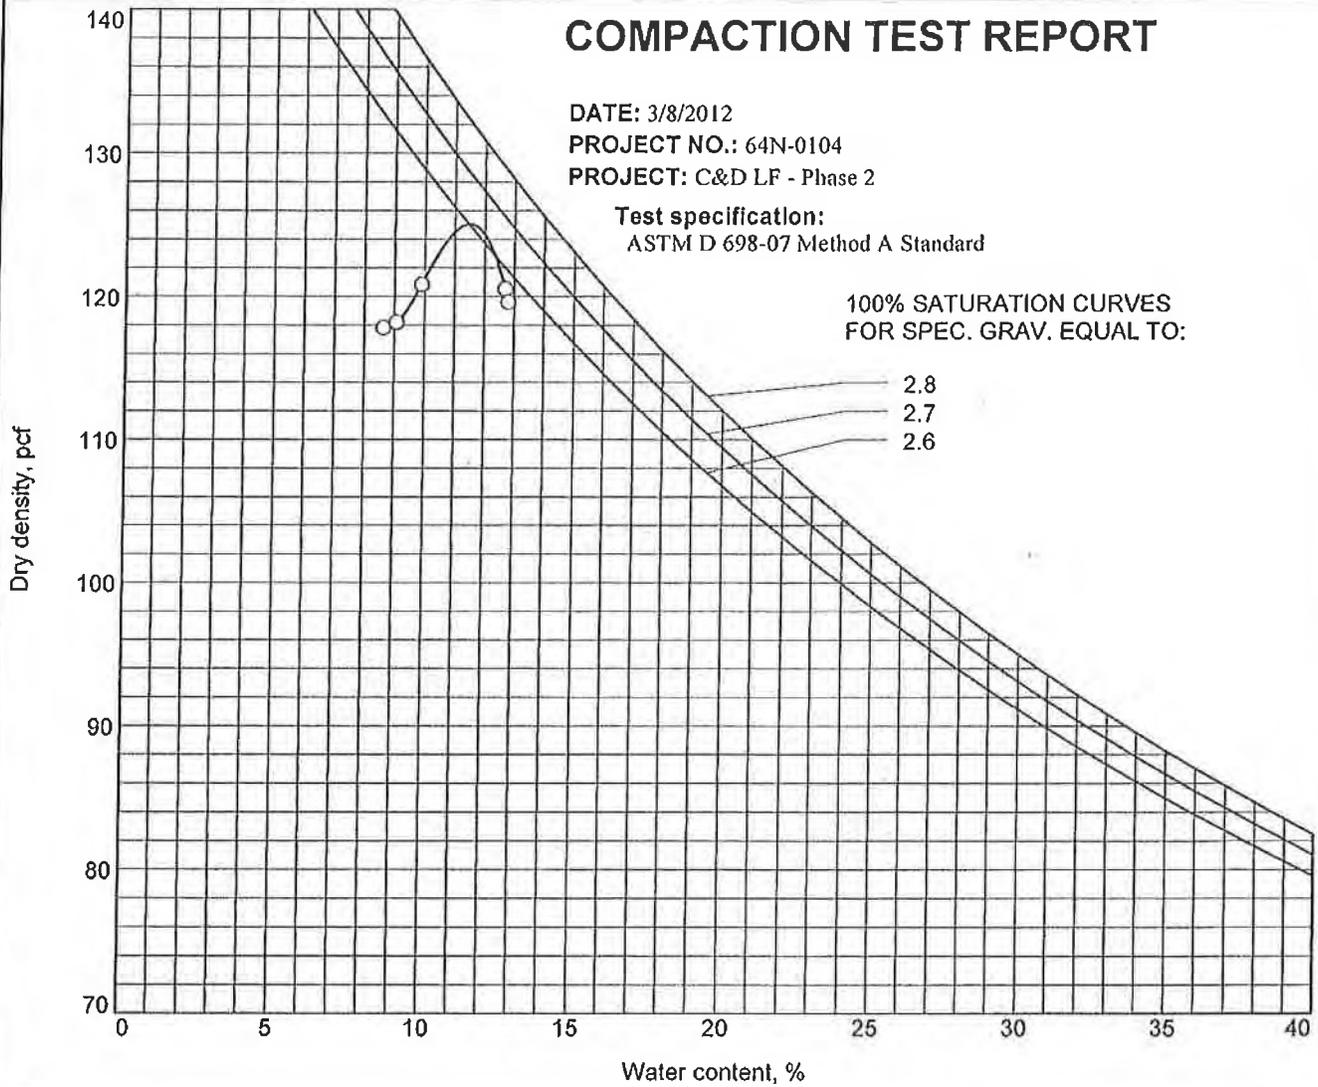
No.	LOCATION AND DESCRIPTION							REMARKS
○ 115187	Sample Number: 115187 Reddish Brown Silty Sand							
No.	USCS	LL	PI	NAT. MOIST.	OVERSIZE	% < No.200	MAX. DRY DEN.	OPT. MOIST.
○ 115187	SM	NP	NP	9.15	%>#4=1	18 %	125.1	11.5 %

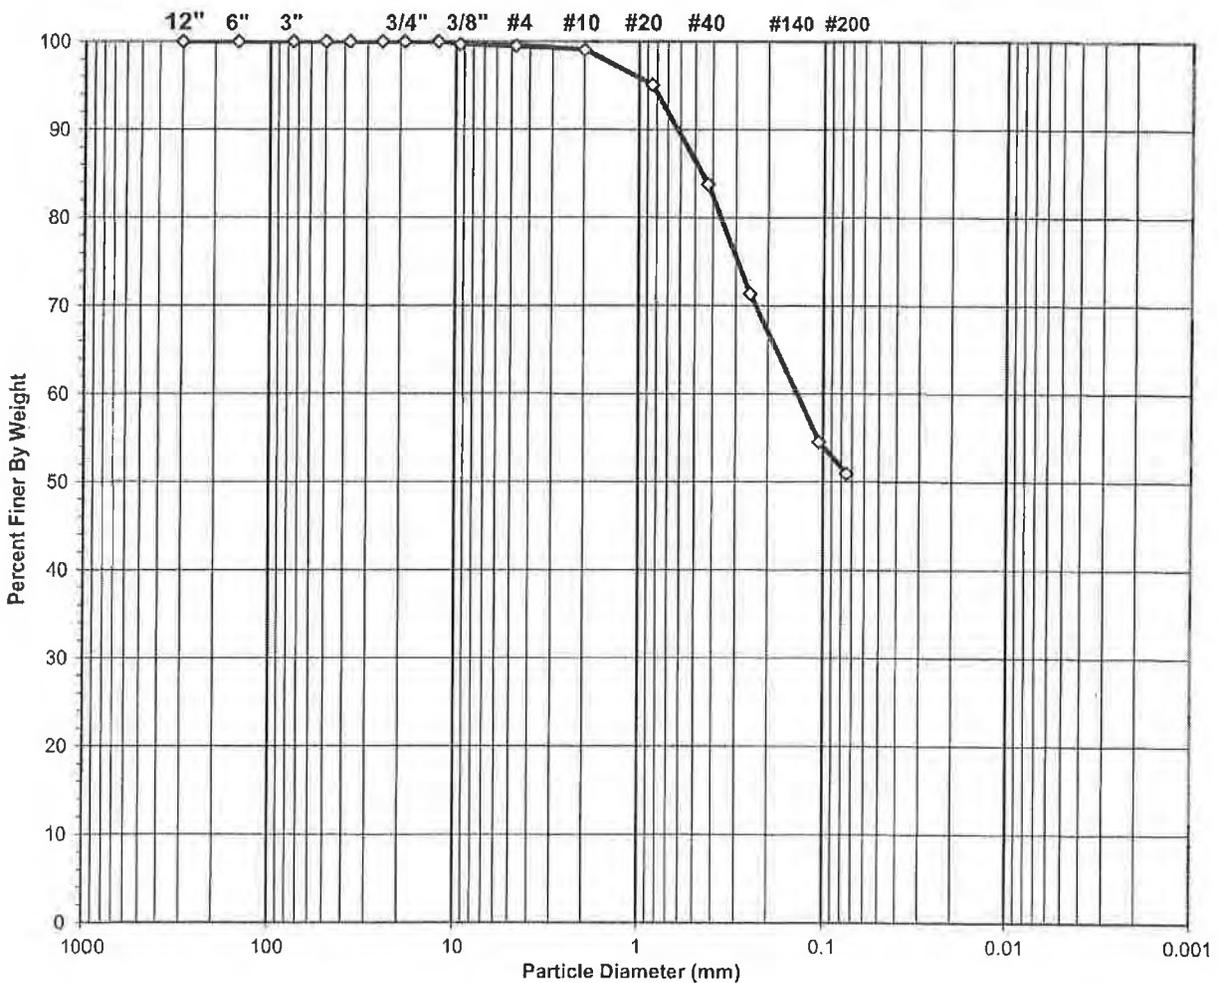
**USCS Symbol**      **CL, TESTED**

**USCS Classification** **SANDY LEAN CLAY**

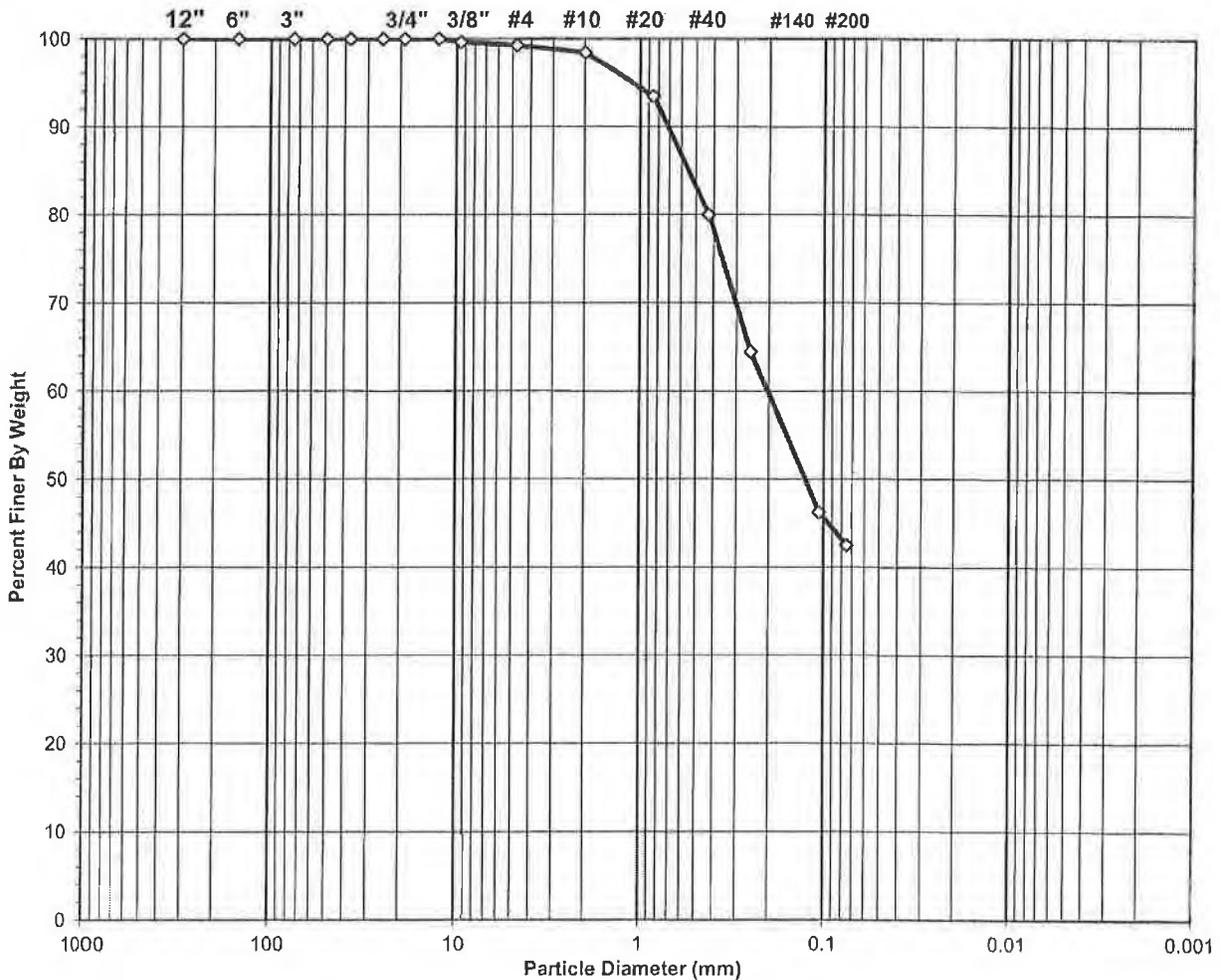
**USCS Symbol**        **SC, TESTED**

**USCS Classification** **CLAYEY SAND**
