FACILITY COMPLIANCE INSPECTION REPORT
Division of Waste Management
Solid Waste Section

Cramerton Road MSW (Closed)
 413 Cramerton Road
 Cramerton, NC

Comprehensive Audit

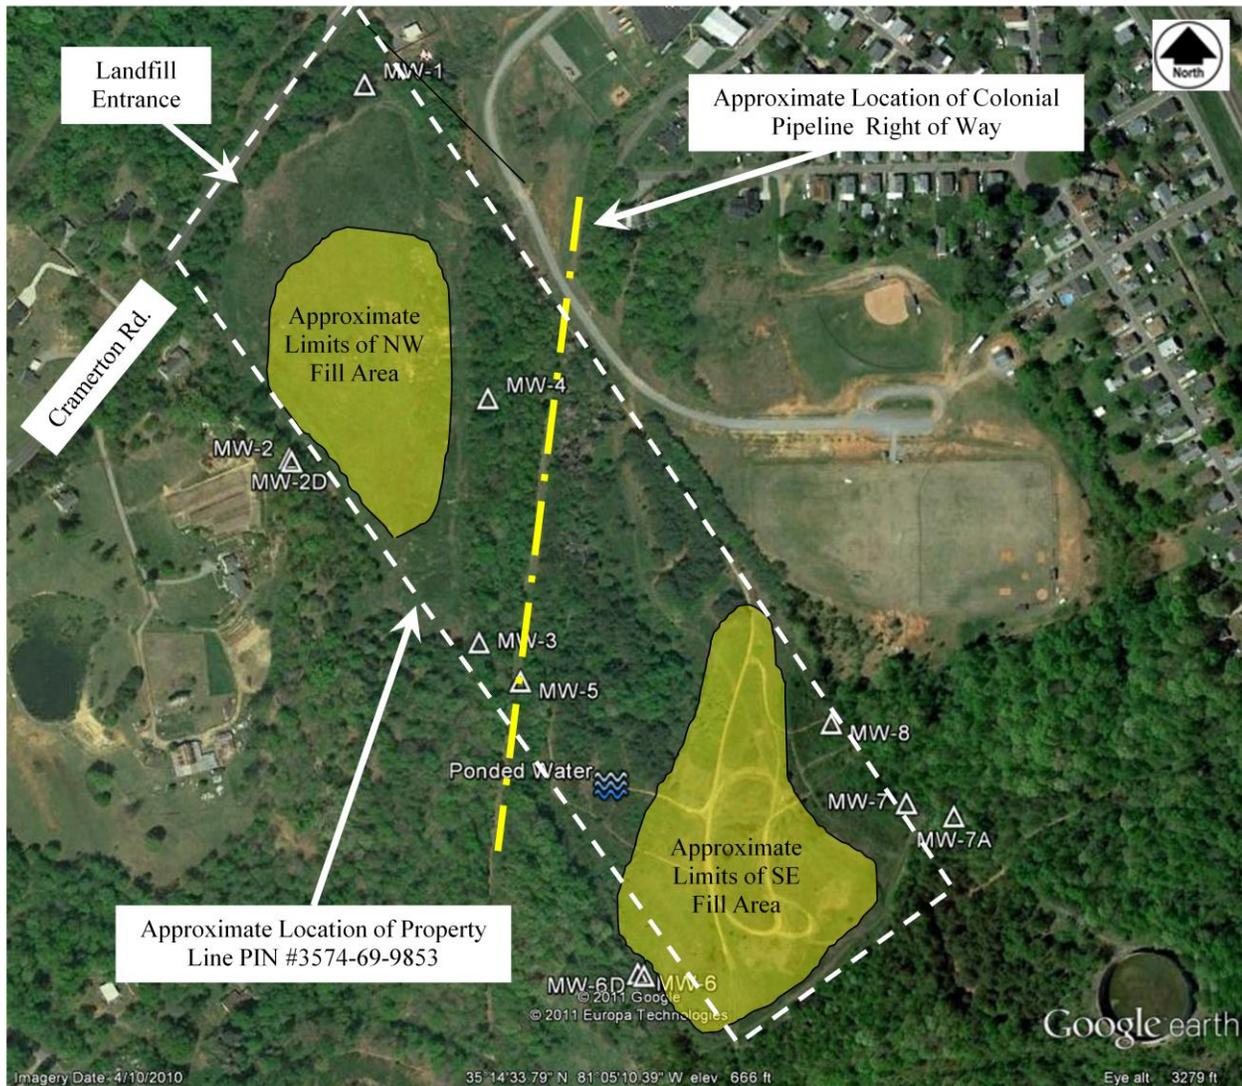
Figure 1: Google Earth Aerial: Cramerton Closed MSW Landfill 36-01
(Groundwater monitoring well locations verified 1/10/12 in the field.)

No property line markers were observed. Using the Gaston County GIS, the parcel property lines were overlaid on an approximation of the locations of the landfill limits of waste. (Figure 1) Given that Figure 1 suggests that the edge of waste is very near, if not over the property lines, and there is insufficient documentation available to show that the required buffers are being maintained, permanent waste boundary markers, along with property line markers are needed. These markers should clearly and accurately delineate the limits of waste and the property lines. (See the attached May 29, 2009 Memo: “*Permanent Edge-of-Waste Markers at Construction and Demolition Debris Landfills, Industrial Solid Waste Landfills and Municipal Solid Waste Landfills*”)

Within 60-days of your receipt of this report, please determine and mark the limits of waste of the landfill; and determine and mark the property lines of the landfill in accordance with the enclosed May 29, 2009 Memo (*Permanent Edge-of-Waste Markers at Construction and Demolition Debris Landfills, Industrial Solid Waste Landfills and Municipal Solid Waste Landfills*)”.

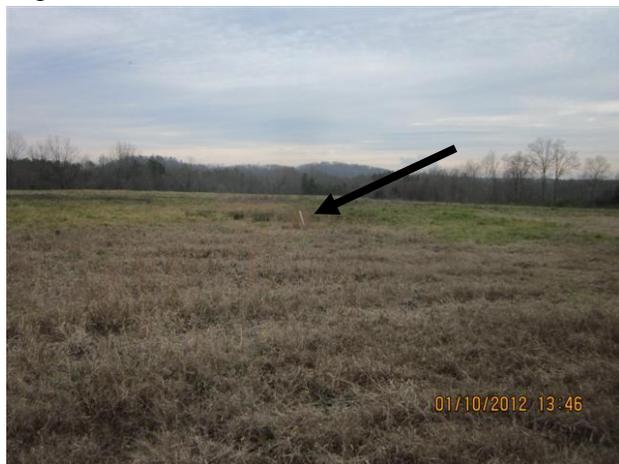
NCGS 15A NCAC 13B .0503(2)(f) requires that “a site shall meet the following buffer requirements: (i) A 50-foot minimum buffer between all property lines and disposal areas.” The property lines and limits of waste have not been clearly delineated with permanent markers. While there are some edge-of-waste markers in place (2-inch PVC piping – Photos #1and #2), these markers do not appear to match up with the site maps provided by Buxton Environmental, Inc.

1. PVC “edge of waste” marker on the NW fill area.

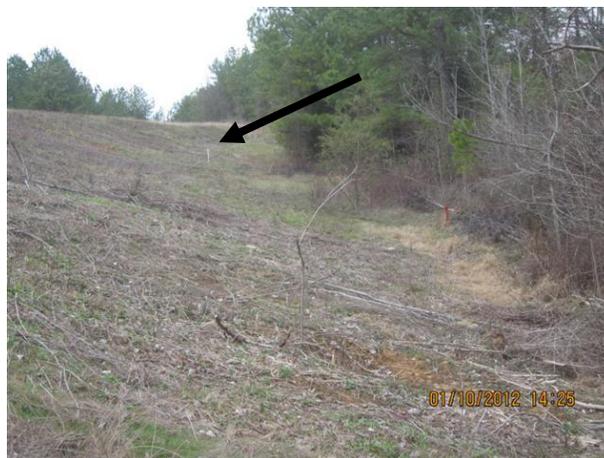
2. PVC “edge of waste” marker on the NW fill area.

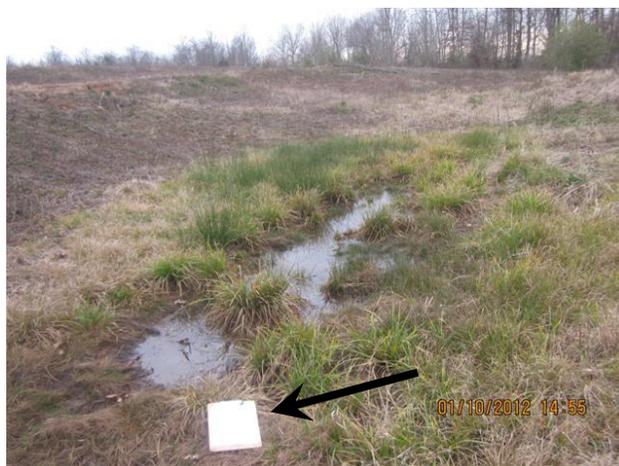
Also, there is a small area of impounded water (Photo #5) located near or on the SE Fill Area. (Figure 1) As the limits of waste are not clearly defined, it is not possible to determine if this impounded water is over waste. Should it be determined that this impounded water is over waste, this would be a violation of “Post Closure Condition #2” of the July 24, 1996 closure letter. The closure conditions specified in the “Closure Letter” included, in part, the following operational requirements:

“The landfill unit shall be maintained such that surface water runoff occurs in a controlled manner, and surface water shall not be impounded over waste.”

At this time, given the lack of conclusive documentation, these issues are not considered to be violations of the North Carolina solid waste rules.

5. Looking south across the impounded water located near or on the SE Fill Area. (White clipboard in the foreground for scale.)

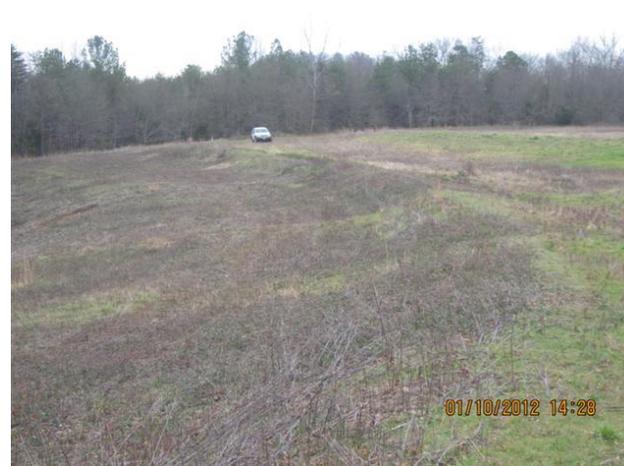
6. Looking SE along the eastern side of the SE fill area.

6. Results of the analysis of water quality samples that were collected on May 17, 2011 were reviewed.
7. The cap of the landfill has a well established vegetative cover and is free of trees and woody vegetation. (Photo #6)

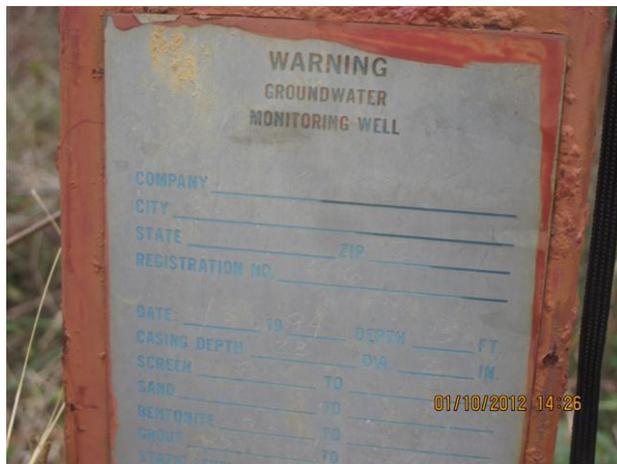
3. Only one of the groundwater monitoring wells (MW-6D) is clearly marked with a unique ID. (Table 1) Please ensure that each groundwater monitoring well is clearly marked with a unique ID and that site maps are updated to show the correct locations and IDs of each groundwater monitoring well.

3. Illegible well tag – believed to be MW-7.

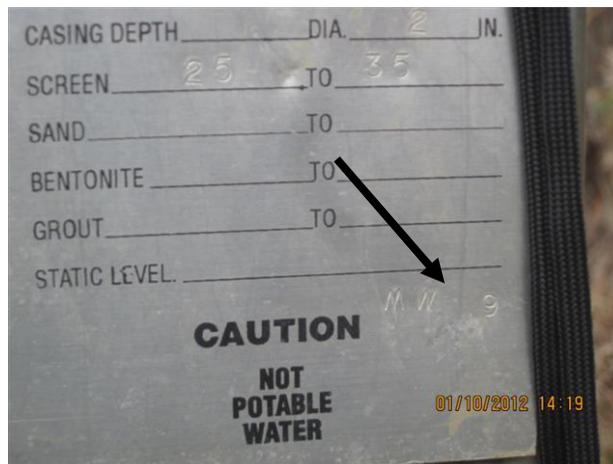
Well ID	Latitude (N)	Longitude (E)	Comment
MW-1	35.24577	-81.08834	Has well “tag”, but should be more clearly identified.
MW-2	35.24331	-81.08897	Needs new well tag & should be more clearly identified.
MW-2D	35.24333	-81.08899	Has well “tag”, but should be more clearly identified.
MW-3	35.24210	-81.08745	Has well “tag”, but should be more clearly identified.
MW-4	35.24373	-81.08736	Needs new well tag & should be more clearly identified.
MW-5	35.24184	-81.08711	Needs new well tag & should be more clearly identified.
MW-6	35.23992	-81.8615	Needs new well tag & should be more clearly identified.
MW-6D	35.23991	-81.08610	Good well tag.
MW-7	35.24104	-81.08397	Has well tag but no ID -needs new well tag. (Photo #3)
MW-7A	35.24095	-81.08385	Has well “tag” with wrong ID of “MW-9” (Photo #4)
MW-8	35.24157	-81.08458	Needs new well tag & should be more clearly identified.

4. Mis-labeled well tag with “MW-9” ID – believed to actually be well MW-7A.
