FACILITY COMPLIANCE INSPECTION REPORT
Division of Waste Management
Solid Waste Section

Macon County Municipal Solid Waste Facility
 1448 Lakeside Drive
 Franklin, NC 28724

Comprehensive Audit of MSW Landfill

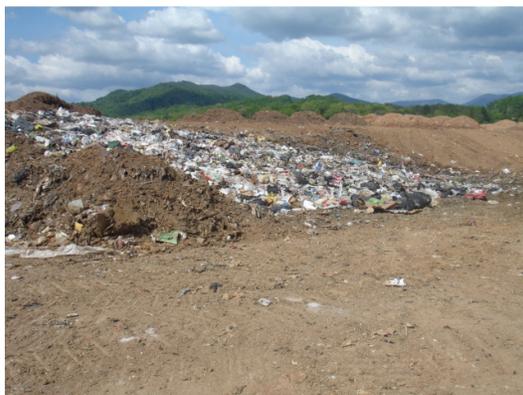
14. The MSW landfill was operating in Phase 2 (active since 1998).
15. The facility is permitted to use a mixture of 50% soil and 50% mulch as an alternate daily cover (ADC). This activity is noted in the operations plan (Section 4.2). Mulch and soil is mixed before application. The facility also uses a fabric tarp as an alternate daily cover as approved in the permit.
16. The working face area was observed being confined to a small area. There was no banned material observed with the exception of incidental amounts. **A small amount of waste was observed in the daily cover. As a reminder, all waste must be covered with at least 6 inches of earthen material or and approved alternate daily cover (ADC).**

Working Face

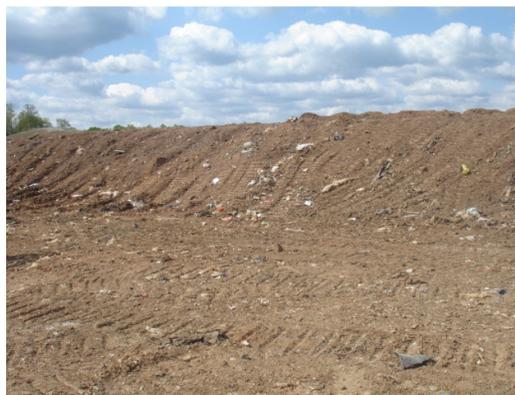
Daily Cover

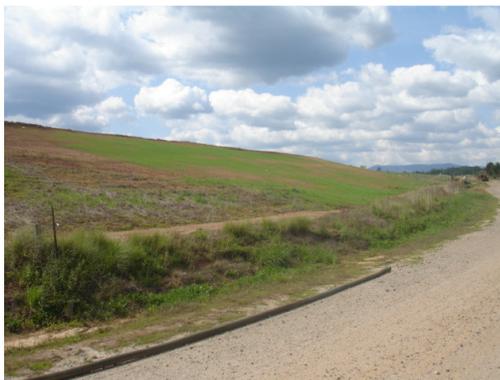
18. The intermediate cover was in excellent condition and seeded with little to no erosion.

Looking South at Phase 2 Intermediate Cover

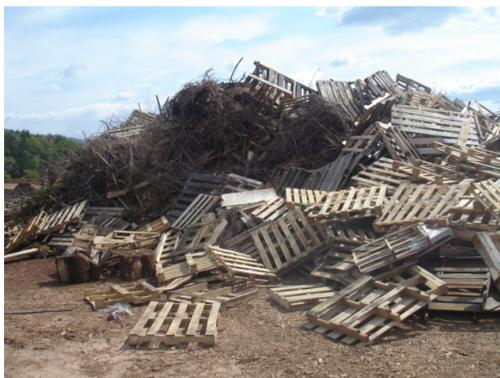
23. This area is used to generate mulch for the alternate daily cover. Material was in a pile waiting for grinding consisted primarily of land clearing debris, yard trash and pallets. This material is not available to the public.

LCID & Pallets awaiting Grinding
