FACILITY COMPLIANCE INSPECTION REPORT
Division of Waste Management
Solid Waste Section

Domtar Paper Company Landfill
 Ken Trowbridge Road
 Plymouth, North Carolina

Partial Audit without records review for pre-operative inspection of newly constructed ILF Cells 3 and 4

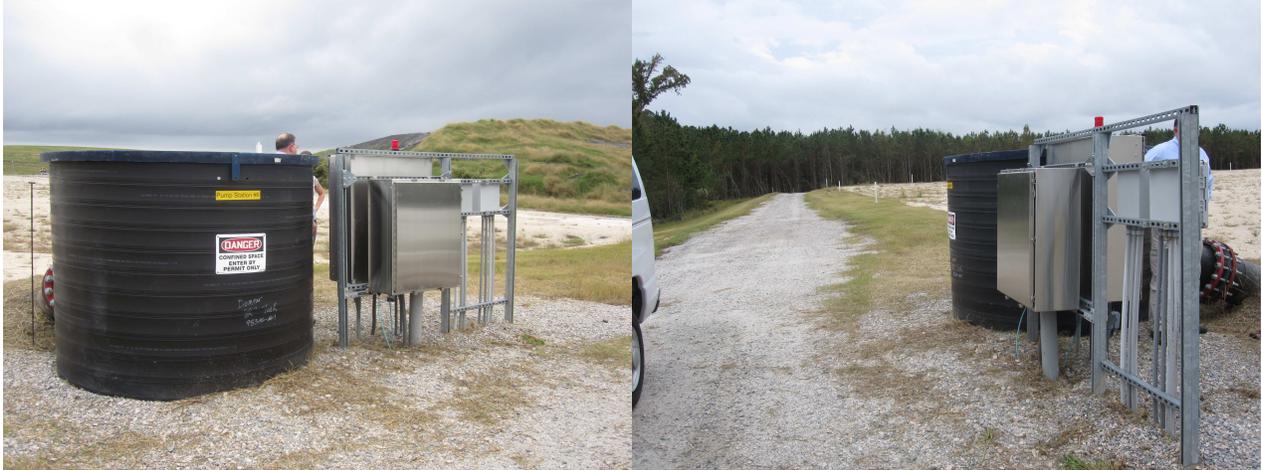
- 10) The leachate collection system cleanouts are being well maintained and are visible and accessible. The leachate collection system is scoped and cleaned annually.

Leachate collection and monitoring system in newly constructed unit

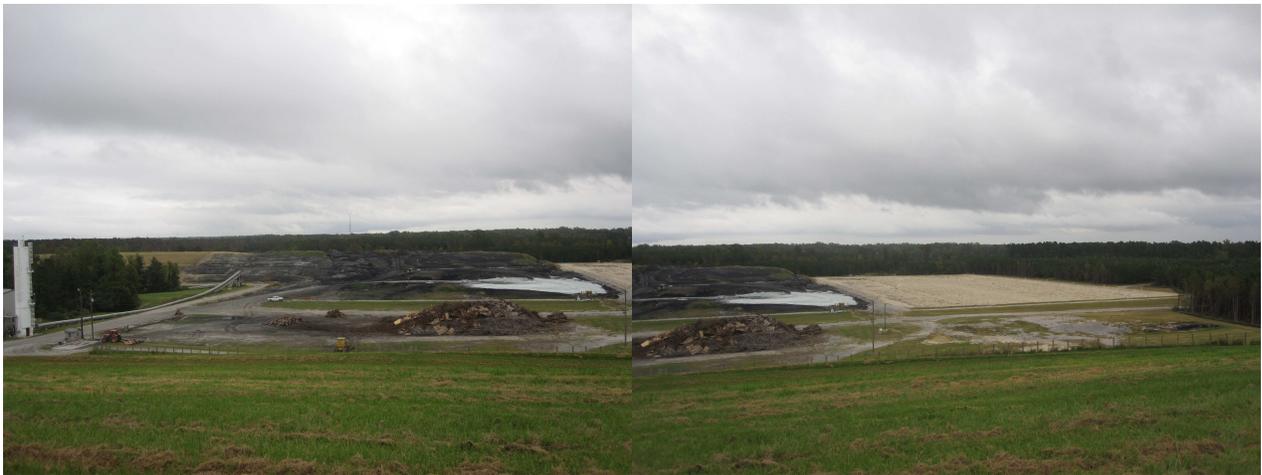
- 8) This landfill is currently operating in Unit III Cell 2. Unit II Cell 1 has been closed and covered.
- 9) Construction of Landfill Unit III Cells 3 and 4 has been completed. * It is recommended that these areas be protected by the use of either a temporary rain cover system or by the establishment of a cover crop to prevent the erosion of the newly constructed landfill base layer.

Active working area and newly constructed cells
