FACILITY COMPLIANCE INSPECTION REPORT
Division of Waste Management
Solid Waste Section

Larry Styron LCID Landfill
Herring-Smith Road
Newport, NC 28570

Site visit to review continued measures taken in response to 2 January 2012 fire event

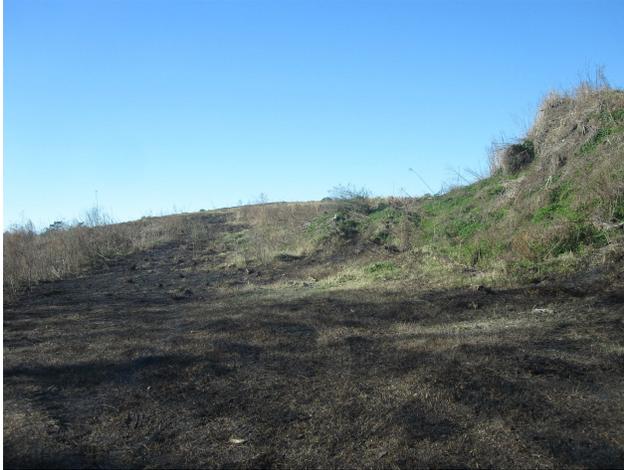
- 9) Soil has been stockpiled on-site for use in cover maintenance adjacent to the old landfill access ramp.
- 10) On 2 January 2012, the landfill supervisor observed the landfill cover crop on fire. She called Carteret County Emergency Services and personnel from the Division of Forest Resources responded and put the surface fire out.

Landfill cover crop damaged by fire, soil stockpile adjacent to old access

- 16) ***Please continue monitoring the entire landfill for further evidence of fire and take appropriate actions if such evidence is found.**
- 17) ***As soon as is safely practicable, repair any areas of your cover crop and cap that were damaged by the fire and any fire suppression activities. Once the repairs have been completed, all sideslopes should be graded at a slope not greater than 3:1 and seeded and mulched to establish a groundcover suitable to prevent erosion.**

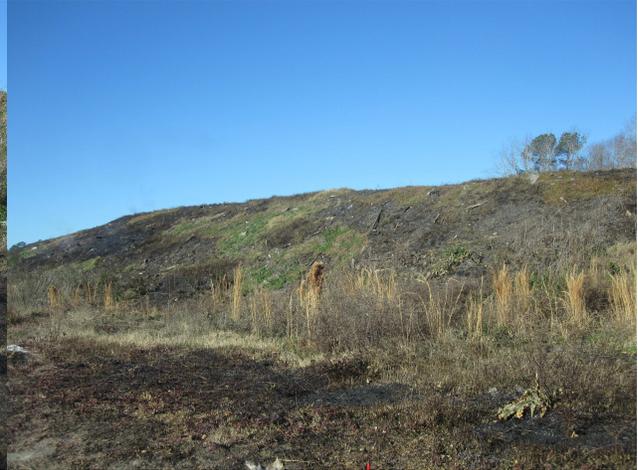
Landfill cover crop damaged by fire

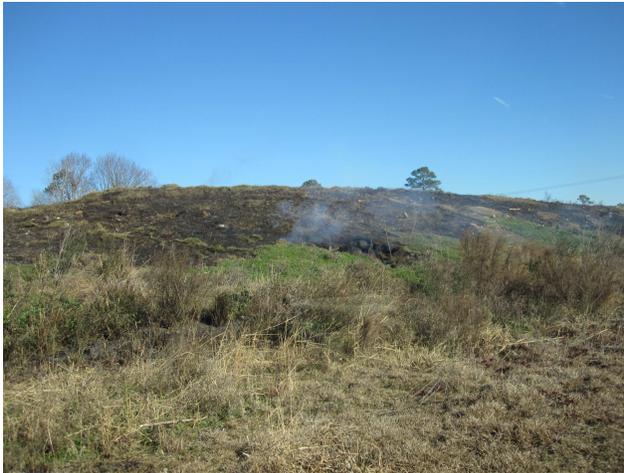
- 13) Smoke was observed emanating from three voids in the landfill cap during this site visit. ***As soon as is safely practicable, please cover and compact all areas of the cap where the smoke was observed with soil to smother any fire that may have begun inside the landfill.**

Landfill cover crop damaged by fire -note smoke emanating from voids opened in the landfill cap system.

- 14) ***Due to the danger of cave-in, special care should be taken with any heavy equipment use on or around the landfill.**
- 15) ***Plans need to be made for the installation of a portable pump and spray system in the event that the fire is not suppressed with these recommended actions.**
