FACILITY COMPLIANCE INSPECTION REPORT
Division of Waste Management
Solid Waste Section

Landfill Improvement LCID Landfill
 corner of Lakewood Drive and Elmwood Drive
 Roxboro, NC 27573

Comprehensive Audit (to ensure that the notified land clearing and inert debris (LCID) landfill is in compliance with 15A North Carolina Administrative Code (NCAC) 13B .0563, .0564, and .0566)

On February 28, 2012, John Patrone conducted a comprehensive audit of the Landfill Improvement LCID Landfill at the corner of Lakewood Drive and Elmwood Drive in Roxboro, Person County.

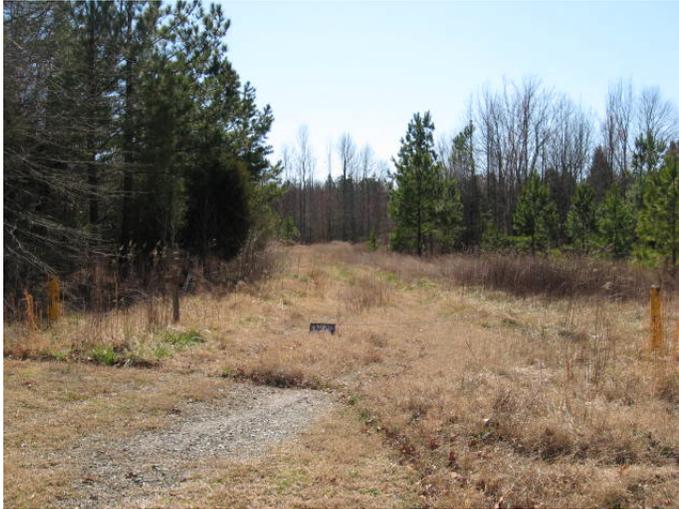
LCID landfill entrance (corner of Lakewood Drive and Elmwood Drive)

14. Ensure that the neighbors are not accessing the landfill area.
15. The landfill entrance is secured with a steel cable and lock.
16. The facility identification number is written on an "Authorized Personnel" sign posted at the entrance. Update facility contact information on the sign.

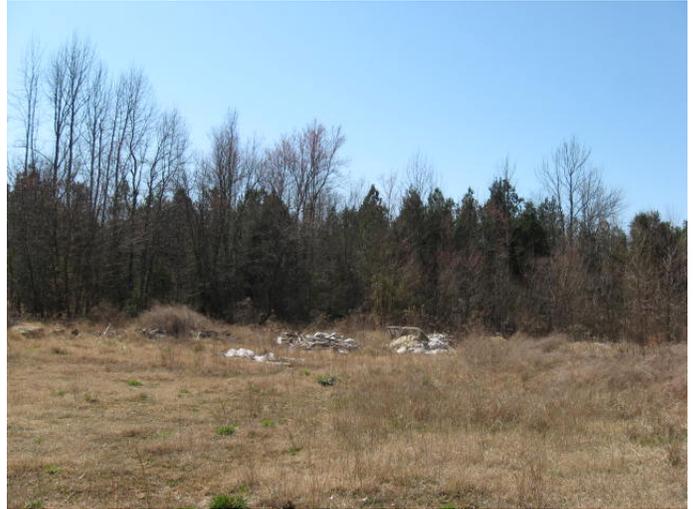
Unpermitted C&D debris, required to be removed and brought to a permitted disposal facility

12. Atop the landfill is native vegetation.
13. Remove the unpermitted construction and demolition (C&D) debris dumped at the landfill. The material must be taken to a disposal facility permitted to accept C&D debris. Mail a copy of the disposal receipts to: NCDENR – SWS, Attn. John Patrone, 585 Waughtown Street, Winston-Salem, NC 27107.

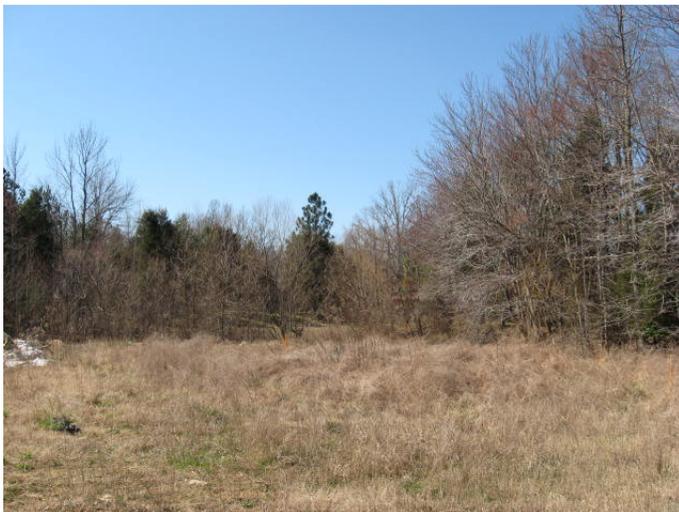
10. The aforementioned (Nos. 8 and 9) should be verified.
11. The landfill is covered with soil and appeared to be graded in accordance with the surrounding area.

Additional landfill area

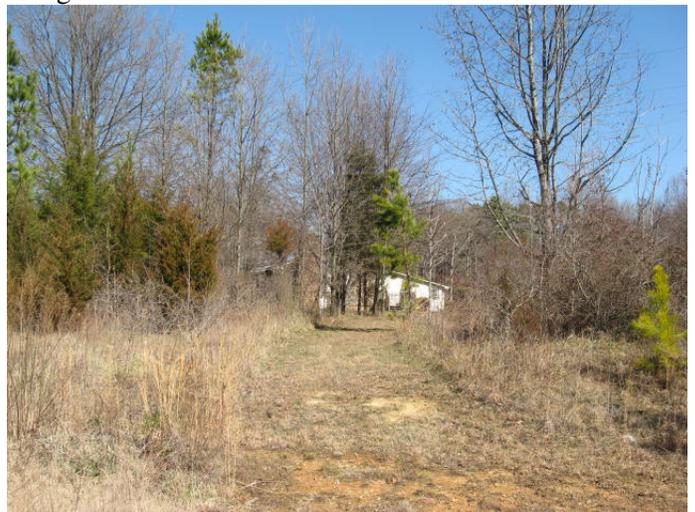
Mowed path to the LCID landfill from adjacent neighbor's residence
