Closed Avery County MSW Landfill

Ground Water Monitoring Report

September 2009 Semi-annual Monitoring Event

**Avery County Landfill
Newland, North Carolina
NC Solid Waste Permit # 06-01**

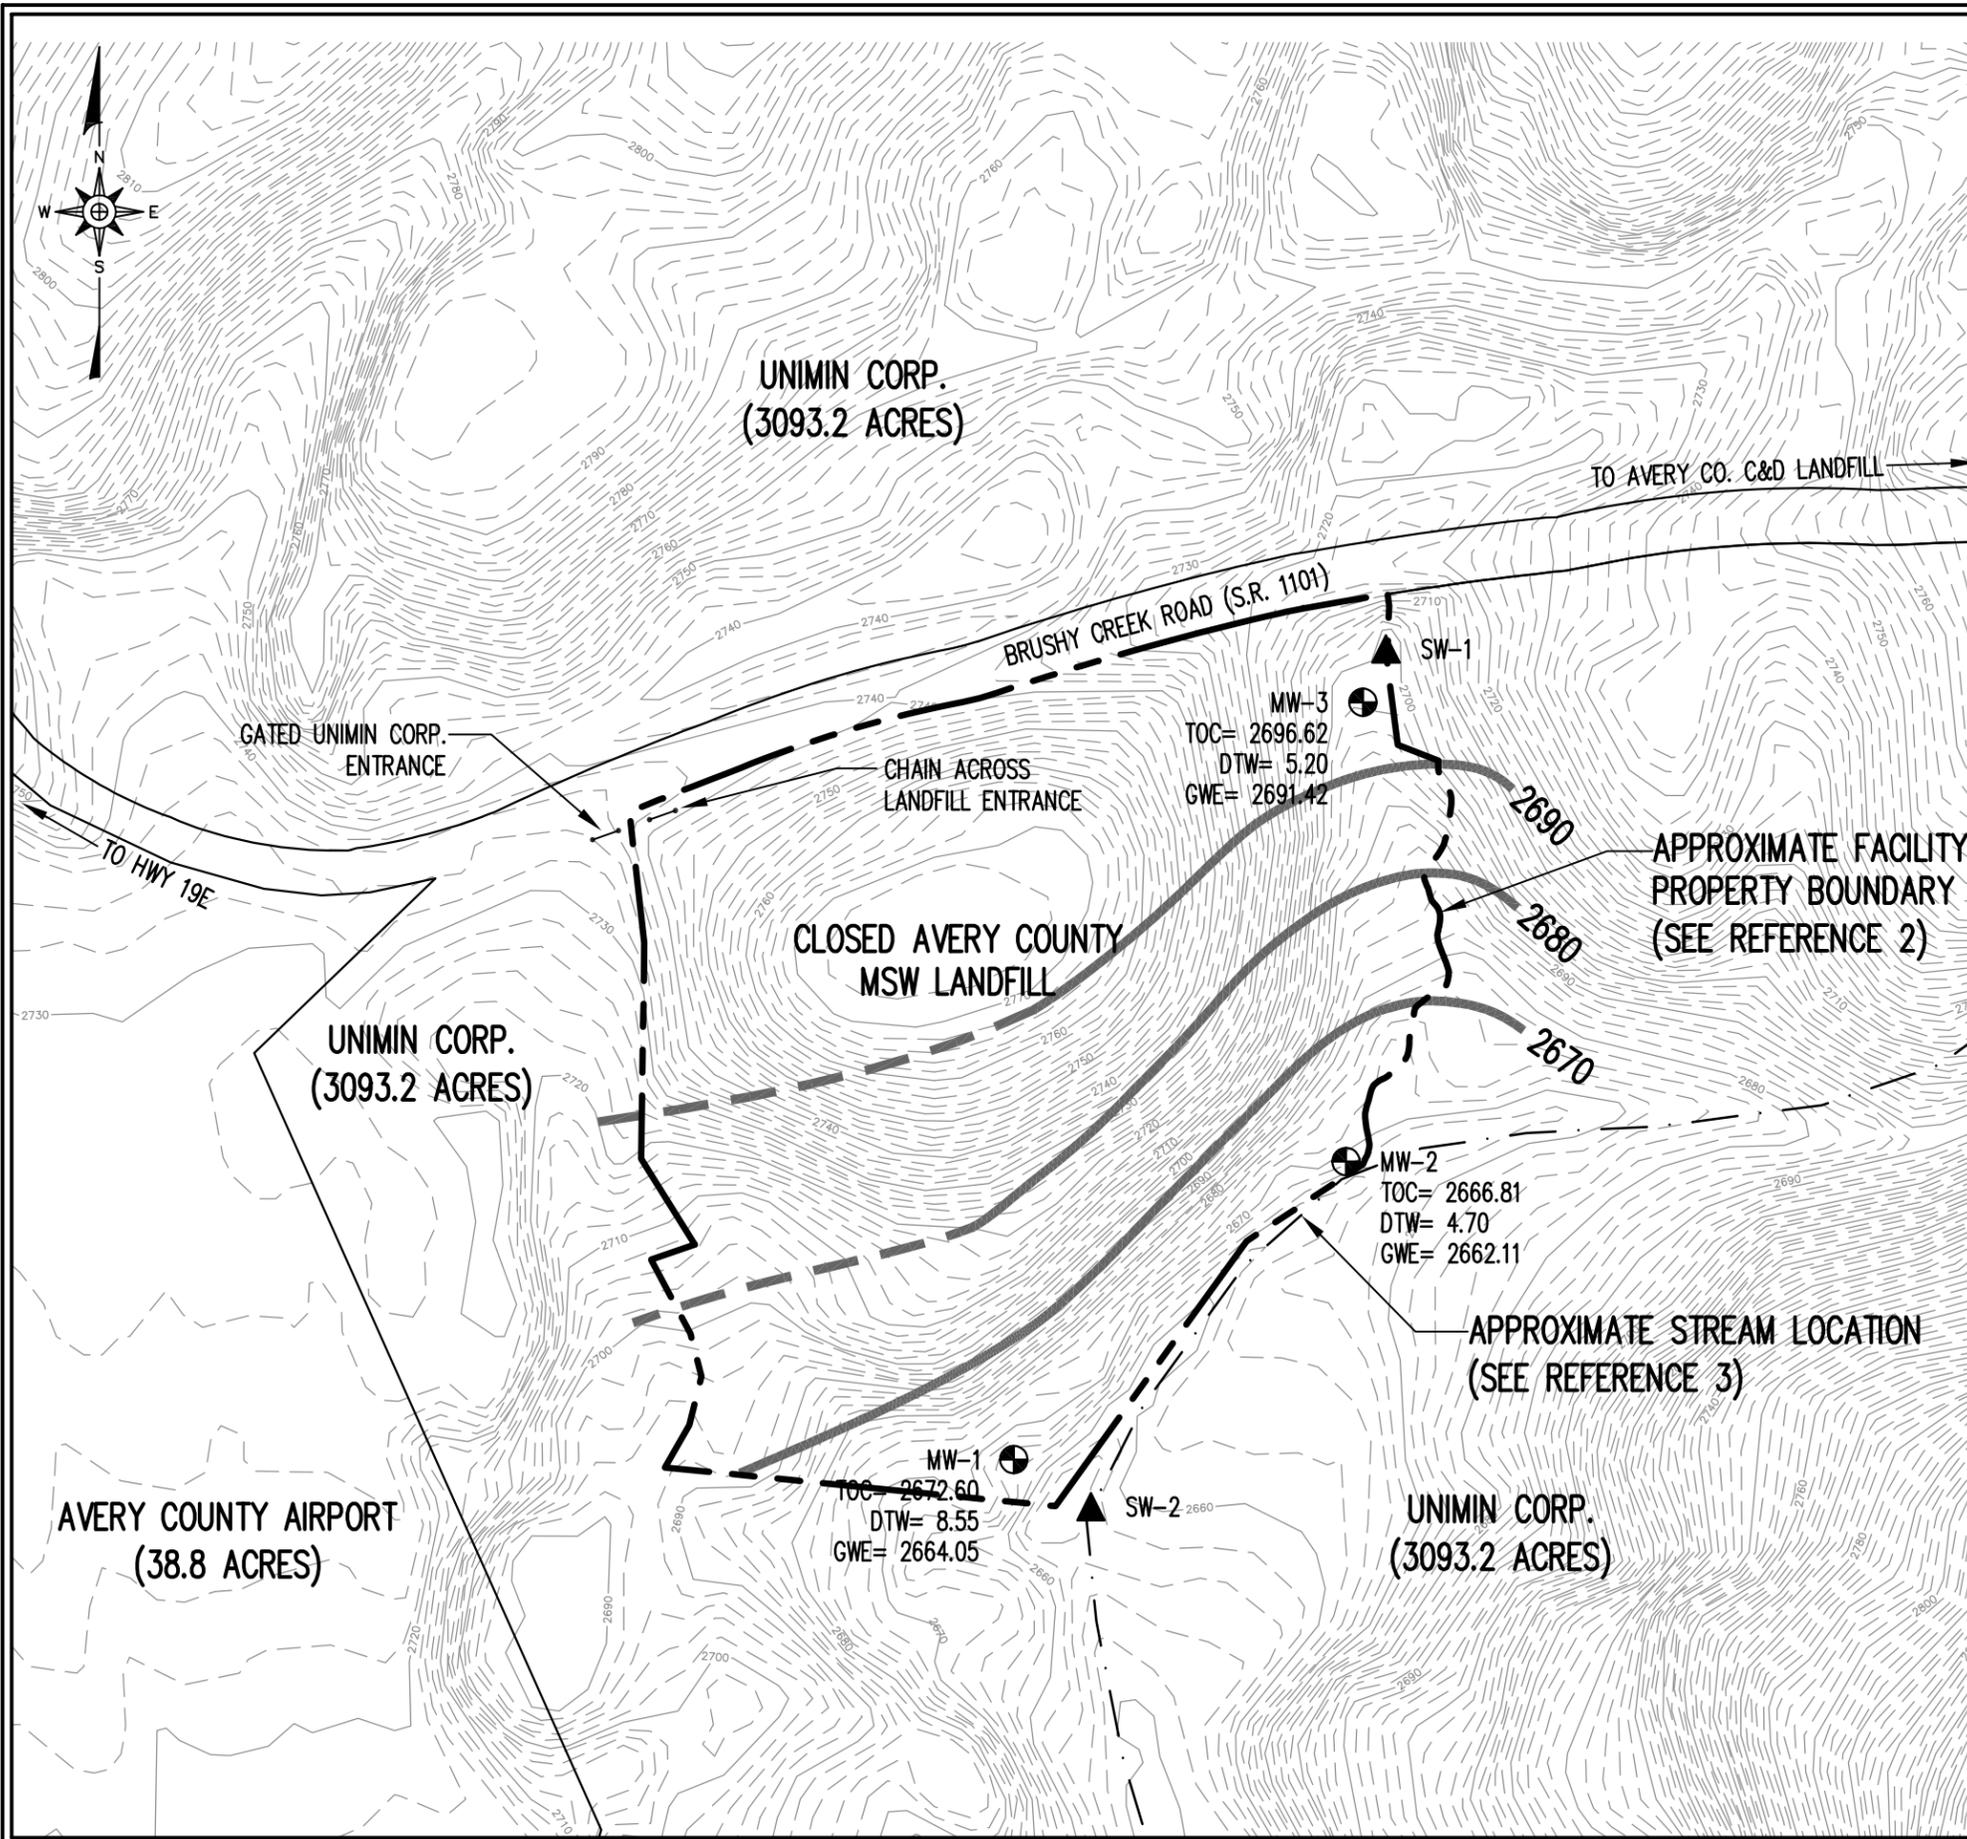
Figure 1 – Ground Water Potentiometric Map

A potentiometric surface map was prepared from ground water elevation data collected during this sampling event. The data indicates that ground water is flowing generally to the south and southeast across most of the site. Hydraulic conductivity data was not available for these wells so ground water velocities could not be calculated. The potentiometric surface map (**Figure 1**) is also attached for your review.

TITLE:
 AVERY COUNTY
 SOLID WASTE DEPARTMENT
 AVERY COUNTY MSW LANDFILL
 POTENTIOMETRIC MAP FALL '09

The sampling event was performed by trained personnel from RSG on September 29th 2009, and consisted of collecting samples from three (3) ground water wells, shown in **Figure 1**. Surface water samples were collected from two locations (SW-1 and SW-2) adjacent to the landfill. Field data sheets for the monitoring wells are included in **Appendix A** and a table of well information is available in **Appendix B**. No boring logs for these monitoring wells could be located during a file search at NCDENR.
