Avery County C&D Landfill

Ground Water Monitoring Report

**September 2009 Semi-annual
Monitoring Event**

**Avery County Landfill
Newland, North Carolina
NC Solid Waste Permit # 06-03**

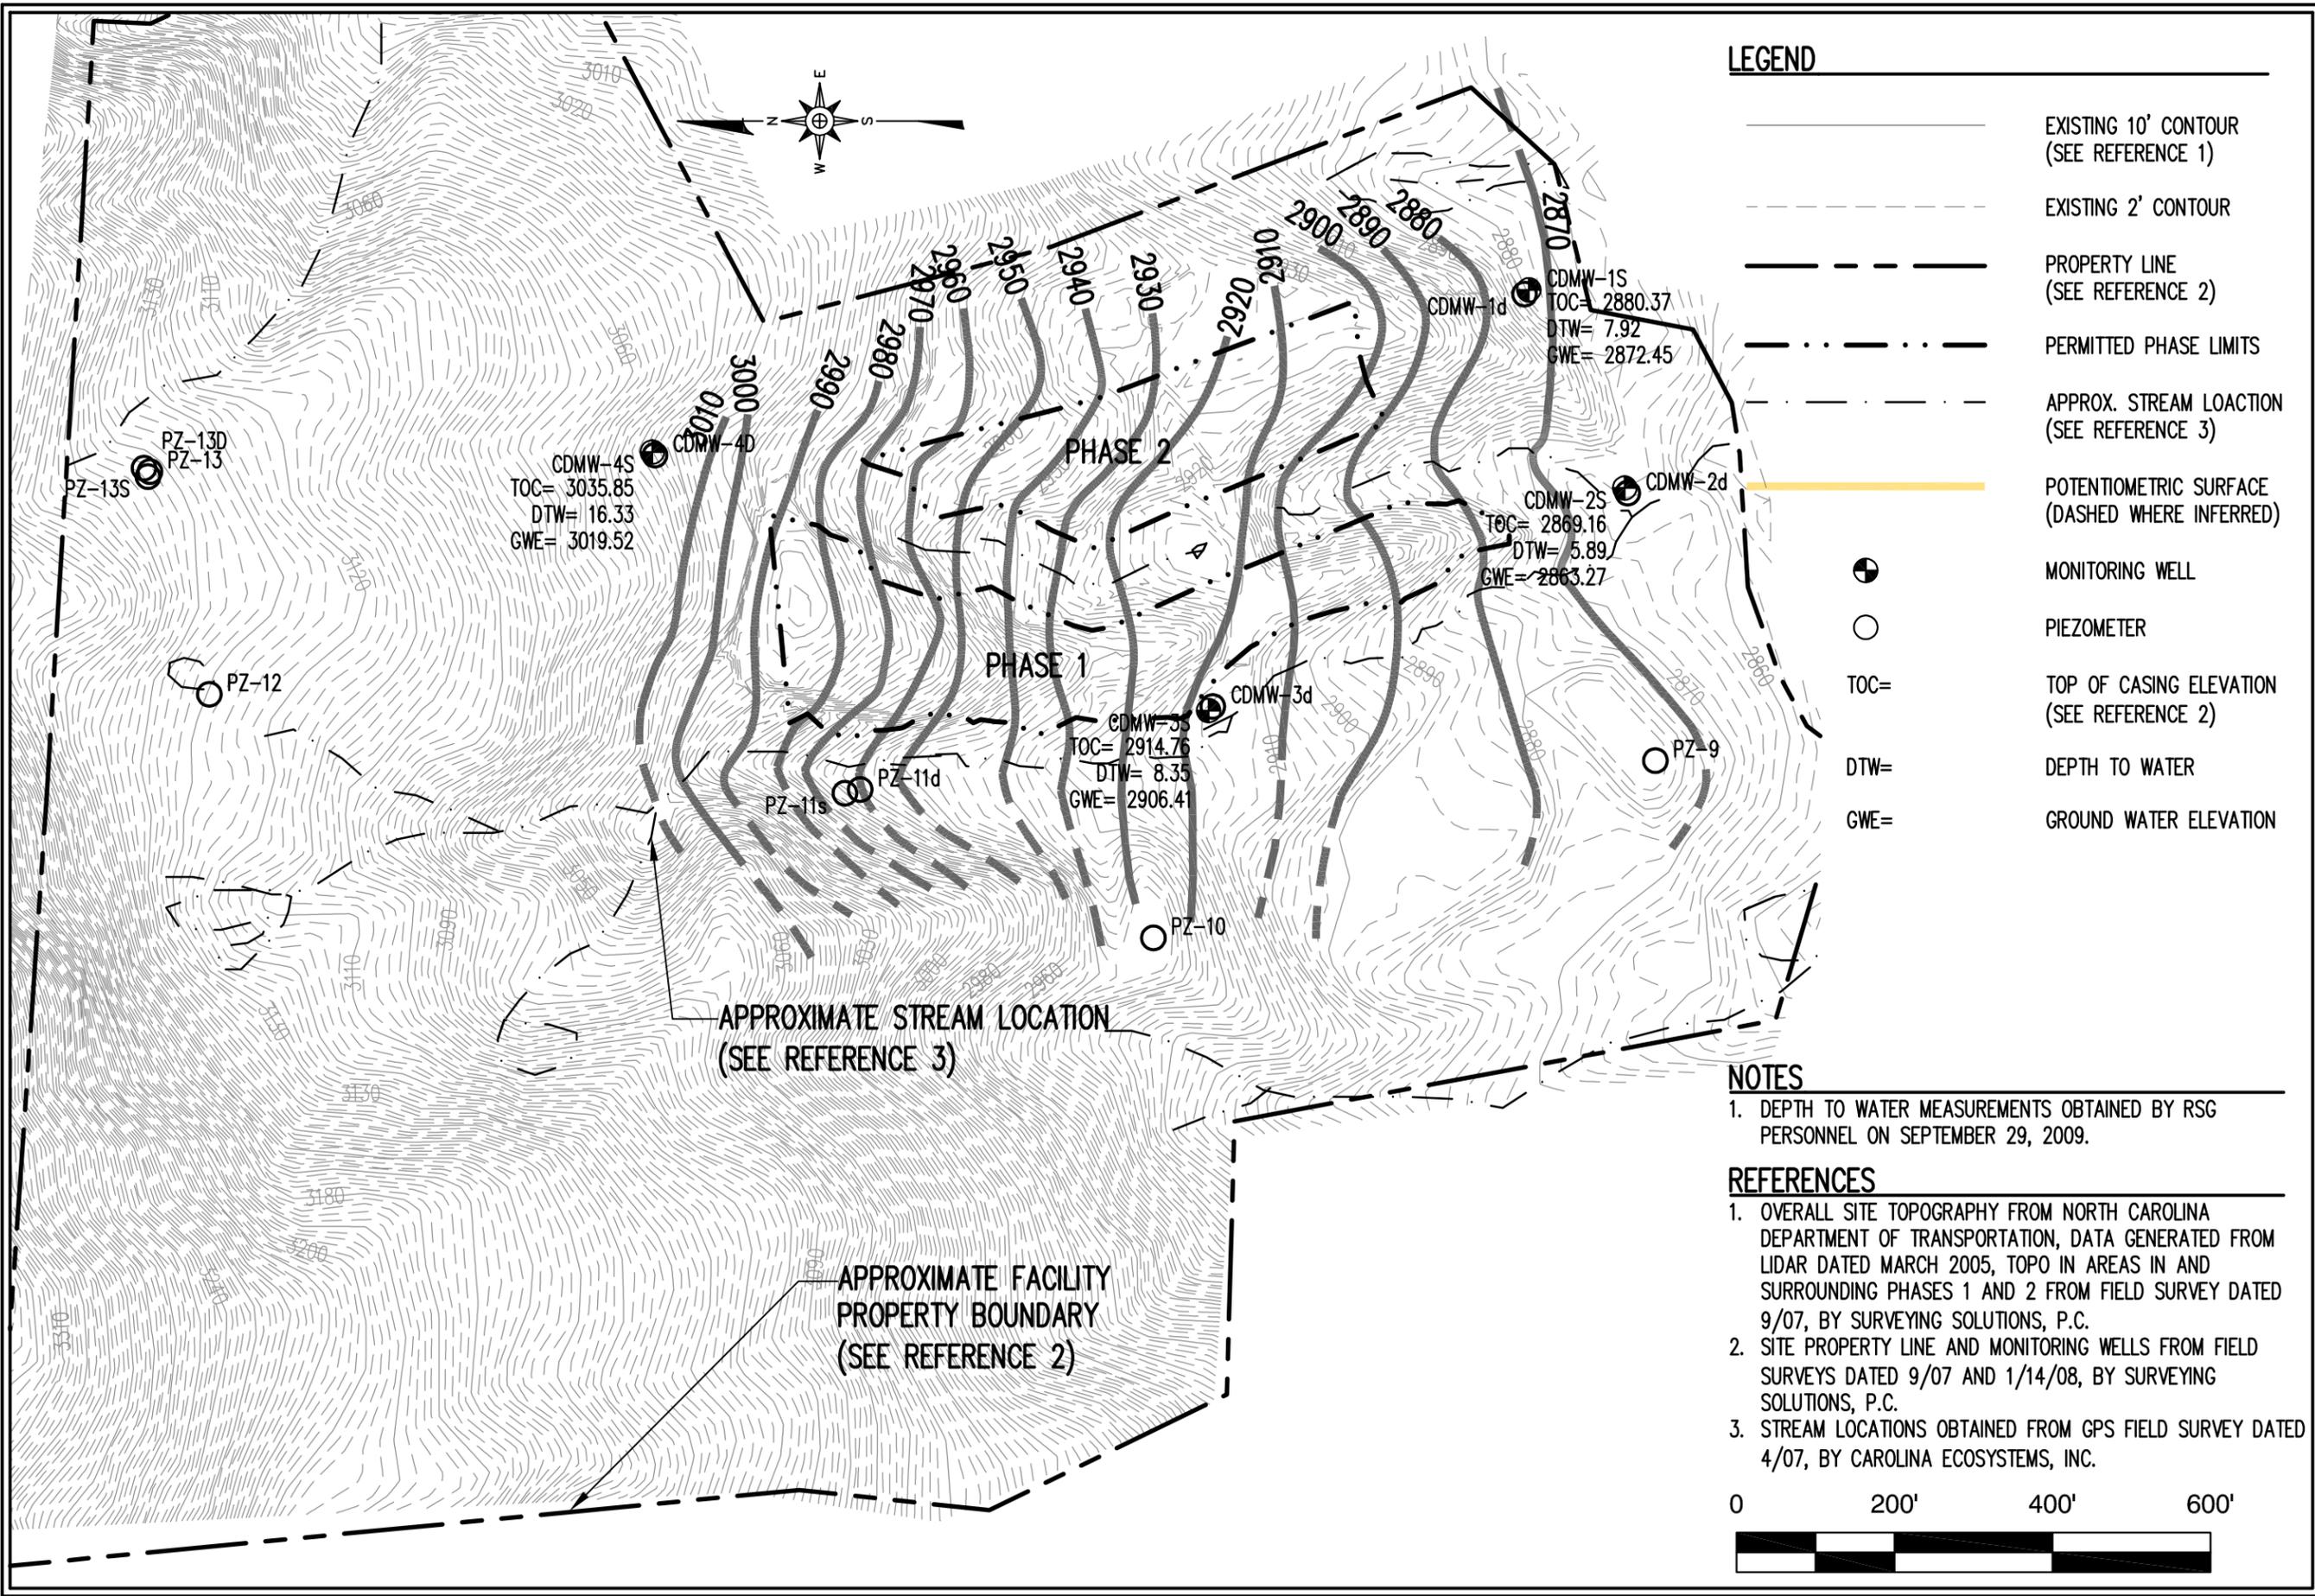
FIGURE NO.	1	FILE NAME	AVERY-B0116
SCALE:	AS SHOWN	PROJECT NO.	AVERY 09-2
CHECKED BY:	J.A.S.	DATE:	Nov. 2009
DRAWN BY:	C.T.J.

A potentiometric surface map was prepared from ground water elevation data collected during this sampling event. The data indicates that ground water is flowing generally to the south across most of the site. Hydraulic conductivity data is not available for these wells however; an average hydraulic conductivity and effective porosity for shallow wells across the site have been used to evaluate groundwater velocities. Groundwater velocity ranges from 0.004 ft/day (CDMW-3) to 0.019 ft/day (CDMW-4). The potentiometric surface map (**Figure 1**) is also attached for your review.

TITLE:
 AVERY COUNTY
 SOLID WASTE DEPARTMENT
 AVERY COUNTY C&D LANDFILL
 POTENTIOMETRIC MAP FALL '09

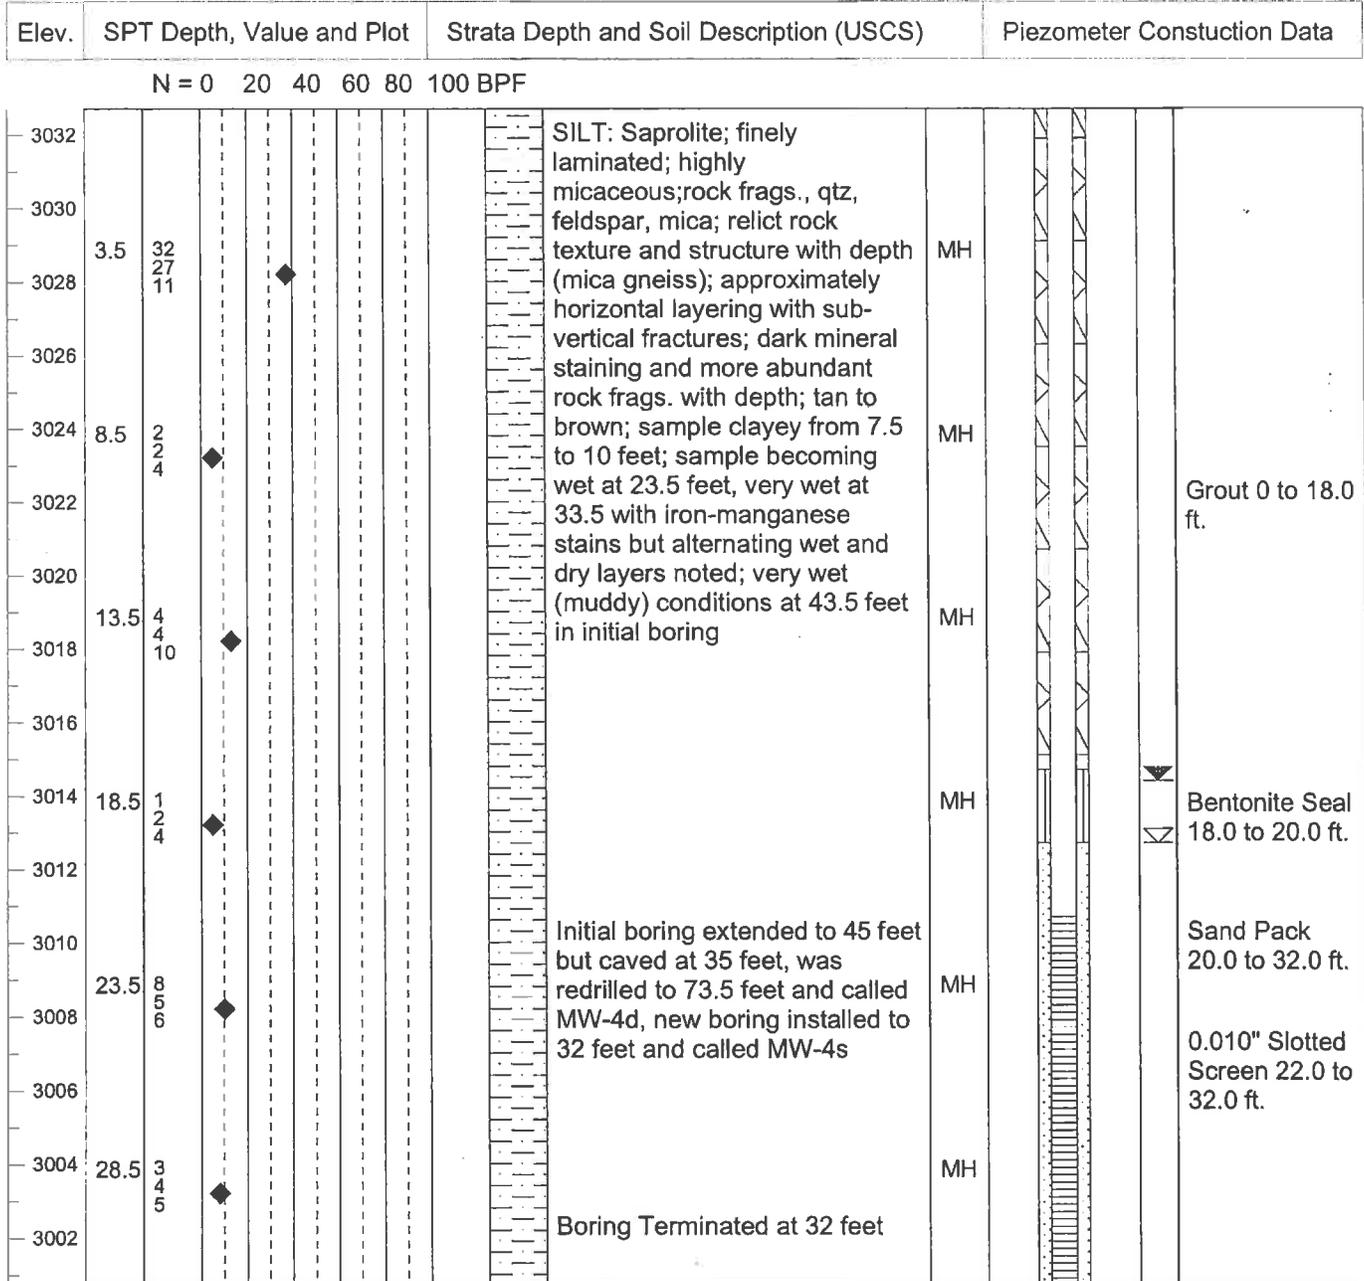
Boring No. MW-4s

Client and Project **Avery County C&D Expansion**

Ground Elevation **3032.72**

Water Level, TOB **20.00** \sphericalangle

Water Level, 24 Hr. **15.78**

Stabilized Level **18.30** \sphericalangle

Comments **Immediately north of landfill**

Total Depth **32.0**

Note: survey data from 9/07 and 1/14/08 by Surveying Solutions, P.C.
 Depth to Water and Depth to Bottom measured from Top of Casing
 No boring logs available for monitoring wells MW-1s, MW-2s and MW-3s
 screened interval assumed based upon depth to bottom measurements.
 Monitoring well MW-4s data is actual data from boring log (attached)
