**FACILITY COMPLIANCE INSPECTION REPORT**  
**Division of Waste Management**  
**Solid Waste Section**

Beaufort County Closed MSW Landfill  
 1342 Hawkins Beach Road  
 Bath, NC 27808

Partial Facility Compliance Inspection without records review to review corrective measures taken in response to Facility Compliance Inspection Report 0702-20120806INSP

0702-20121114INSP

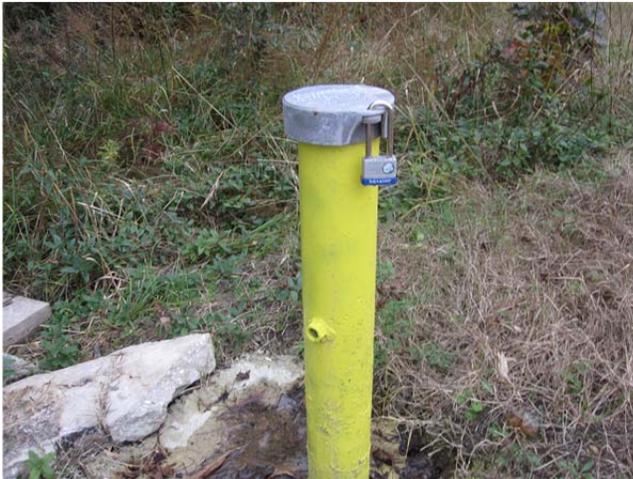
- 6) The damaged facility monitoring well noted in the previous Inspection Report has been repaired. This well has been painted with high visibility paint, the cap has been replaced with a new lock installed, and the concrete pad has been replaced.

Monitoring well repainted, with new cap, lock, and concrete pad

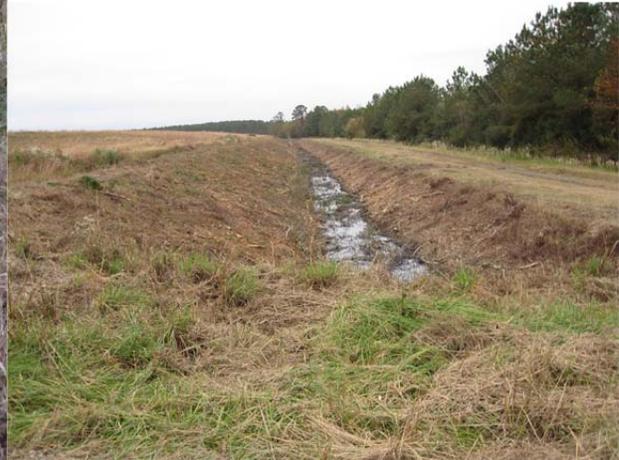
- 5) The trees and woody vegetation noted as growing in and along the surface water ditch that runs along the western sideslope of the landfill have been removed.

Surface water ditch cleared of trees and woody vegetation
