**FACILITY COMPLIANCE INSPECTION REPORT**  
**Division of Waste Management**  
**Solid Waste Section**

**Date of Site Inspection:** 3 January 2013

Beaufort County Transfer Station  
 500 Flanders Filters Road  
 Washington, NC

0703T-20130103INSP

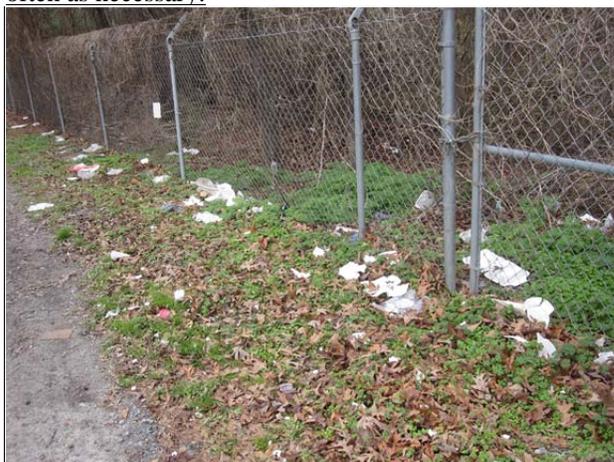
- 15) Windblown debris was noted outside of the perimeter fence and along the inside of the fence directly behind the transfer station. \*Please ensure that all windblown debris is collected and properly managed at the end of each workday or more often as necessary.

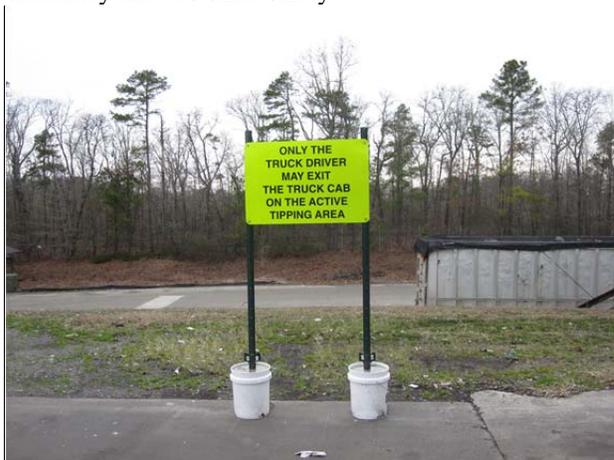
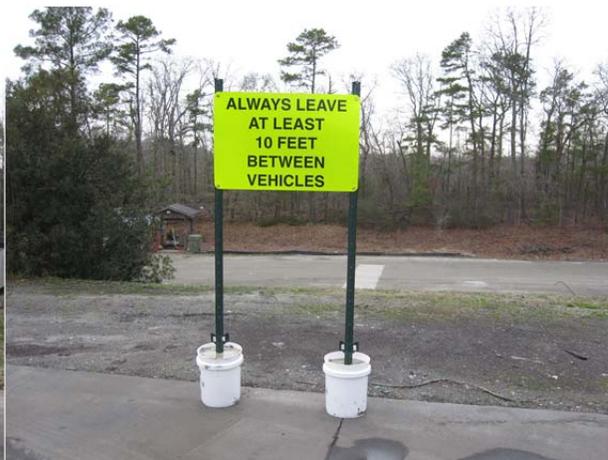
- 22) Signage has been posted at the tipping floor turn around with operating instructions to increase facility operations efficiency and customer safety.
