FACILITY COMPLIANCE INSPECTION REPORT
Division of Waste Management
Solid Waste Section

Beaufort County Transfer Station
 500 Flanders Filters Road
 Washington, NC

Comprehensive Facility Inspection

0703T-20120806INSP

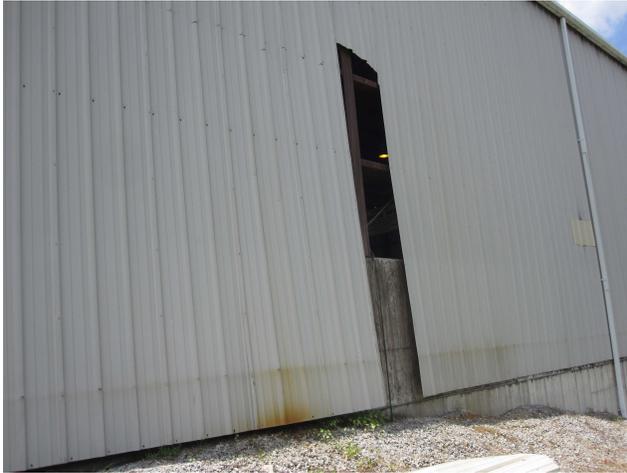
- 33) A portion of the transfer facility's metal siding has been blown from the facility wall. *Within thirty days of receipt of this Facility Compliance Inspection Report, please repair/replace this section of the facility wall.

Damaged siding on facility wall

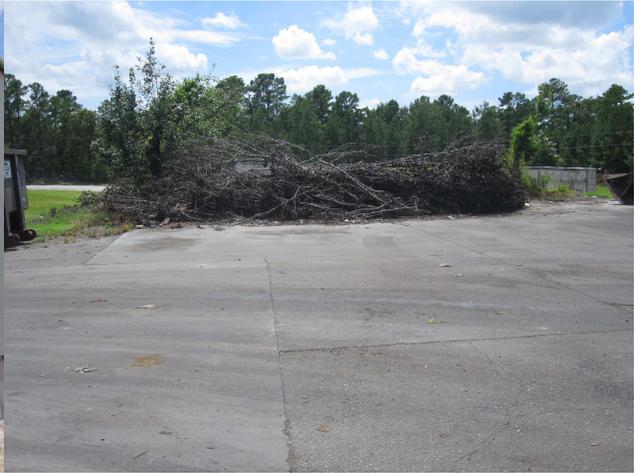
- 32) A pile of vegetative waste was observed stored on the concrete turnaround at the tipping floor access. This debris may pose a safety hazard by impeding equipment operator visibility and equipment turnaround as well as being a vector attractant. Facility personnel indicated that the material was from on site and was from damage related to a storm that occurred in late spring. *Within thirty days of receipt of this Facility Compliance Inspection Report, please collect this debris and move it to a safer area away from the concrete turnaround. As this material is from on site, it does not have to be removed from the site for disposal. However, to prevent its use by vectors, it is recommended that it be removed from the facility.

Vegetative debris on concrete turnaround
