FACILITY COMPLIANCE INSPECTION REPORT
Division of Waste Management
Solid Waste Section

FACILITY NAME AND ADDRESS:
 Carteret County/CRSWMA Transfer Facility
 800 Hibbs Road
 Newport, NC

PURPOSE OF SITE VISIT:
 Comprehensive Facility Audit

1604T-20130207INSP

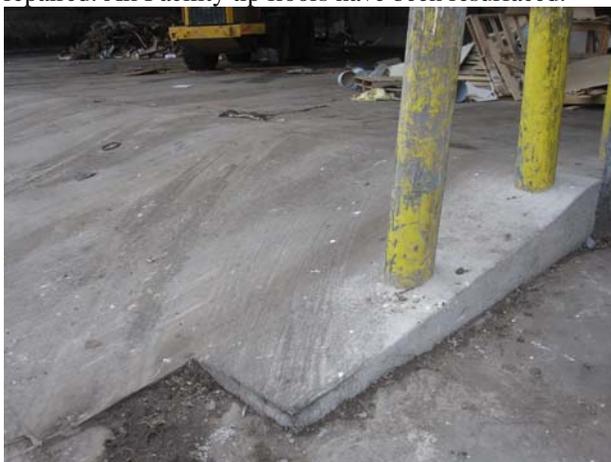
- 16) Recyclable metals and unacceptable waste streams are removed from the facility daily.
- 17) The areas of excessive wear on the tipping floor noted in the previous Facility Compliance Inspection Report have been repaired. All Facility tip floors have been resurfaced.

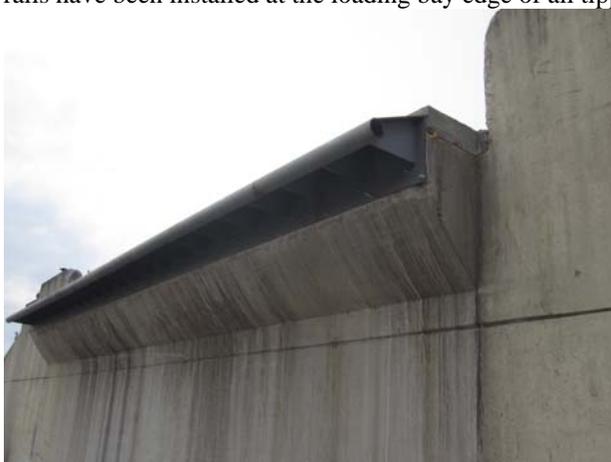
- 18) The exposed re-bar that was noted at the loading bay edge of the tipping floor has been repaired. New reinforced steel rails have been installed at the loading bay edge of all tipping floors.

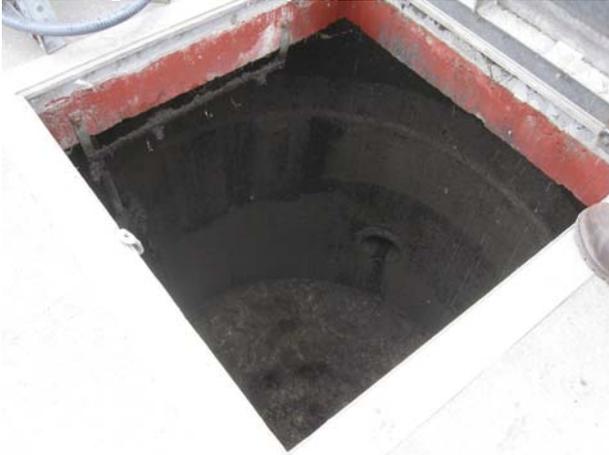
- 25) Wood pallets are stored in an area adjacent to the yard waste collection area. These pallets are removed as needed and hauled to the Coastal Environmental Partnership Compost Facility, permit #25-09, in Craven County where they are ground for use as boiler fuel.
- 26) Scrap tires are collected and placed into trailers for direct haul to the tire management facility.
- 27) Leachate is collected on-site in an above ground storage tank and is pumped down and hauled for treatment as needed.
- 28) The underground leachate pump station has been cleaned of sediment and debris.
