**FACILITY COMPLIANCE INSPECTION REPORT**  
**Division of Waste Management**  
**Solid Waste Section**

**Date of Site Inspection:** 8 March 2013

Weyerhaeuser Industrial Landfill  
 Washington Post Road  
 Vanceboro, NC

Comprehensive Facility Audit

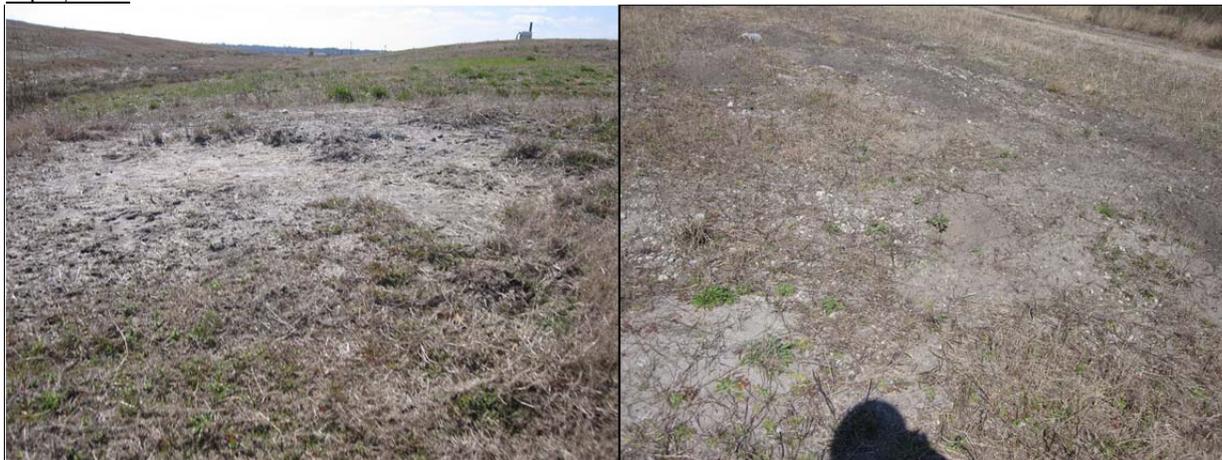
- 11) Overall the cover crop has been well established and maintained on the landfill sideslopes. However, several small areas of sparse cover were noted throughout the landfill. The site supervisor stated that a contractor has been scheduled to review the site and begin work on establishing a cover crop suitable to prevent erosion of the landfill cap system in these areas. \*As soon as possible, please ensure that these areas are graded, seeded, and mulched to establish a cover crop suitable to prevent erosion and that the cover is maintained throughout the landfill to protect the integrity of your landfill cap system.

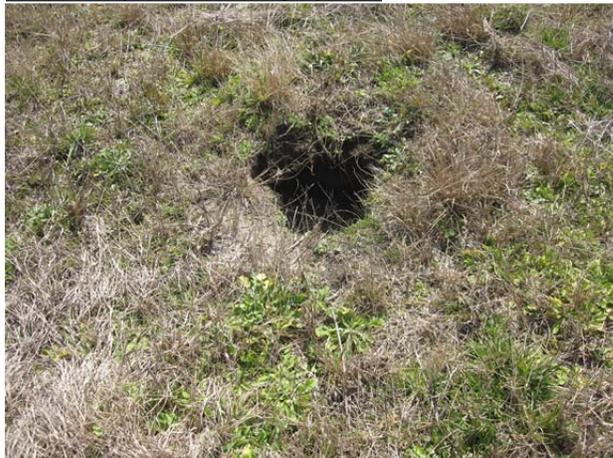
- 12) A sinkhole was observed near the top lift at the southeastern end of the landfill. \*Within thirty days of receipt of this report, please repair this area. The sinkhole should be filled with clean soil and packed. The repaired area should be graded at a slope not greater than 3:1, and then seeded and mulched to establish a groundcover suitable to prevent erosion of your landfill cap system.
