FACILITY COMPLIANCE INSPECTION REPORT
Division of Waste Management
Solid Waste Section

MCAS Cherry Point Transfer Facility
 Mockingbird Road
 MCAS Cherry Point, NC 28533

Comprehensive Facility Compliance Inspection

2510T-20130509INSP

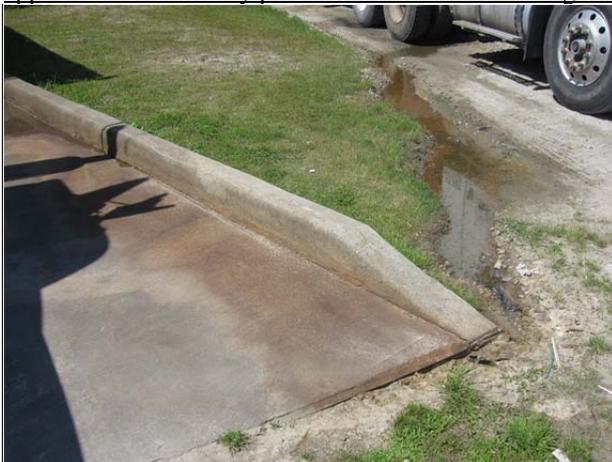
- 21) The leachate collection drains were free of debris during this Facility Compliance Inspection.
- 22) Leachate was observed draining off of the concrete trailer loading pad and collecting in the trailer parking area.
*Immediate actions should be taken to prevent any leachate releases and to restrict leachate to the loading bay leachate collection drains. No leachate was observed leaving the Facility. It is recommended that a concrete bumper be installed across the entry to the loading bay to restrict leachate to the loading area. Within thirty days of receipt of this Facility Compliance Inspection Report, please submit a written plan for the installation of a concrete bumper or other such apparatus to effectively prevent leachate from leaving the trailer loading area.

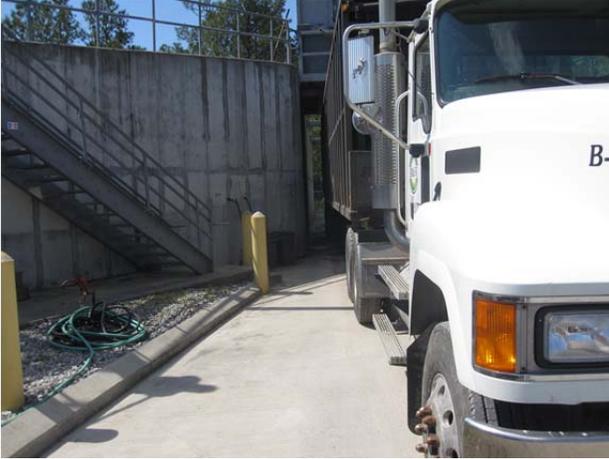
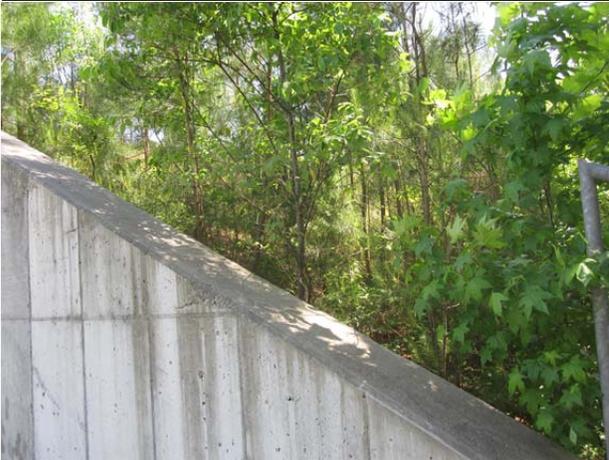
- 27) Brush and woody vegetation have not been removed from back sideslope of the facility. *Please remove all brush and woody vegetation from this area and maintain the grass cover crop to prevent erosion.
