FACILITY COMPLIANCE INSPECTION REPORT
Division of Waste Management
Solid Waste Section

Date of Site Inspection: 3 December 2012 **Date of Last Inspection:** 4 September 2012

Dare County C&D Landfill
 1603 Cub Road
 Manns Harbor, NC 27953

2803-20121203INSP

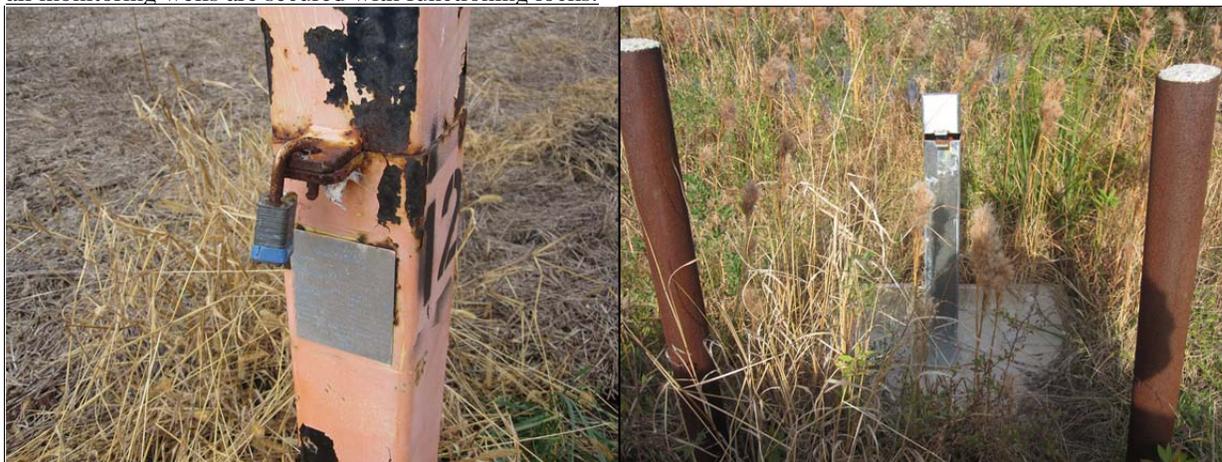
- 20) Windblown debris is being well managed at this time.
- 21) The white goods/metal recycling area is being well managed at this time.
- 22) Facility monitoring wells were reviewed during this Facility Compliance Inspection. None of the wells were secured with locks. Many of the wells were lacking locks and the wells with locks in place were not locked. *Please ensure that all monitoring wells are secured with functioning locks.

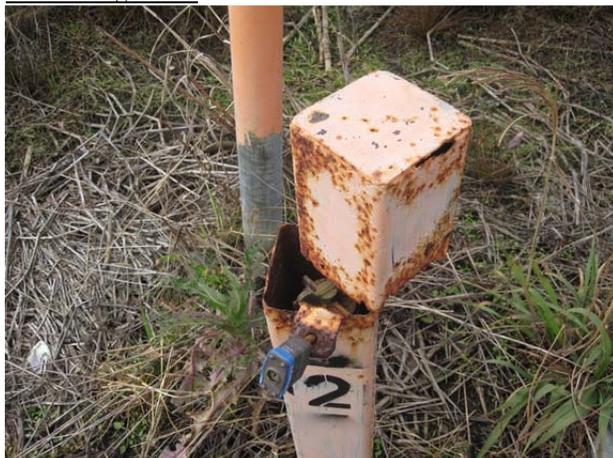
- 23) Several of the older wells adjacent to Cell #1 were noted as needing repair or replacement of the well casing due to damage and/or corrosion. Monitoring well #2 cannot be secured due to rust damage. *Within thirty days of receipt of this Facility Compliance Inspection Report, please repair all damaged wells and ensure that they remain secured with functioning locks.
