**Groundwater Monitoring Report  
October 2012 Semi-Annual Event**

**Davidson County Closed Holly Grove Landfill  
NC Solid Waste Permit No. 29-02**

# Groundwater Monitoring Report – October 2012

## Davidson County Closed Holly Grove Landfill NC Solid Waste Permit No. 29-02

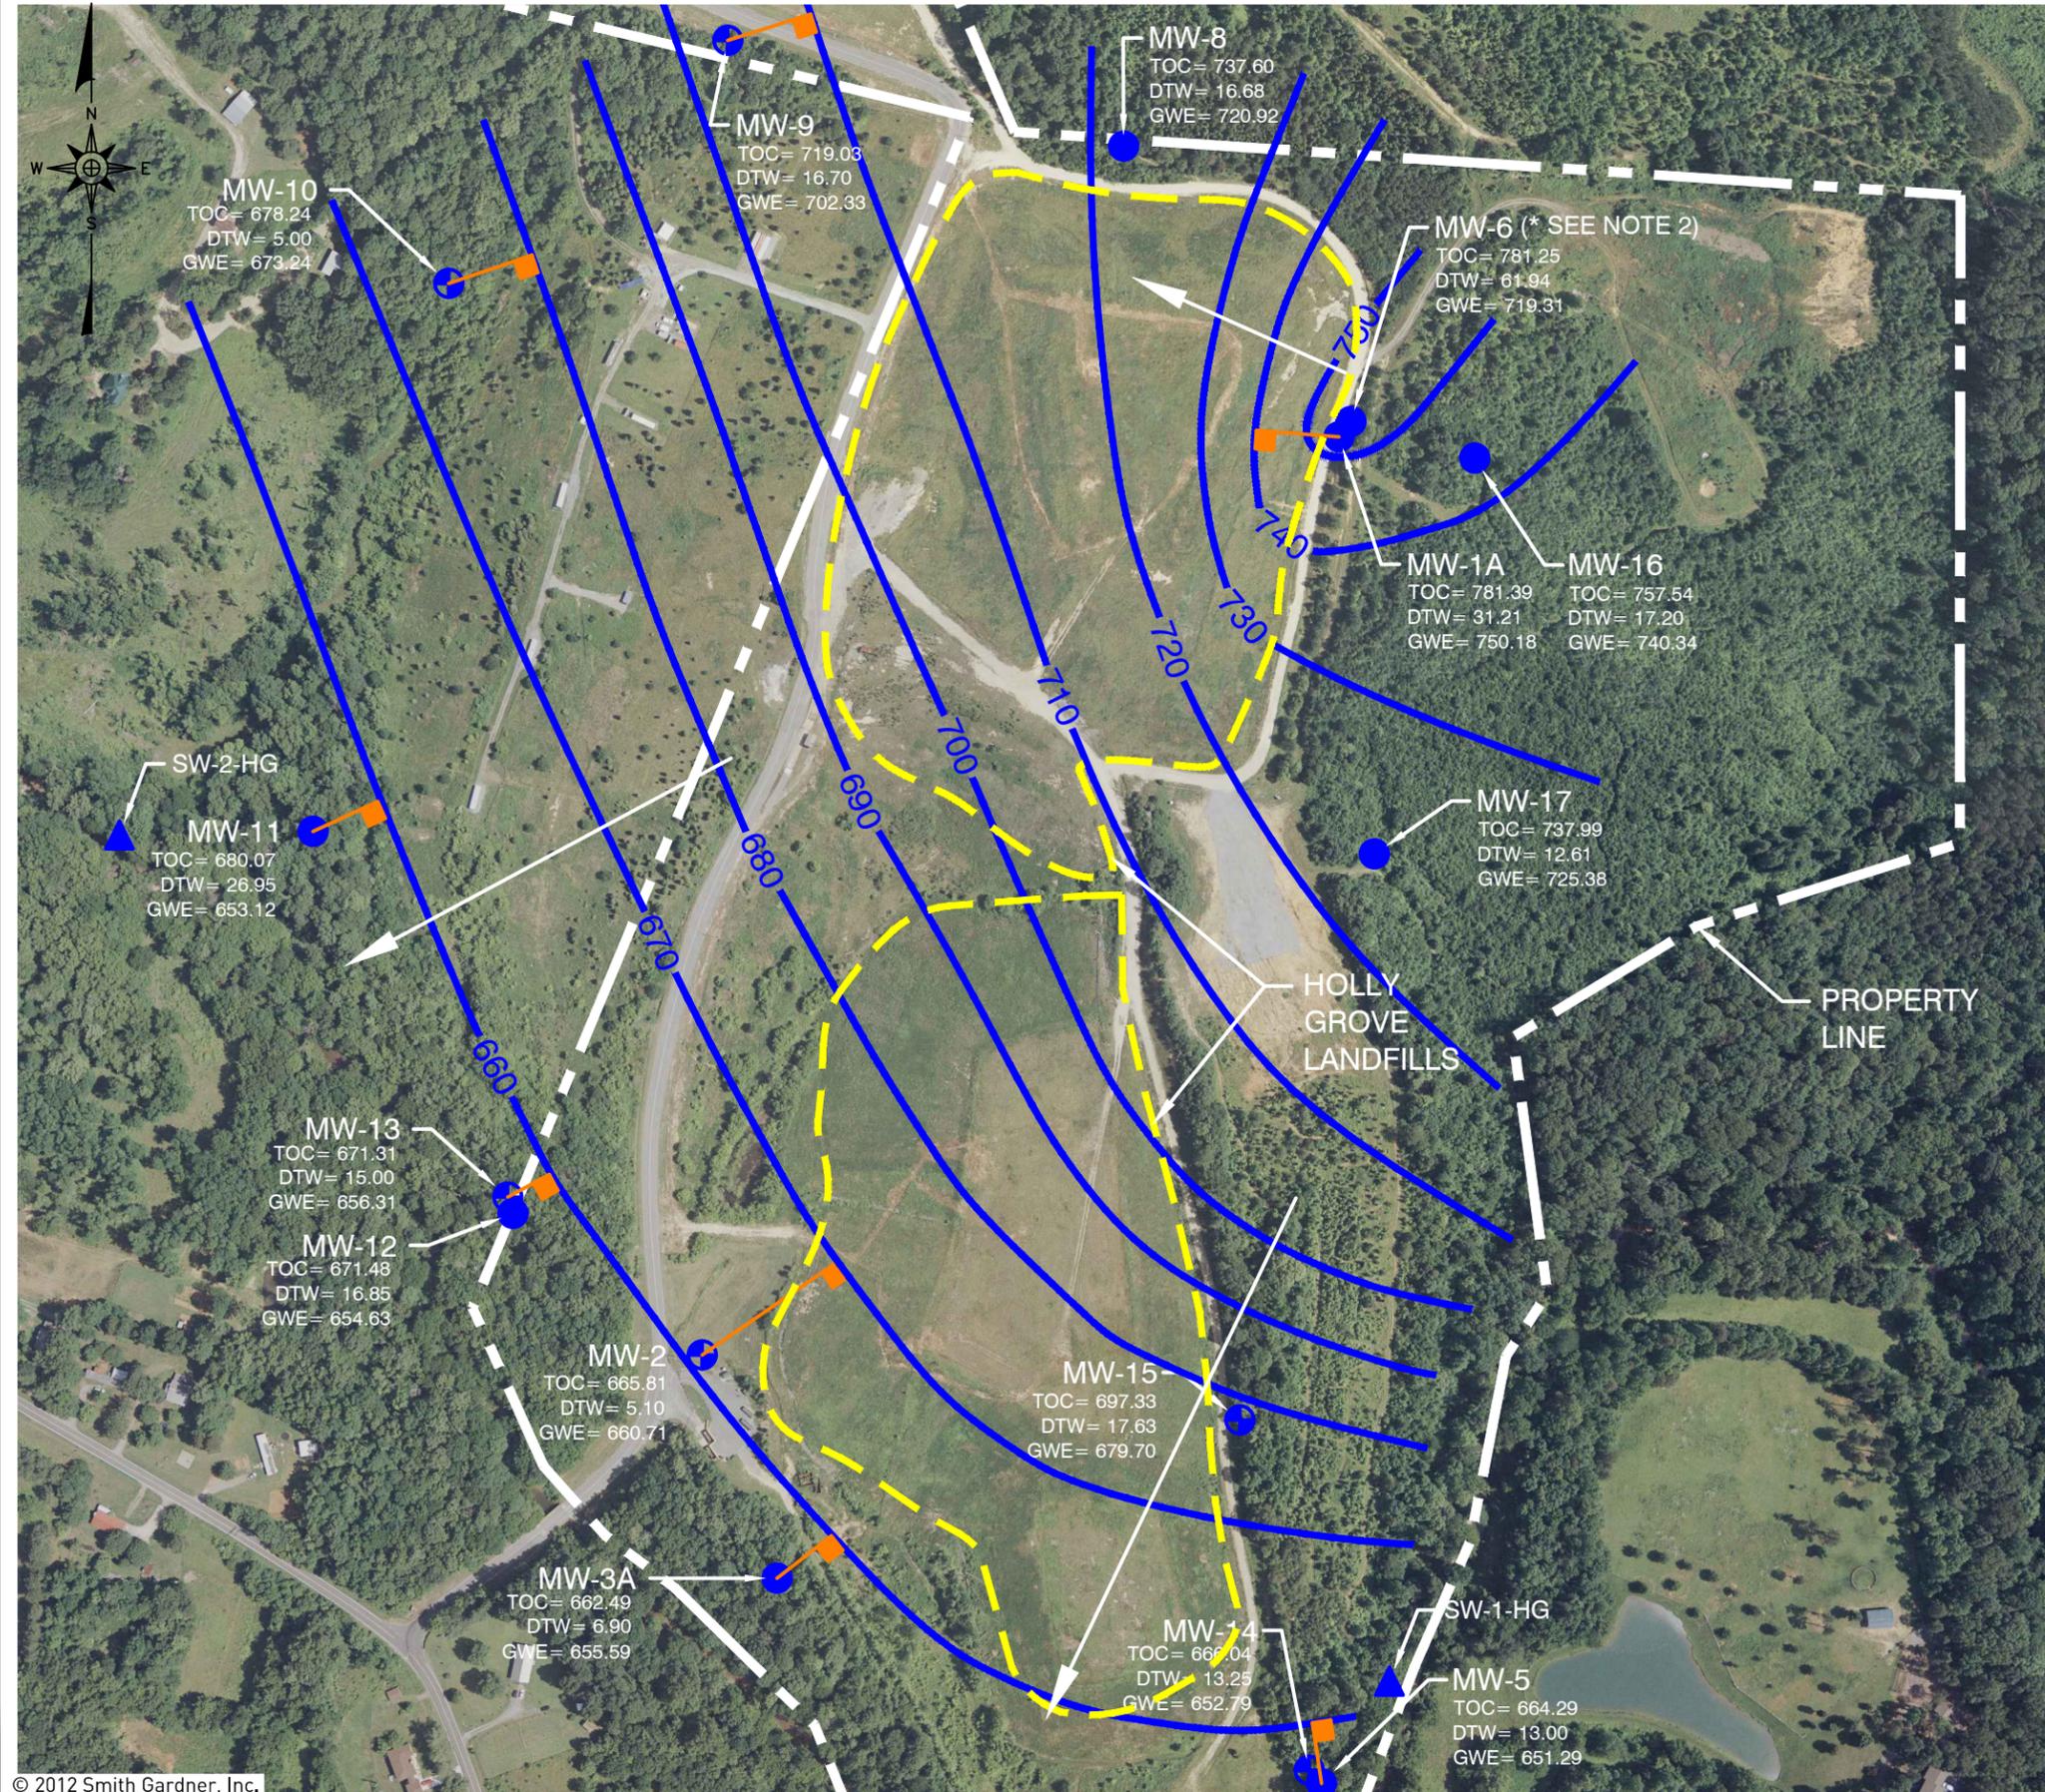
**POTENTIOMETRIC SURFACE MAP**  
**FALL 2012**  
**CLOSED HOLLY GROVE LANDFILL**  
**DAVIDSON COUNTY, NC**

A map illustrating the sampling locations is provided as **Figure 1**.

A potentiometric surface map was prepared from ground water data from this sampling event. Ground water flow velocities for this sampling event were calculated for monitoring wells using the equation:

Ground water velocities in the uppermost aquifer at the Holly Grove Landfill ranged from 0.027 feet/day (MW-3A) to 1.672 feet/day (MW-15) and averaging 0.685 feet/day. Calculations are included in **Table 5**. Groundwater elevations indicate the flow direction is generally south and southwest across the site; which is consistent with historically reported ground water flow patterns. The potentiometric surface map is included as **Figure 1**.
