Groundwater Monitoring Report April 2013 Semi-Annual Event

Davidson County Closed Holly Grove Landfill NC Solid Waste Permit No. 29-02

April 2013 Groundwater Monitoring Report

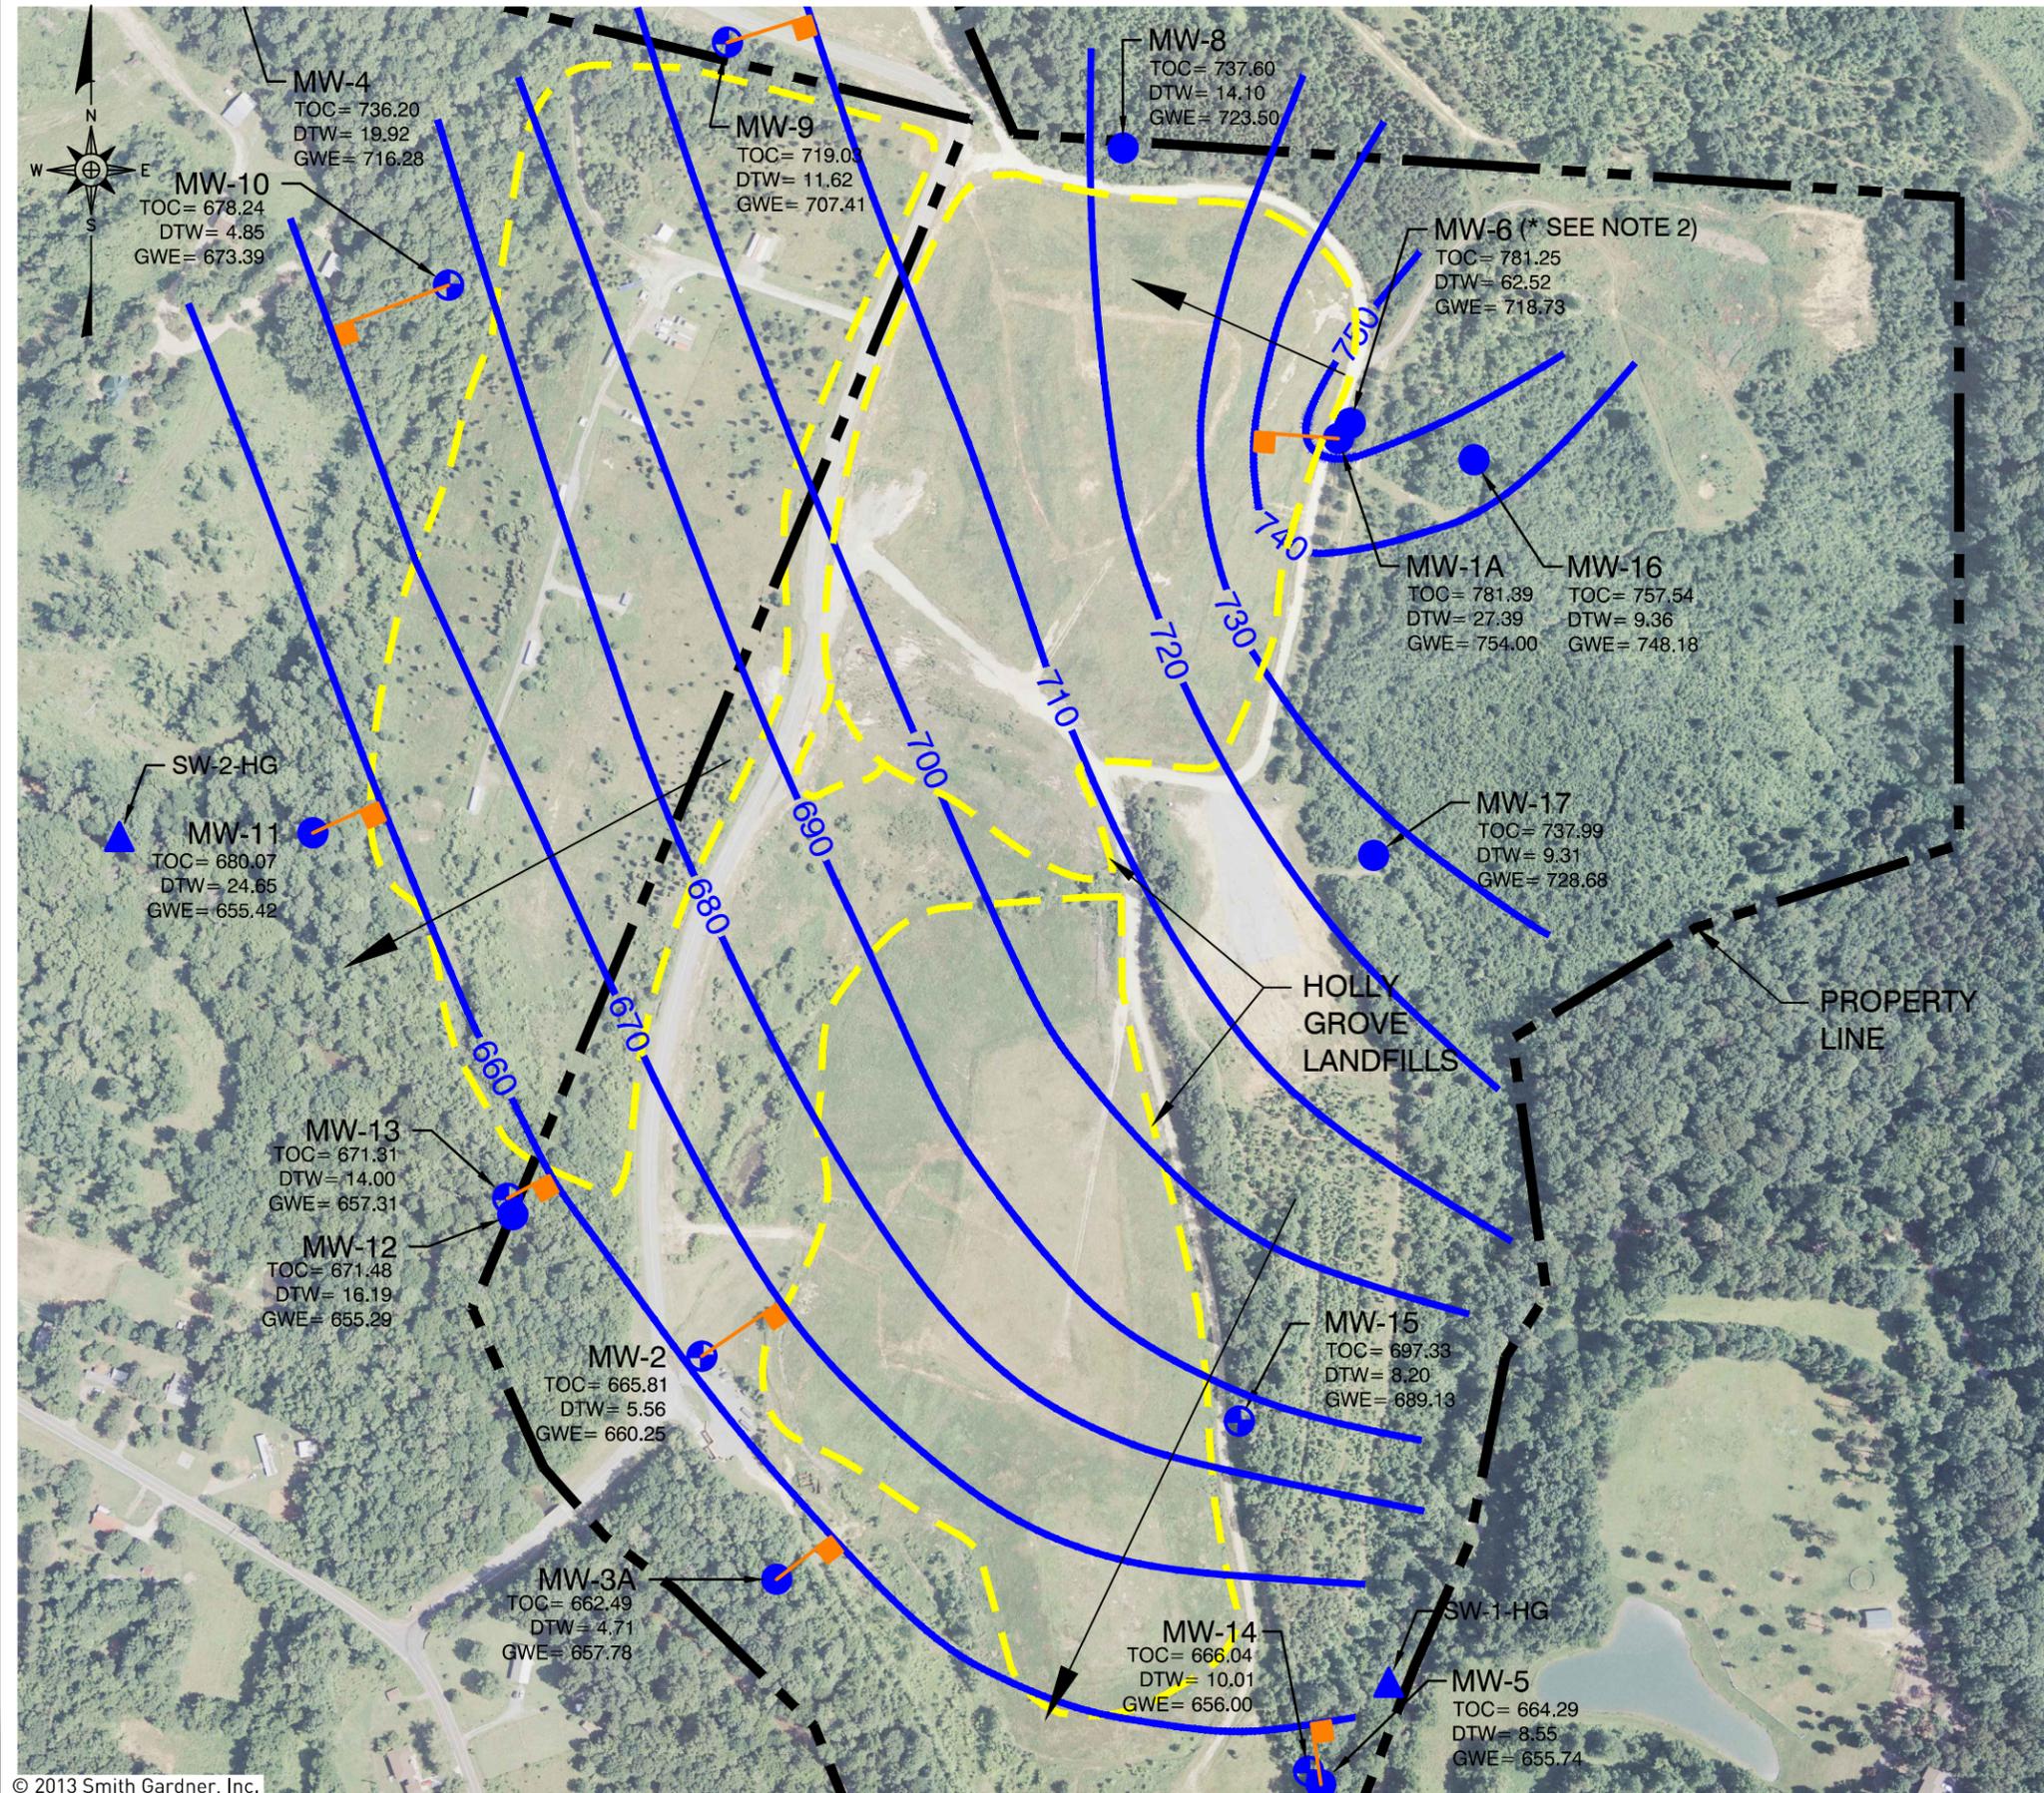
PREPARED FOR: **POTENTIOMETRIC SURFACE MAP**
APRIL 2013
CLOSED HOLLY GROVE LANDFILL
DAVIDSON COUNTY, NC

A map illustrating the sampling locations is provided as **Figure 1**.

A potentiometric surface map was prepared from ground water data from this sampling event. Ground water flow velocities for this sampling event were calculated for monitoring wells using the equation:

Ground water velocities in the uppermost aquifer at the Holly Grove Landfill ranged from 0.011 feet/day (MW-2) to 3.267 feet/day (MW-15) and averaging 0.644 feet/day. Calculations are included in **Table 5**. Groundwater elevations indicate the flow direction is generally south and southwest across the site; which is consistent with historically reported ground water flow patterns. The potentiometric surface map is included as **Figure 1**.
