**Groundwater Monitoring Report  
October 2012 Semi-Annual Event**

**Davidson County Construction and Demolition Debris Landfill  
NC Solid Waste Permit No. 29-06**

# Groundwater Monitoring Report – October 2012

## October 2012 Groundwater Monitoring Report

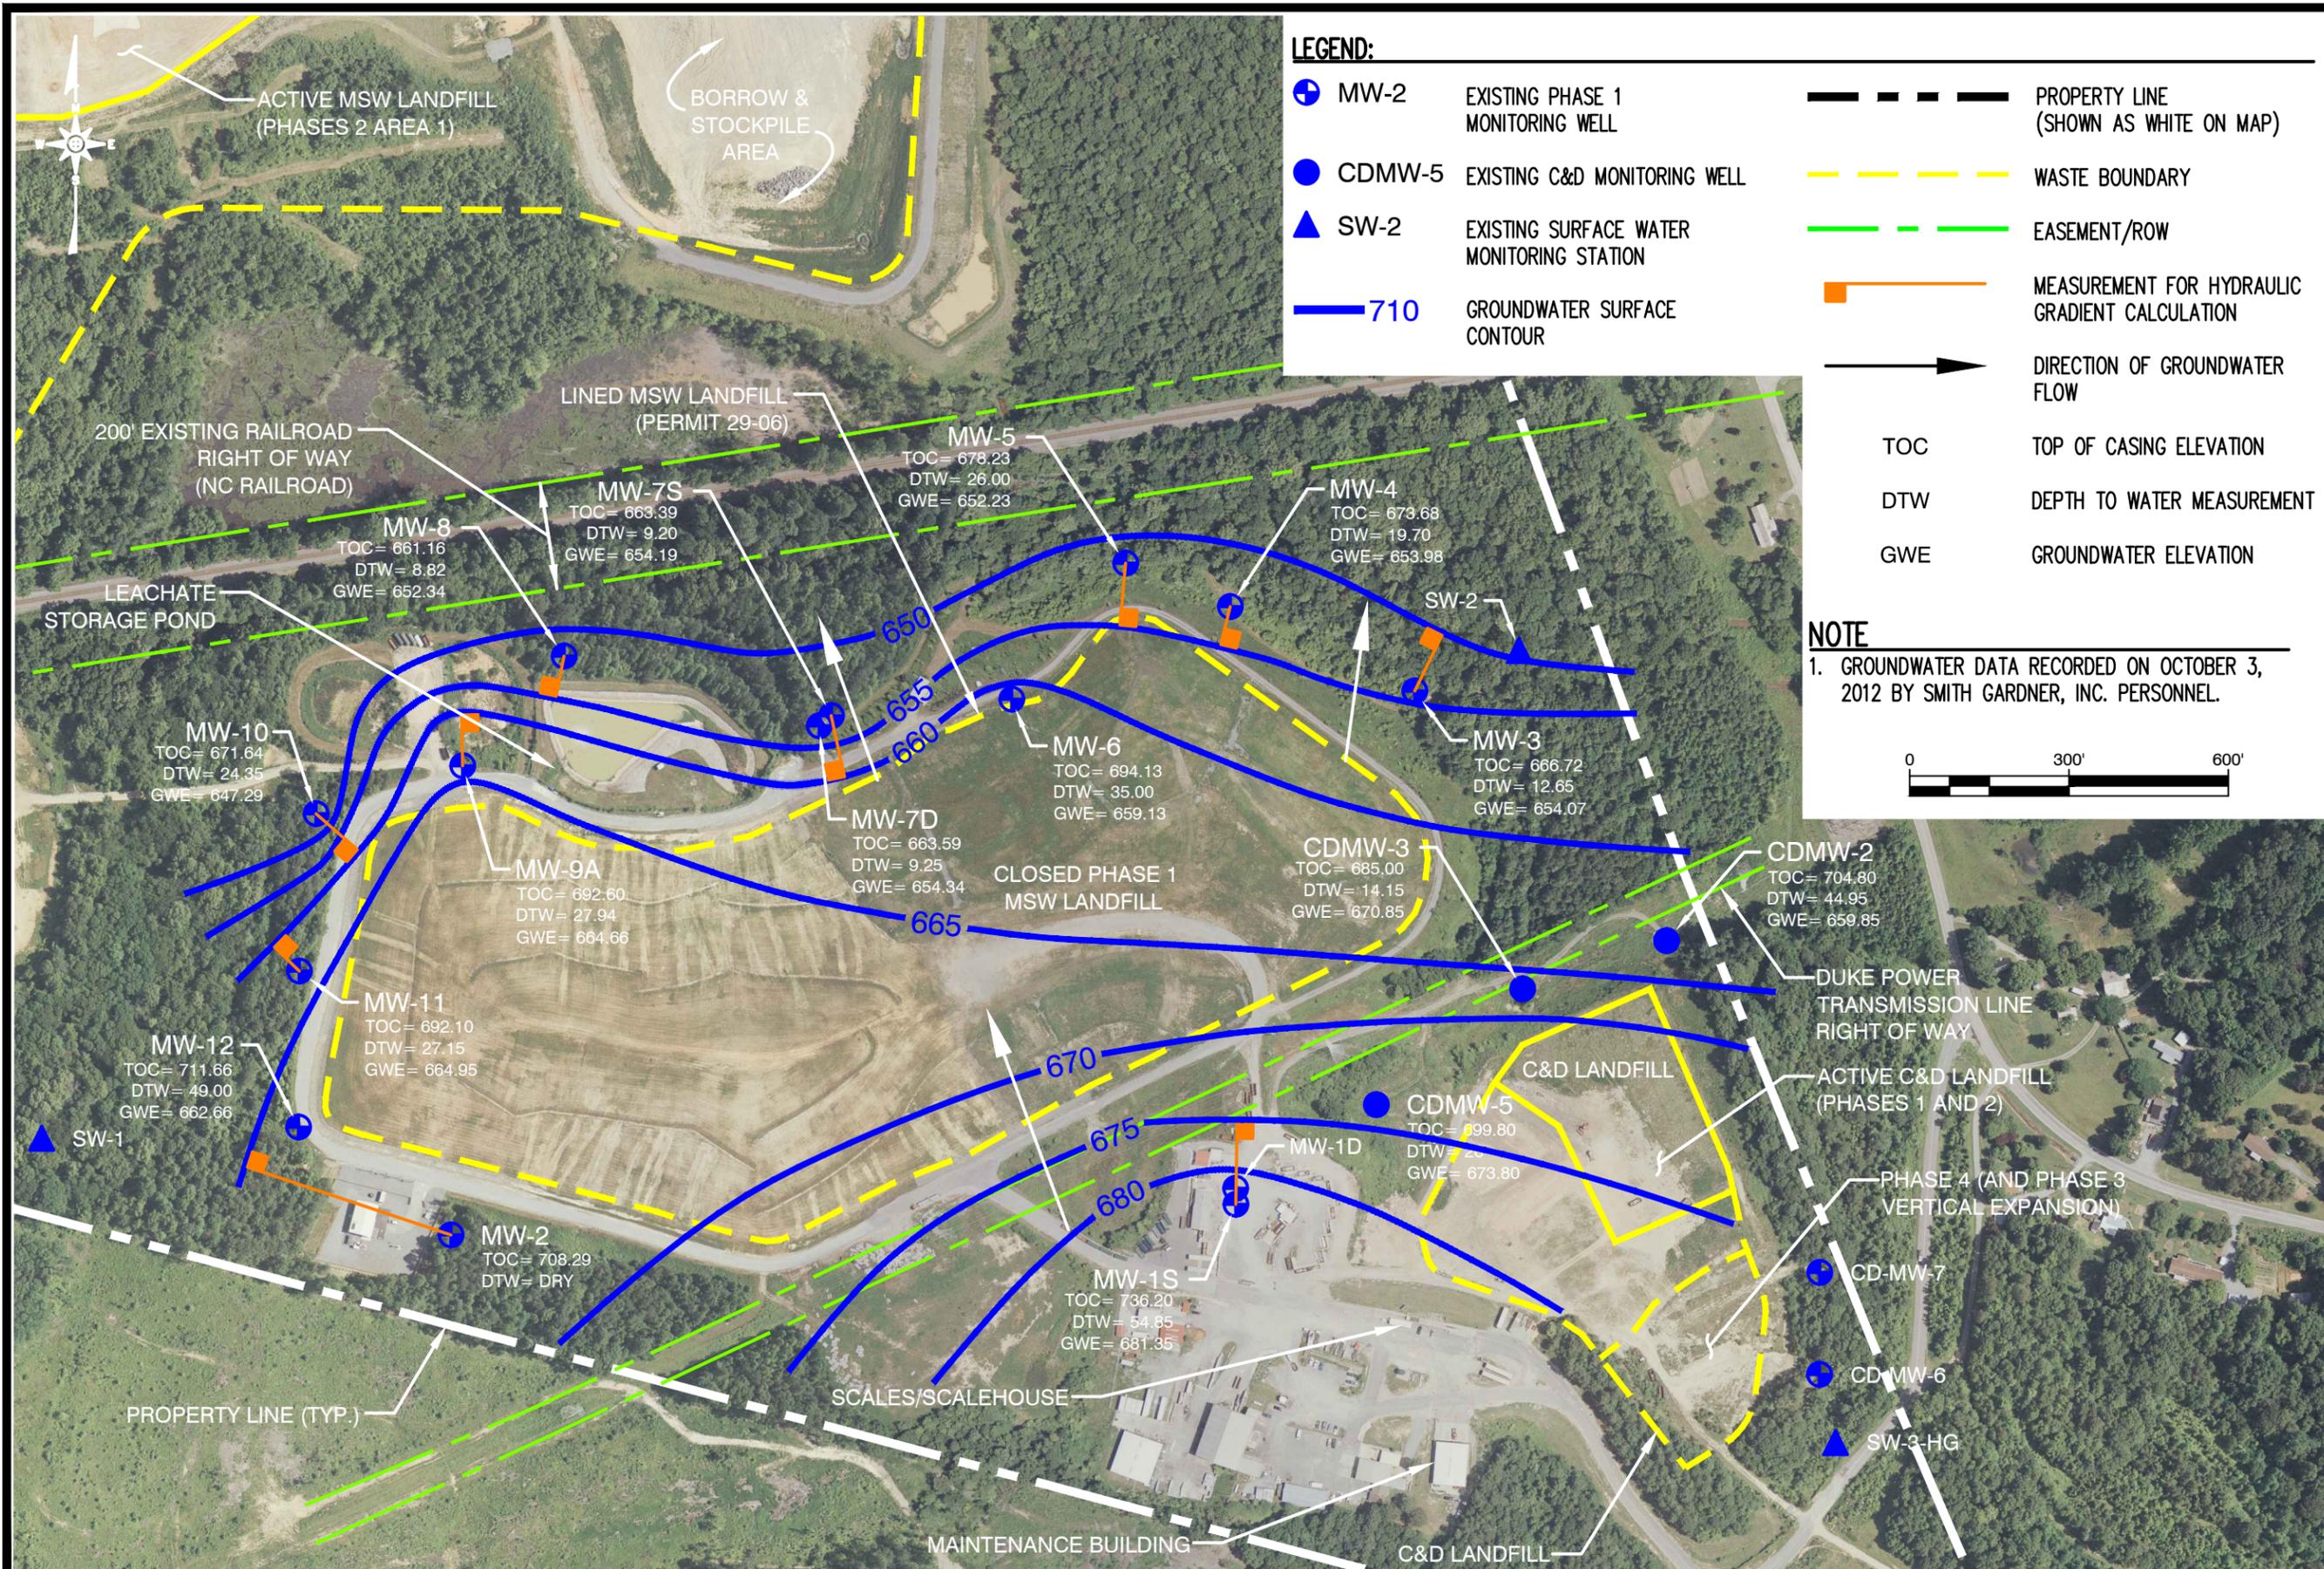
DRAWN: J.A.L.	SCALE: AS SHOWN	FIGURE NO: 1	PROJECT NO: DAVDCO-13A
DATE: Jan 2013	APPROVED:	FILENAME: DAVDCO-B0710

A potentiometric surface map was prepared from ground water data from this sampling event. Ground water at the C&D landfill flows in a generally northern direction. An ephemeral stream is located east and northeast of the C&D landfill. The potentiometric surface for the landfill property is shown on **Figure 1**.

**POTENTIOMETRIC SURFACE MAP**  
**FALL 2012**  
**CLOSED PHASE 1 AND C&D**  
**DAVIDSON COUNTY, NC**

Sampling locations are shown on **Figure 1**. Boring logs and construction records are provided in **Appendix B**.

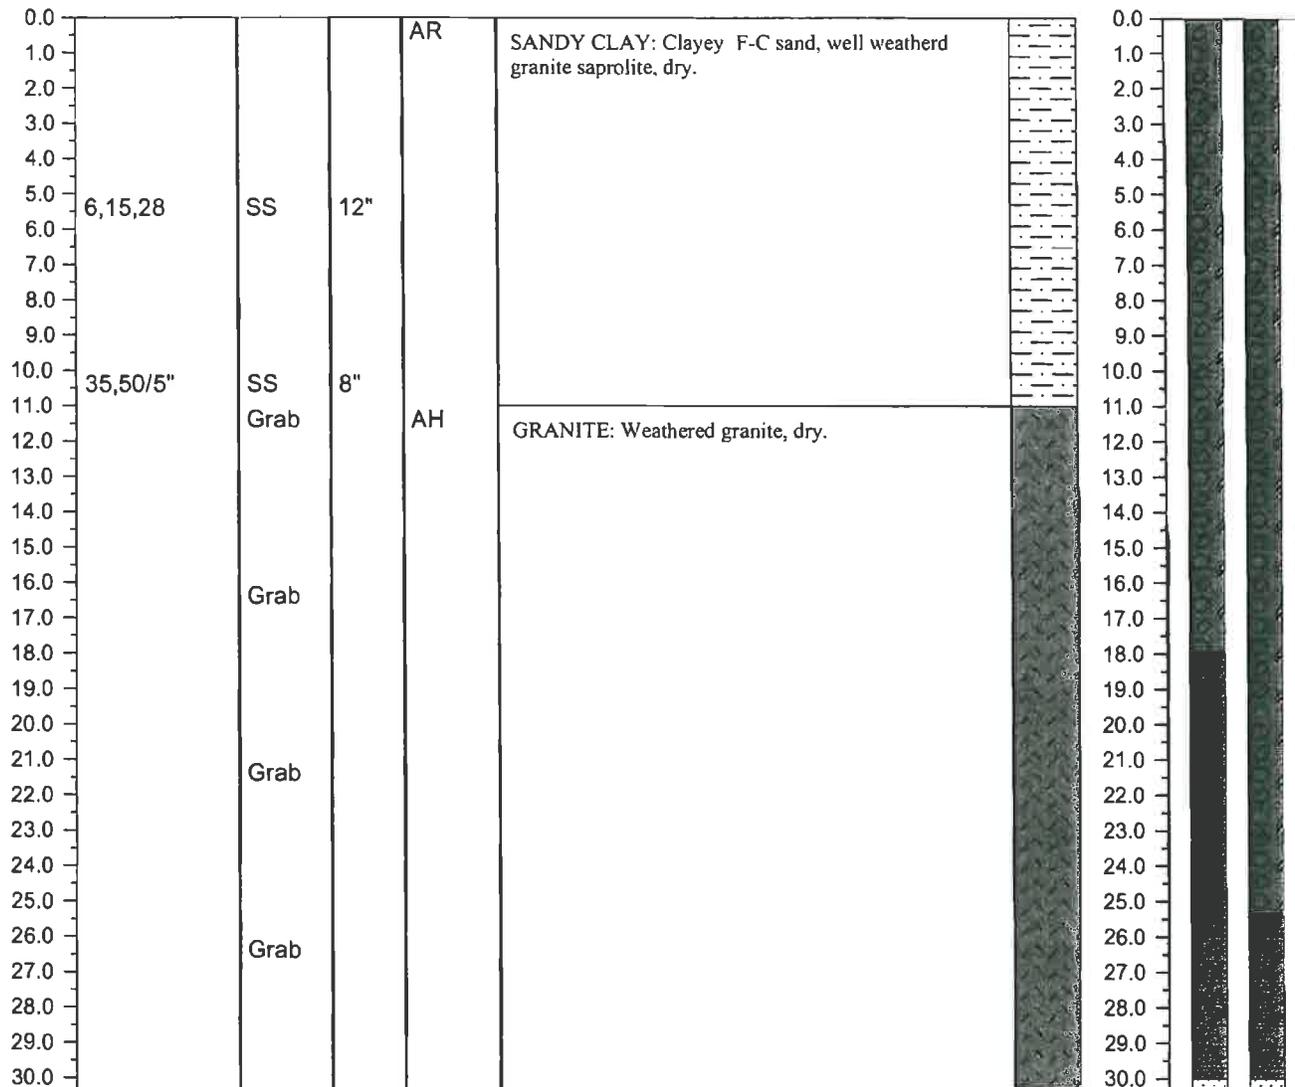
**G. N. Richardson & Associates, Inc.**14 North Boylan Avenue, Raleigh NC 27603  
(919) 828-0577**FIELD BOREHOLE LOG**

DEPTH	BLOW COUNT	SAMPLING METHOD	RECOVERY	DRILL METHOD	DESCRIPTION	LITHOLOGY	DEPTH	WELL INSTALLATION
-------	------------	-----------------	----------	--------------	-------------	-----------	-------	-------------------
