FACILITY COMPLIANCE INSPECTION REPORT
Division of Waste Management
Solid Waste Section

Date of Site Visit: February 14, 2013 **Date of Last Inspection:** February 22, 2012

City of Durham Closed MSW Landfill
 2115 East Club Boulevard
 Durham, NC 27704

Post Closure Site Visit

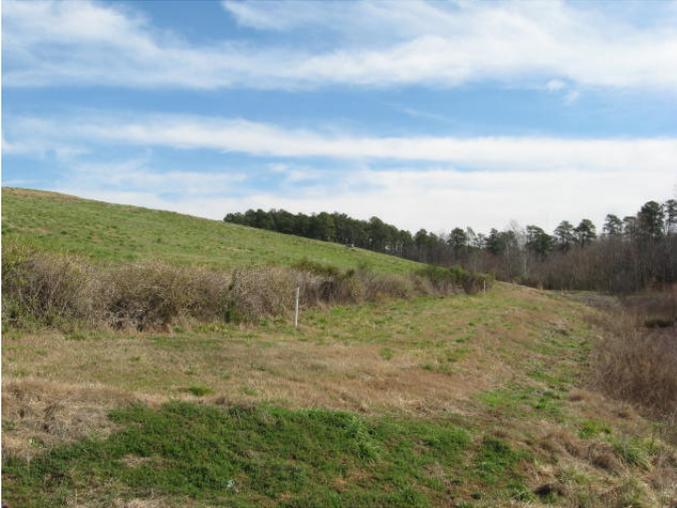
6. Large woody vegetation has been removed from the landfill cap.
7. The facility has installed edge of waste markers. White plastic pipe with metal stake insert have been installed every 50 feet.

Edge of waste markers – white plastic pipe

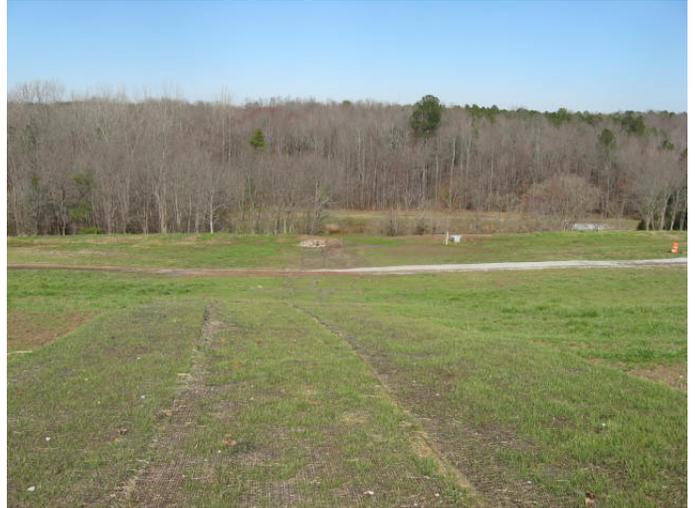
12. The facility recently repaired a collapsed stormwater drainpipe on the west side of the landfill that, it was discovered, was too close to waste. Prior to the repair methane odor was detected at the surface/above the stormwater drainpipe area. The new drainpipe was installed above a layer of cover material (applied atop the waste) and landfill cap repaired accordingly.

Stormwater drainpipe repair area – west side of landfill

13. Mr. Lobdell stated that the facility is in the process of repairing a collapsed stormwater drainpipe on the west side of the landfill. The facility will assess the adjacent area of landfill cap that tends to pond water (aforementioned No. 13) and evaluate if drop box surface drains should be installed. Mr. Lobdell was asked to contact SWS Ed Mussler, Permitting Branch Head, and Ervin Lane, Compliance Hydrogeologist, regarding the purposed remediation plan.

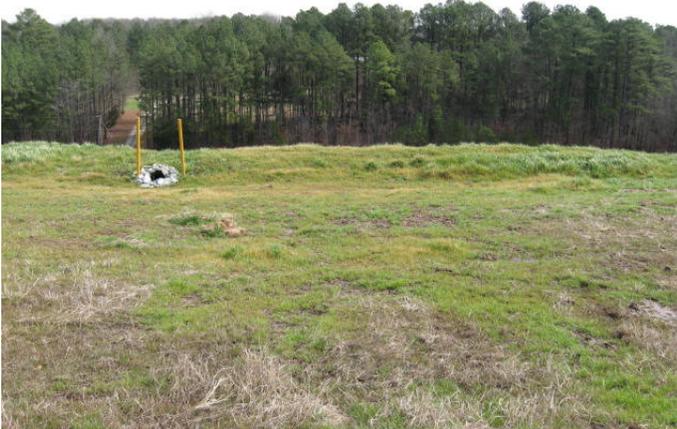
8. Mr. Lobdell stated that monitoring wells with faded labels have been replaced.
9. The facility installed a stormwater drainpipe on the east side of the landfill that routes stormwater to a drainage swale. The stormwater drainpipe was installed to remediate water from accumulating in the area.

Stormwater drainpipe installed at low area (to drain ponding water) – east side of landfill

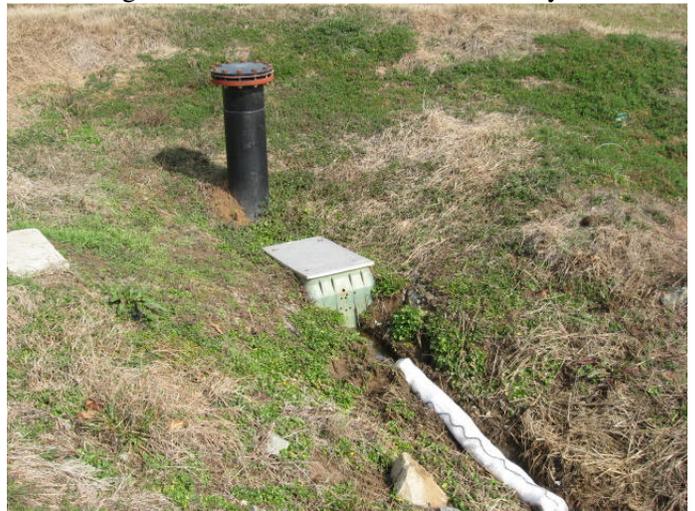
5. The facility had a landfill gas condensate release outside the landfill footprint into a stormwater pond that may have gone into a nearby stream on February 8, 2013 due to a bypass line from a force main that was left open, allowing a condensate trap to pump onto the landfill cap. Ervin Lane, Compliance Hydrogeologist, is corresponding with the facility to ensure appropriate evaluation of the condensate release site and response is conducted.

Landfill gas condensate release area, February 8, 2013
