FACILITY COMPLIANCE INSPECTION REPORT
Division of Waste Management
Solid Waste Section

Date of Site Inspection: December 13, 2012 **Date of Last Inspection:** December 6, 2011

B&B Top Soil Mine, Inc. Treatment and Processing Facility
 1800 Hamlin Road
 Durham, NC 27704

Comprehensive Inspection

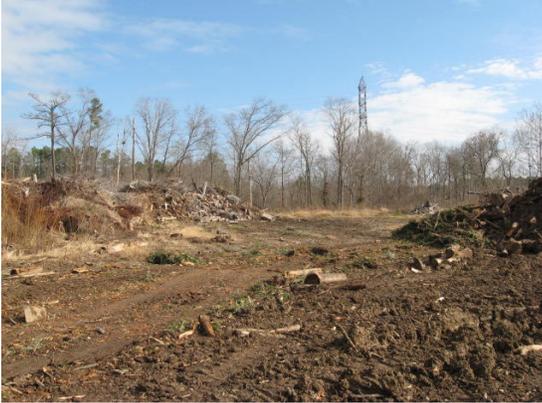
Fire lane maintained (representative example)

21. Ensure that water does not pond at the base of storage and process piles.
22. There was no indication of erosion or runoff.
23. The facility maintains fire lanes between active process piles and stored material. Ensure that all fire lanes are ≥ 20 feet wide.

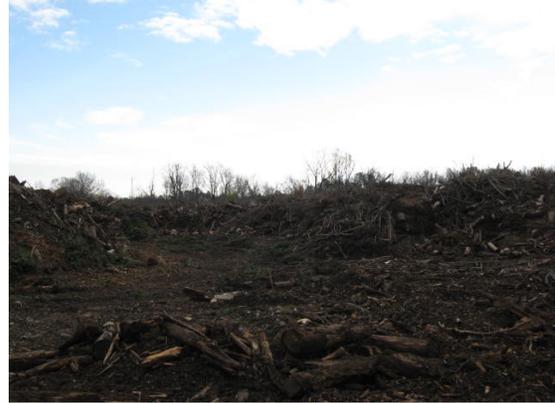
High carbon:nitrogen ratio piled material

16. The facility appeared to maintain a 50 foot buffer from property lines.
17. The Dry Method active process piles appeared to be < 50 feet wide and 30 feet high.

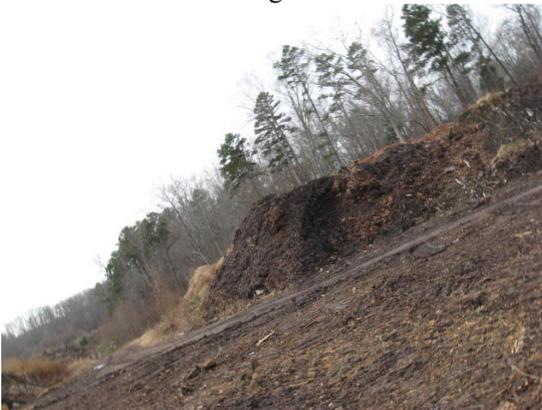
Leaf pile: purchased mulched leaves and small amounts of leaves brought on site

6. Leaves are the only material routinely incorporated into soil.
7. During the fall mulched leaves are purchased and primarily resold to farmers. Mr. Andrews stated that there is ~ 800 yd³ of mulched leaves on site, turned monthly. It is expected that the mulched leaves will be sold by June 2013.

8. Leaves associated with land clearing debris (LCD) or brought on site as a segregated load are stored until needed in the soil mix process. Mr. Andrews stated that there is ~ 2,000 yd³ of leaves on site, turned ~ 3 times a year. Ensure the leaves are turned routinely and used in the soil mix process prior to generating excessive heat and/or breaking-down into compost. Vegetative material should not be permitted to take-root atop the leaf pile.

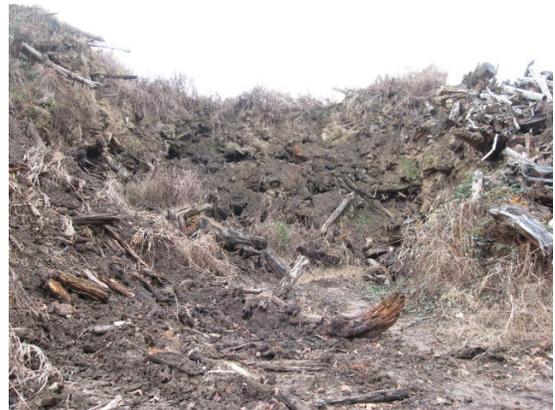
Piled material in process of being mined/removed

4. Material is formed into long piles resembling windrows. The windrows are left in-place, allowing vegetation to grow atop. Material decays in 2 to 5 years. The decayed material/soil is then screened and leaf mulch added. If required, additional material is added for specific soil blends. The soil is sold to the public, landscapers, and builders. Woody material screened-out from the soil, needing more time to break-down, are staged to return to the Dry Method active process.

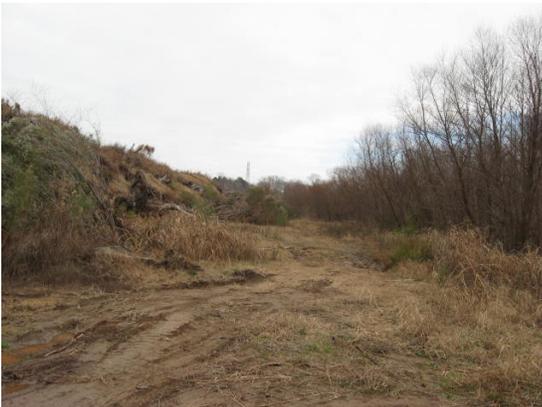
Maintained buffer area, rear area of lot

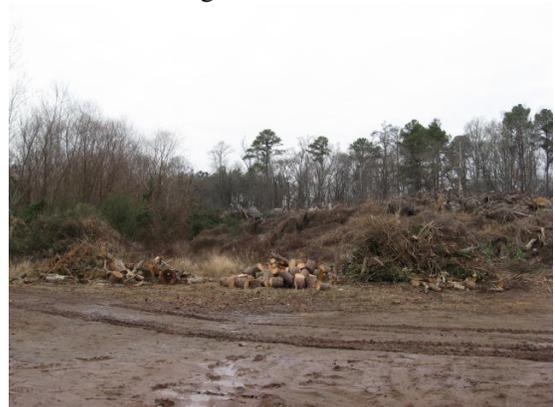
Piled material, right rear of lot
