**RE: Site Inspection Closure Report  
Currin LCID Landfill (Solid Waste Permit 32D-LCID)  
Durham County, North Carolina**

COVER DEPTH CHECK LOCATIONS  
CURRIN LANDFILL - PERMIT: 32D-LCID  
DURHAM, NC

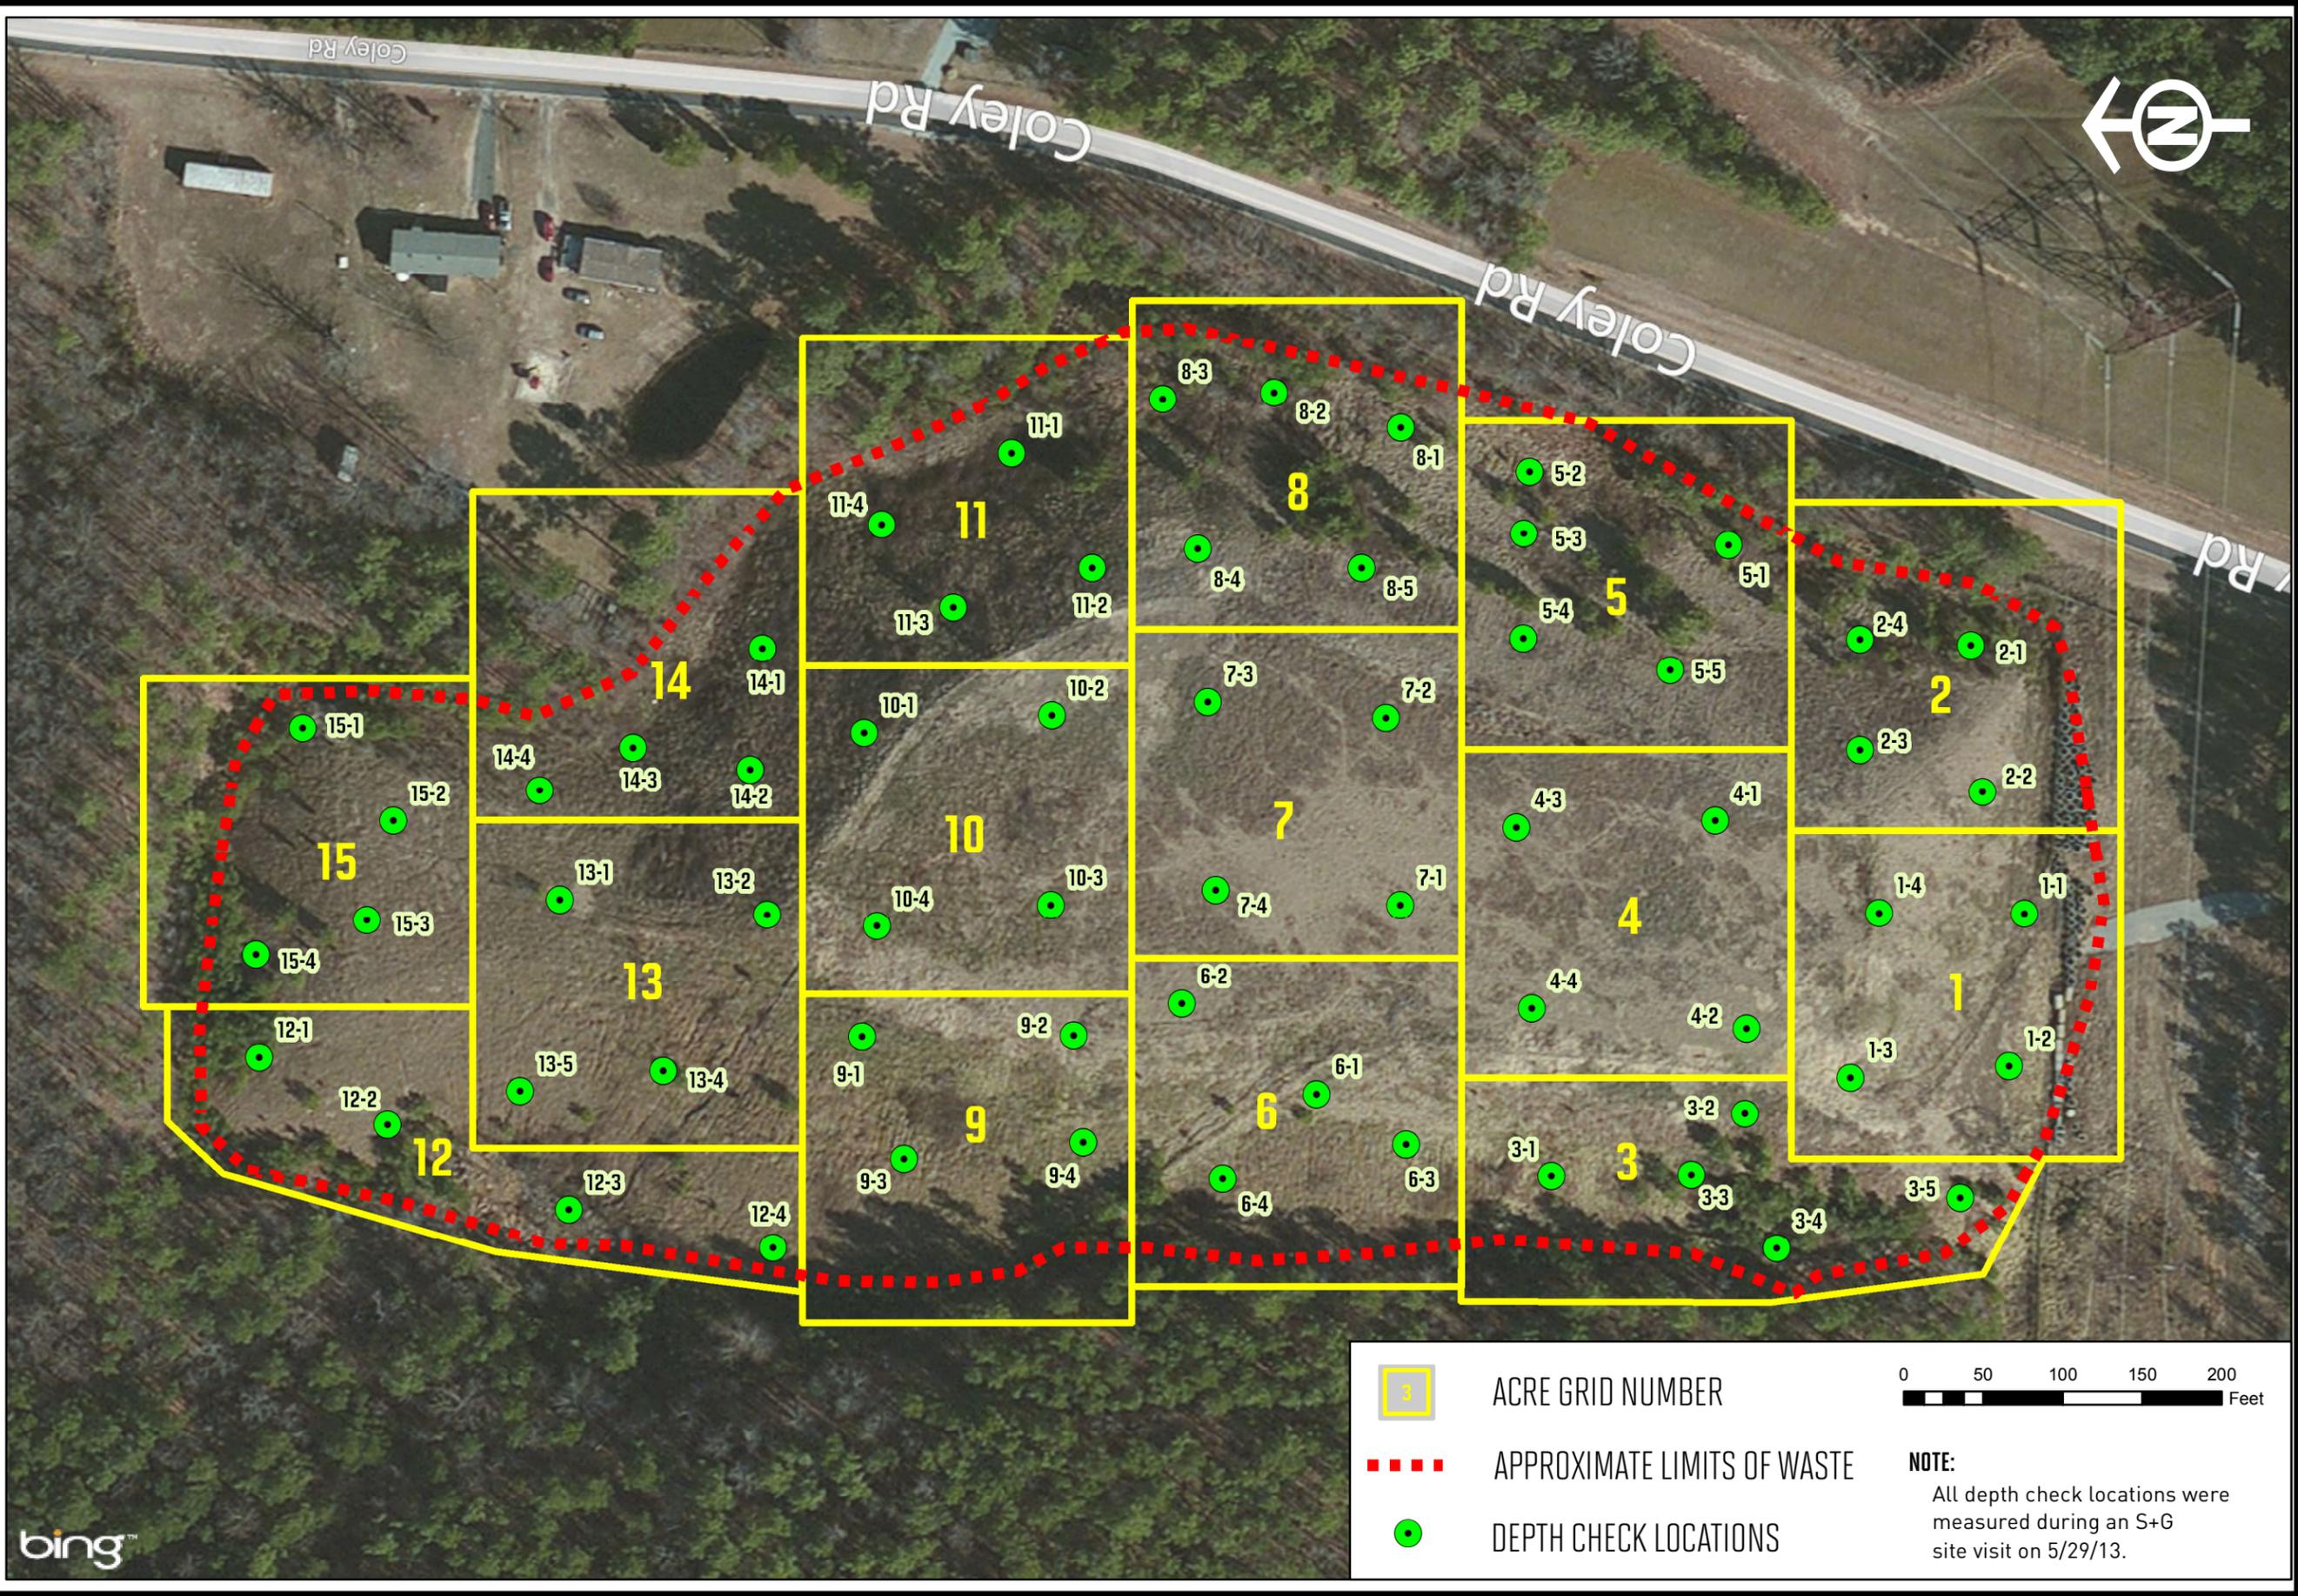
DRAWN:	DMM	APPROVED:	SAS	SCALE:	1:1200	FIGURE NO.:	1
DATE:	May, 2013	PROJECT NO.:	PROJECT	FILENAME:	Verification Map

To begin the verification process, S+G created a numbered grid (shown on **Figure 1**), approximately one (1) acre in size, to cover all disposal areas. S+G then conducted a site visit on May 29, 2013 to perform cover verification. A total of 63 hand auger probes (shown on **Figure 1**) were advanced at a frequency of 4 or 5 per each numbered grid section. At each probe location, S+G proceeded to measure the depth to verify at least 12 inches of soil cover. These measurements were recorded with their associated grid numbers and are summarized in the **attached Table 1**.

**NOTE:**  
All depth check locations were measured during an S+G site visit on 5/29/13.

It is the opinion of S+G that all probe locations confirmed a minimum of 12 inches of cover or greater in accordance with 15A NCAC 13B .0566. It is also our opinion that adequate vegetation is established across the entire site.
