**FACILITY COMPLIANCE INSPECTION REPORT**  
**Division of Waste Management**  
**Solid Waste Section**

**Date of Site Inspection:** June 27, 2013 **Date of Last Inspection:** June 27, 2012 (Site Meeting: July 19, 2012)

Currin Brothers, Inc. LCID Landfill No. 2  
 1810 Coley Road  
 Durham, NC 27703

Comprehensive Inspection

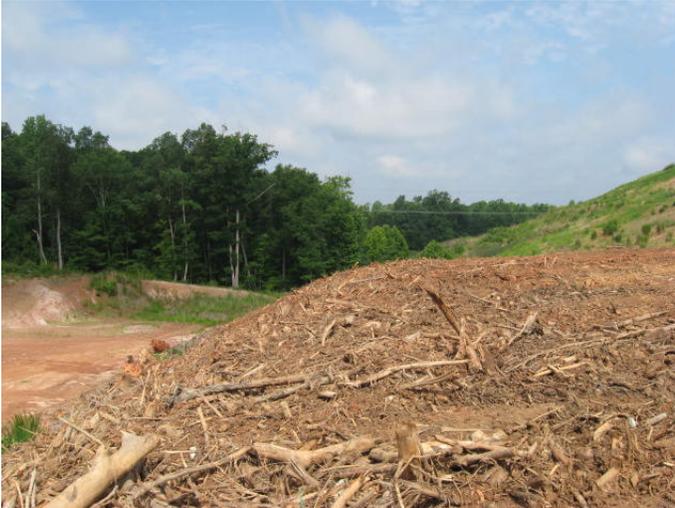
14. Mr. Currin stated that the LCD on the side slope is compacted such that soil (naturally occurring in LCD, deposited from atop the landfill, and moved onto the side slope during rainfall) fills the voids between the woody material such that only the LCD top layer (atop the material- soil mix) is exposed. Mr. Currin stated that soon after the side slope is left/no longer worked native vegetation takes root. And that having the upper most layer of LCD exposed at the side slope lets heat escape and reduces soil runoff (as it is caught within the exposed layer).

15. The working face side slope did appear to be compacted and contain an adequate layer of soil within/under the exposed layer.
16. Per NCAC 13B .0566(4), "Adequate soil cover shall be applied monthly, or when the active area reaches one acre in size, whichever occurs first." The operation of the LCID landfill as described above does not meet the requirement of .0566(4).

Working face side slope

19. Within 30 days (thirty-days) of receipt of this inspection report reduce the size of the working face/side slope and ensure that new material is applied atop uncovered waste within 30 days or continually cover all material adequately with soil within 30 days of receipt (such that it is not visible).

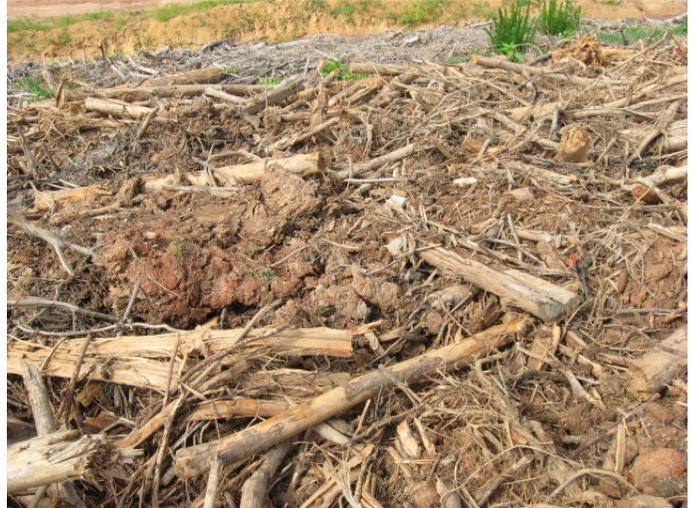
Soil layer within compacted LCD (on side slope)

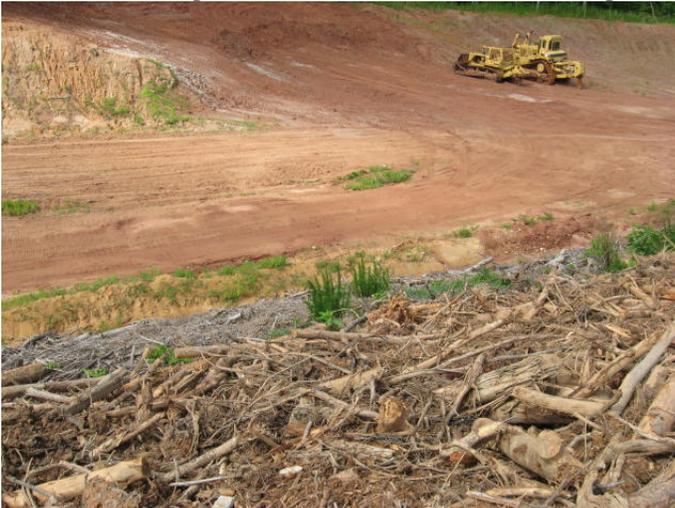
LCD on side slope (view setback – same as second pic)

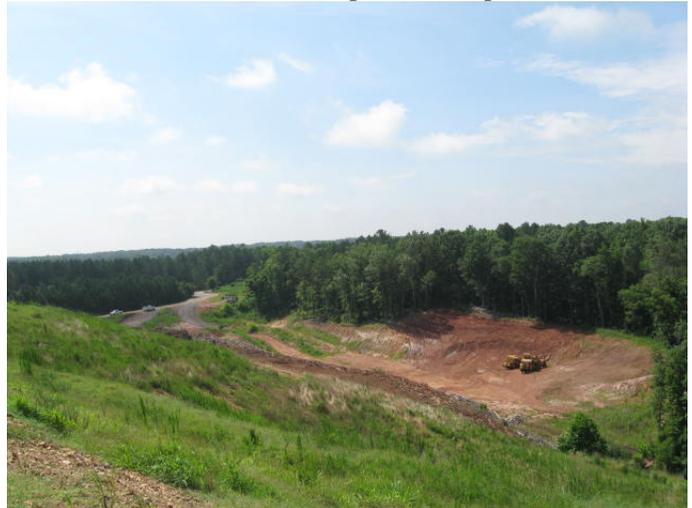
17. Non-active internal landfill side slopes appeared to contain an adequate soil layer, an exposed layer of LCD was not visible.
18. The landfill cap appeared in good order. It contains soil cover and vegetative material.

View of non-active side slope from atop Area 3
