**FACILITY COMPLIANCE INSPECTION REPORT**  
**Division of Waste Management**  
**Solid Waste Section**

**Date of Site Inspection:** 01/03/13

Waste Management Transfer Station, Ranlo Facility  
 2712 Lowell Rd.  
 Gastonia, NC 28054

Comprehensive compliance audit.

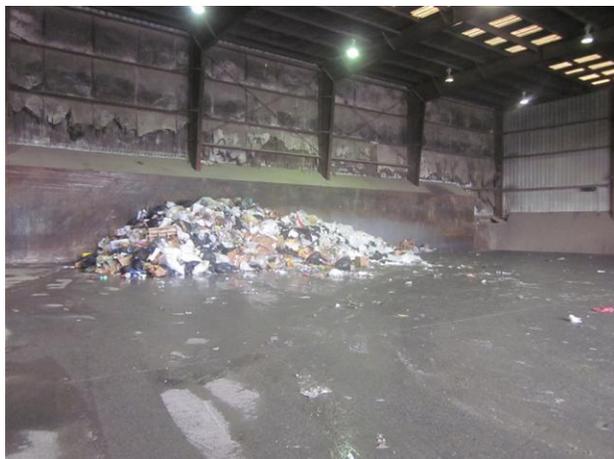
1. Looking across the tipping floor. The receiving bay is located along the right side of the facility. (Note the clean & well maintained tipping floor.)

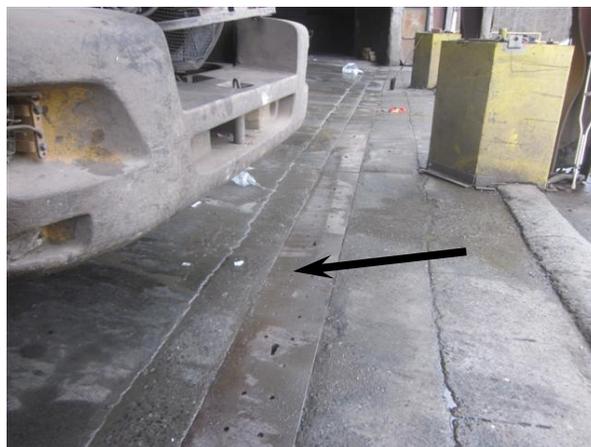
2. Looking across the entrance to the transfer station at the trench drain.

14. There was no evidence of any vectors (flies, rodents, insects or other vermin) in or around the transfer station.
15. Leachate and wash down water are collected in a trench drain across the entrance to the transfer station (Photo #2) and in two floor drains in the receiving bay (Photo #3). These trench drains are cleaned weekly.
16. These drains feed into an underground storage tank (UST) located behind the station. This UST serves as a “grit chamber” to settle out any solids before the liquids flow into an adjacent underground oil-water separator (Photo #4). The outfall from the oil-water separator is direct piped to the Gastonia waste water treatment plant for final treatment and disposal. The “grit chamber” UST is pumped out approximately twice a year by *Safety-Kleen Systems, Inc.*

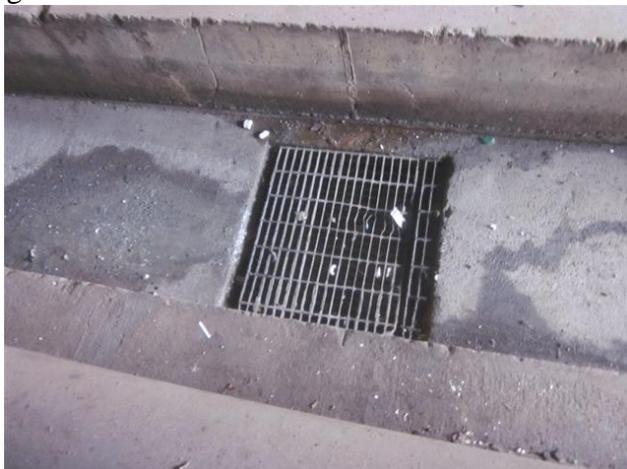
3. One of two floor drains in the receiving bay.

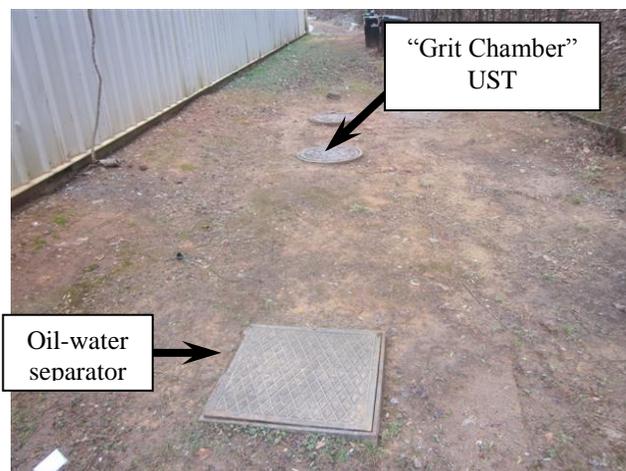
4. Looking at the access points to the "Grit Chamber" UST and the oil-water separator located behind the transfer station.

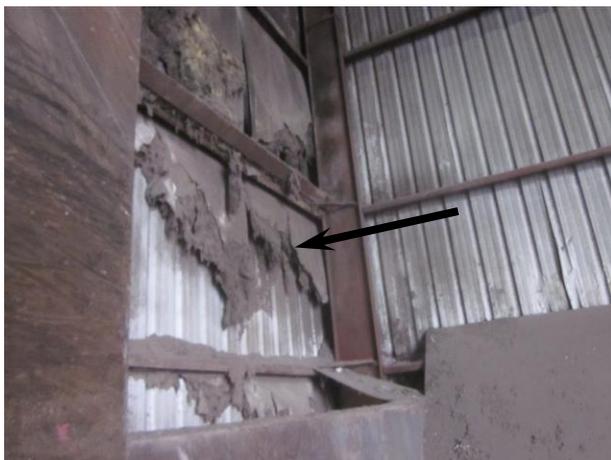
17. The upper back wall of the transfer station has been lined with insulation batting to deaden the noise from the facility. Since the last inspection of this facility on 10/31/11, this insulation is covered with soot and grime. Efforts to clean the upper back wall, has caused the insulation to become loose, broken and in some areas, missing (Photo #6). **The facility must develop and initiate procedures to ensure that the insulation and the interior walls of the transfer station are maintained in a clean and sanitary condition at all times.**

5. Looking at the back of the transfer station, the end of the receiving bay. Note the broken and loose insulation batting on the upper back wall.

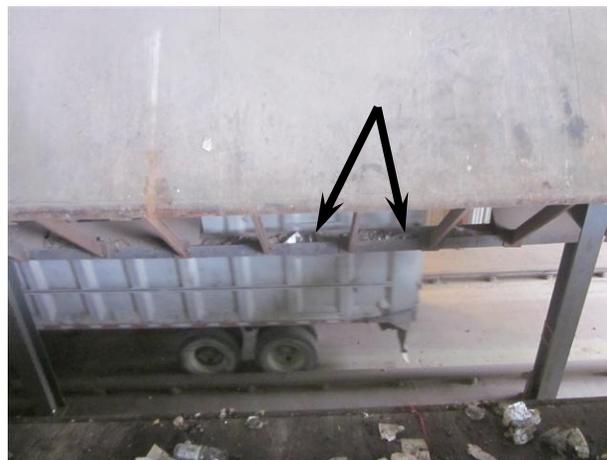
6. Looking from the tipping floor of the transfer station, down into the receiving bay. Note the loose trash on the horizontal support beam.

18. **Loose trash was observed on multiple horizontal support beams on the back wall and ceiling of the receiving bay. The trash must be removed the end of each days operations.** (Photo #6 and #7)
19. A small shed located outside of the transfer station is used to store household hazardous wastes pending their removal and transport to the Gaston County Landfill in Hardin, NC. (Photo #8)

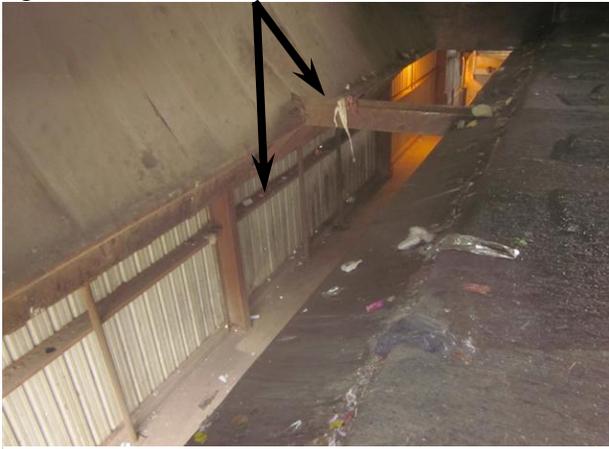
7. Looking from the tipping floor of the transfer station, down into the receiving bay. Note the loose trash on the horizontal support beams.

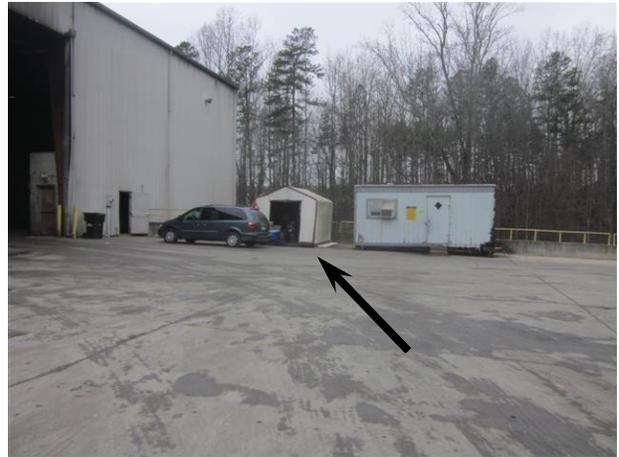
8. Small shed for the temporary storage of household hazardous wastes. (Entrance to the transfer station is on the left.)

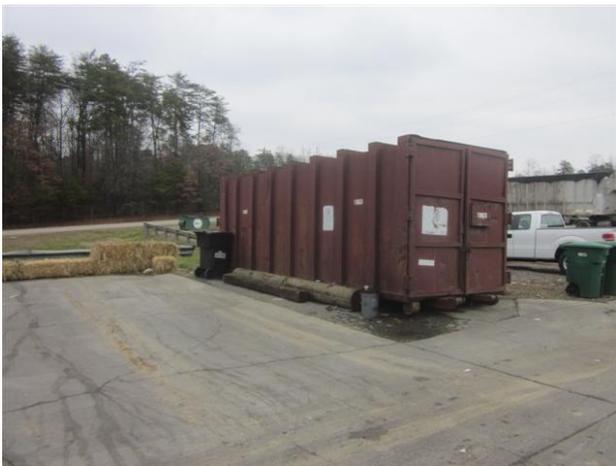
20. A roll-off box is staged outside of the transfer station for the collection of scrap tires that eventually transported to the *US Tire* facility in Concord, NC for final disposal. (Photo #9) While the facility is permitted to receive tires and scrap tires, other than removing the occasional tire from the municipal solid waste stream, they do not currently accept tires.

9. Roll-off box staged outside of the transfer station for the collection of scrap tires.

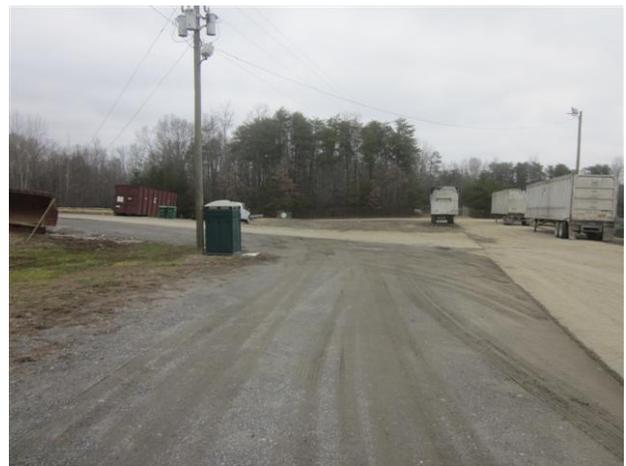
10. Looking (N) at the staging area for transfer trailers. (Transfer station is to the left.)
