FACILITY COMPLIANCE INSPECTION REPORT
Division of Waste Management
Solid Waste Section

Date of Site Inspection: February 29, 2012

Weldon Transfer Facility
 2211 Highway 301 North
 Weldon, NC 27839

Partial Audit

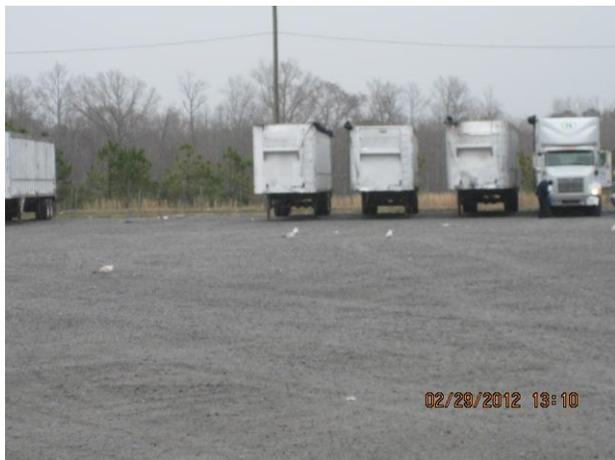
Front lot repaired

7. The yard has been graded and more gravel has been added. There did not appear to be any ponding water in the yard to the front and back side of the building. Very Good!

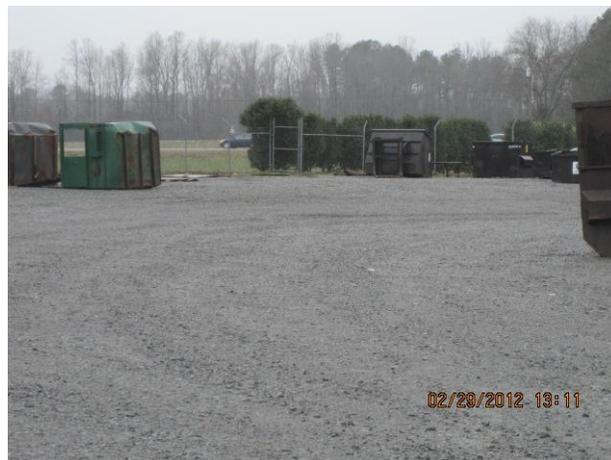
Rear lot repaired

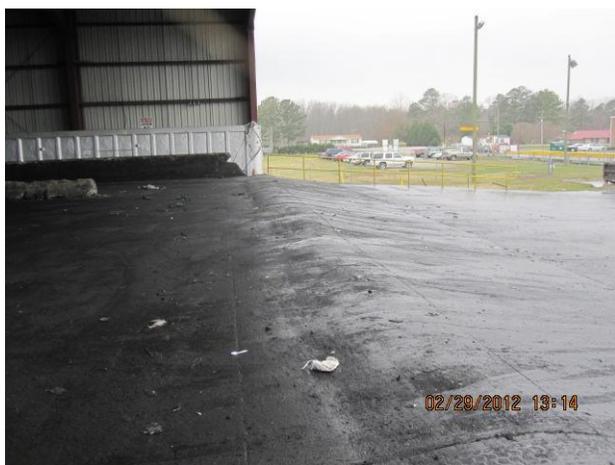
Bermed area to keep leachate from going down the approach ramp.

3. The tipping floor has been repaired. There is a bermed area before leaving the tipping floor to go back out of the building. This was done to prevent leachate from flowing out onto the approach ramp.

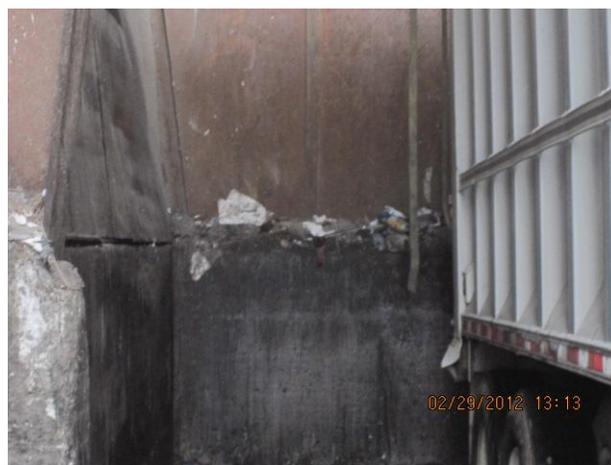
Area needing daily cleaning

8. The co-mingled recyclables in the trailer, in the facility, are removed every three weeks. The area around the trailer is somewhat dirty, especially along the edges of the walls and the open area above the push walls towards the tipping floor. **This area needs to be cleaned daily.**

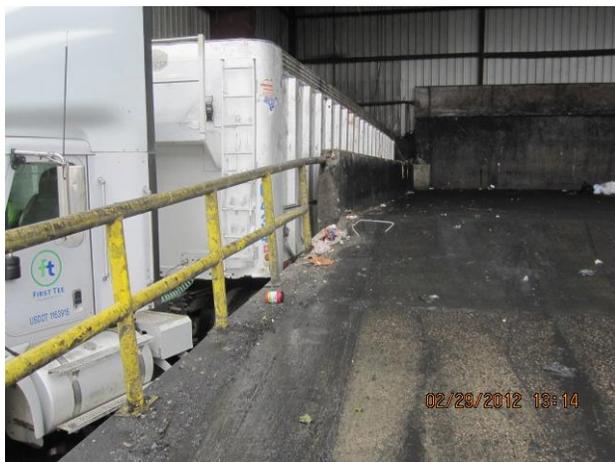
Area needing daily cleaning

1. The inside of the WTS building appeared to be much cleaner. Williams stated that they are cleaning the interior on a more frequent basis. The tops **of the push walls, the tipping floor and the area where the trailers park to be loaded must be cleaned daily.** There are steel plates above the push walls to prevent waste from collecting on the horizontal beams. These plates do not extend up to the higher horizontal beam and thus waste can get behind these plates. This area must be kept clean and free of waste.

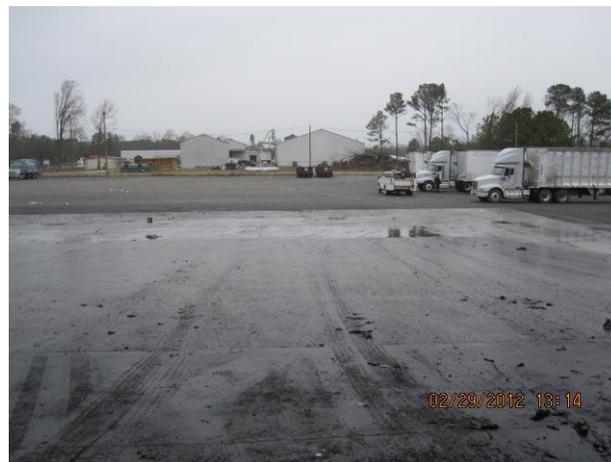
Repaired approach ramp to tipping floor

9. The approach ramp to the tipping floor has been repaired.
10. CERTIFIED TRANSFER STATION OPERATIONS SPECIALIST– Willie Hargrove, expires 12-8-12.
George L Mayo, Jr., expires 2-9-14.
Maurice A. Squire, expires 11-13-12.
