**FACILITY COMPLIANCE INSPECTION REPORT**  
**Division of Waste Management**  
**Solid Waste Section**

**Date of Site Inspection:** 5/6/2013 and 5/10/2013

Henderson County Solid Waste Transfer Facility  
 802 Stoney Mountain Road  
 Hendersonville, NC 28791

Comprehensive Site Inspection(s)

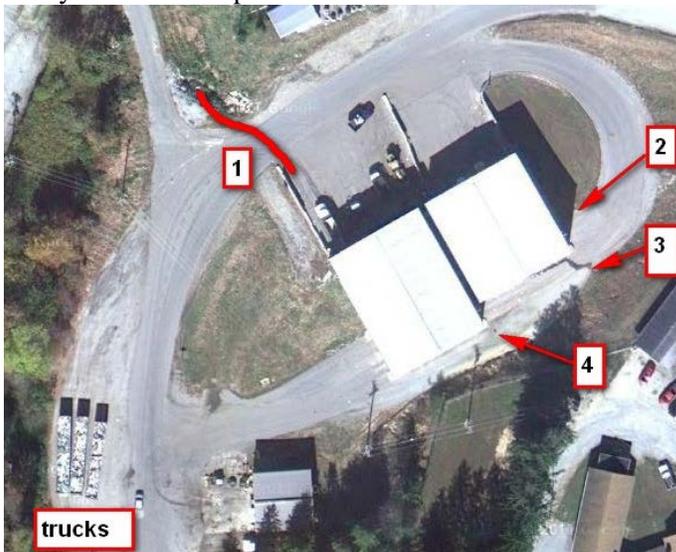
1. On site on May 6, 2013 and May 10, 2013 for comprehensive site inspection, document review, technical assistance regarding Yard Waste management, and to discuss observations from the May 6, 2013 inspection.
2. During the May 6, 2013 site inspection the transfer station was in operation. The region had recently received heavy rainfall and specific areas of concern were identified at that time (see map below).

Aerial GoogleMap - there have been changes to the traffic pattern that this photo does not represent, specifically in region #1.

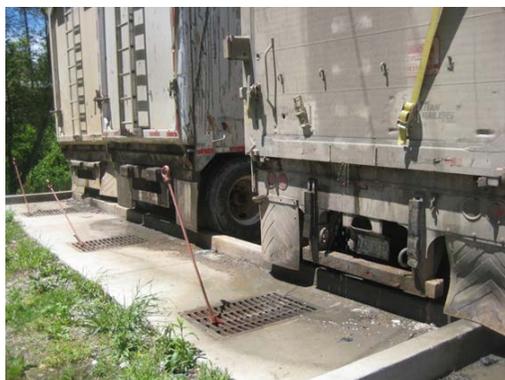
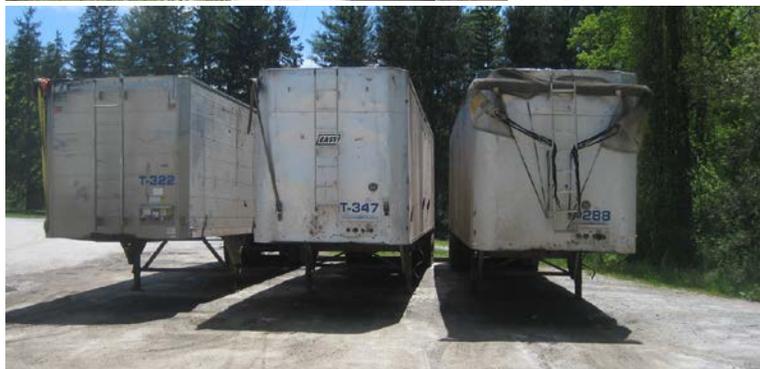
- a. Trucks: During the inspection three loaded transfer trailers were parked over the existing leachate containment drain system. Trailers were leaking from the rear seals but the leachate was captured at the wastewater collection points.

KR Drenth trucks T-322 and T-347 were leaking from the undercarriage of the transfer trailers onto the gravel/soil surface (not paved). Surface water is located to the right of this region (down grassed slope). No visible leachate was observed flowing off the gravel lot at the time of the inspection. Mr. Wiggins stated that the facility notifies KR Drenth of leaking trucks and keeps a log of calls. A. Keller discussed the need to control all leachate releases, whether by moving the trailers to within the leachate capture/collection system or by developing a method to catch any leachate/leaks from the trucks (troughs, buckets, etc.).

- a) **Immediately restrict all leachate from reaching on-site surface water drains** (which may additionally include repair of the leachate collection system in order to meet original design intent); and

- c) Submit a Plan to the Section for review and approval that details contingency plans for leaking trailers; and
- d) Submit a Plan for review approval to the Section that details a proposed soil and surface water assessment for the regions potentially impacted by the clogged trench drains associated with the lower transfer bays and associated storm drains located outside the two lower loading bays; and

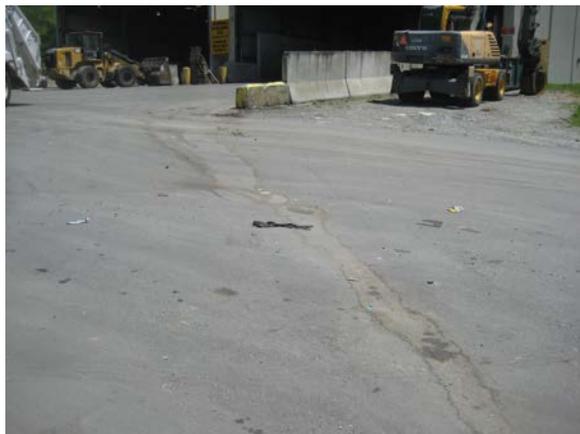
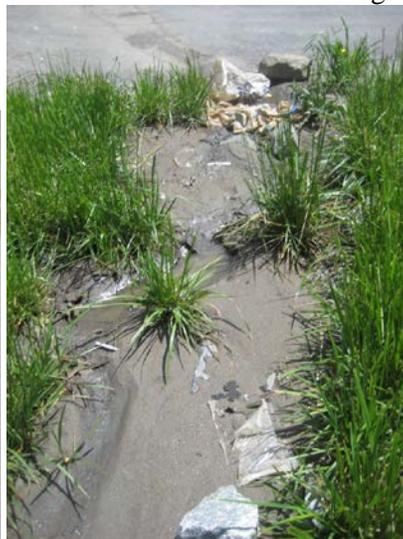
- b. Area 1: No flow was observed at the time of the inspection. However, a stained path was observed leading from the transfer station bay to a surface water drainage ditch (leading to a sed basin) – the drainage channel contained some solid wastes (see photo below). This area of concern was discussed in detail on May 10, 2013 with Mr. Wiggins and Ms. Berry. All leachate must be contained within the approved leachate collection system, all water that comes in contact with waste is considered leachate, and all windblown wastes should be collected at the end of each working day.

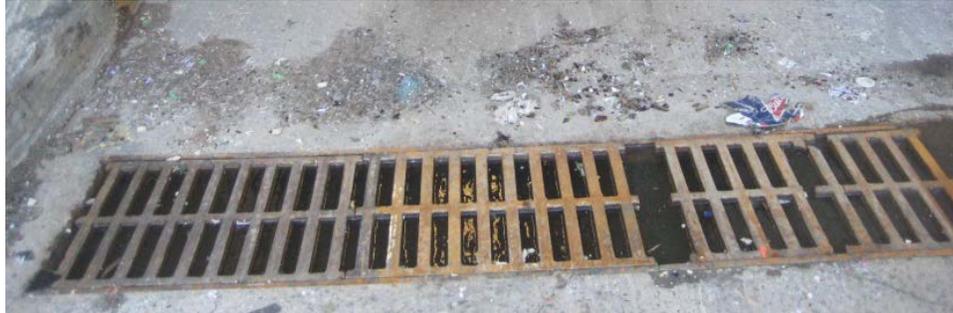
- c. Area 2: The drain located outside of the leachate collection trench drain has been a continuous area of concern. The facility determined (through investigation and document review) that this drain (along with drains in Area 3 and Area 4) were not leachate collection / wastewater drains but rather stormwater drains. The leachate collection trench drain has a history of clogging and overflow. During the 5/6/13 site inspection the leachate was standing (no flow) in the drain. (see photo below), but overflow was not observed.

3. Regarding the impacts noted above, the Facility had a capital improvement plan to address these issues, slated for construction around 2015. It was discussed that this timeframe was not adequate in addressing current impacts and that the stormwater drains must be protected from solid wastes (particulates) and leachate in accordance with Permit conditions and Rules. Options were discussed within the Section and with the facility representatives, and the facility was informed that all changes should be submitted to Larry Frost, permit engineer with the Section, for approval prior to any major changes to the current design.

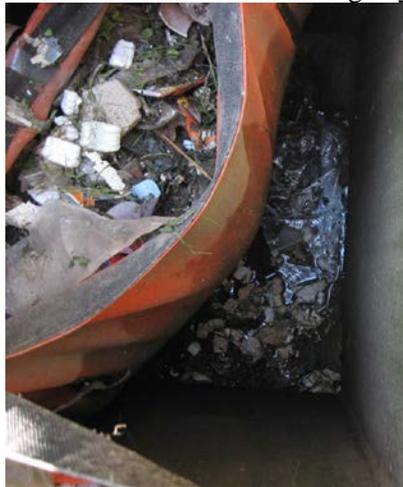
4/3/12

The recently identified surface water drain has exhibited solid waste impacts from possible overflow from the trench drain / loading bay during previous inspections.

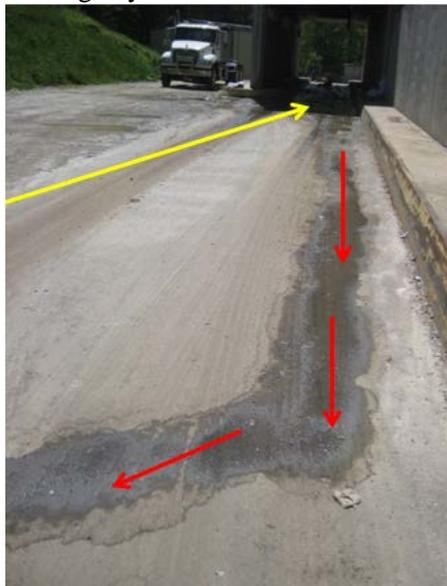
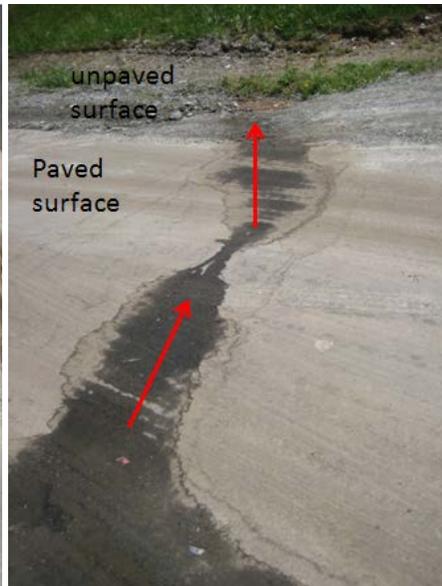
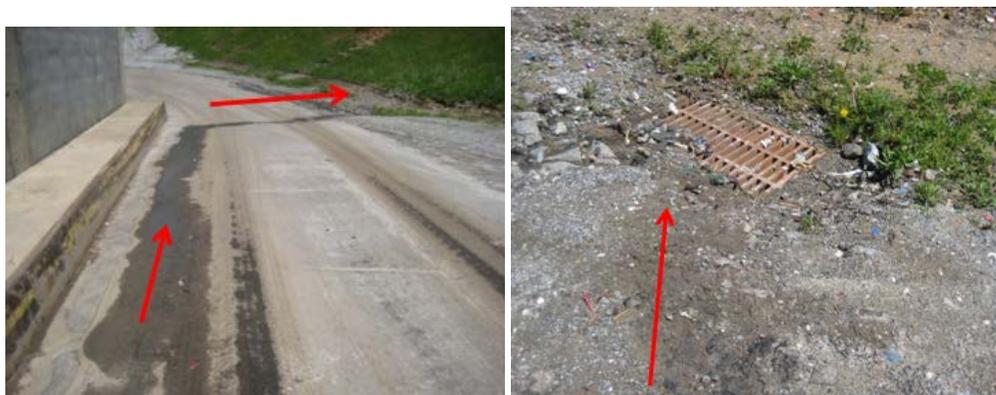
- d. Area 3: Recently (~February 2012, per N. Berry) identified stormwater drain, located in gravel/soils, appeared to have direct leachate impacts (see photos below) from the overflow from the second loading bay trench drain.

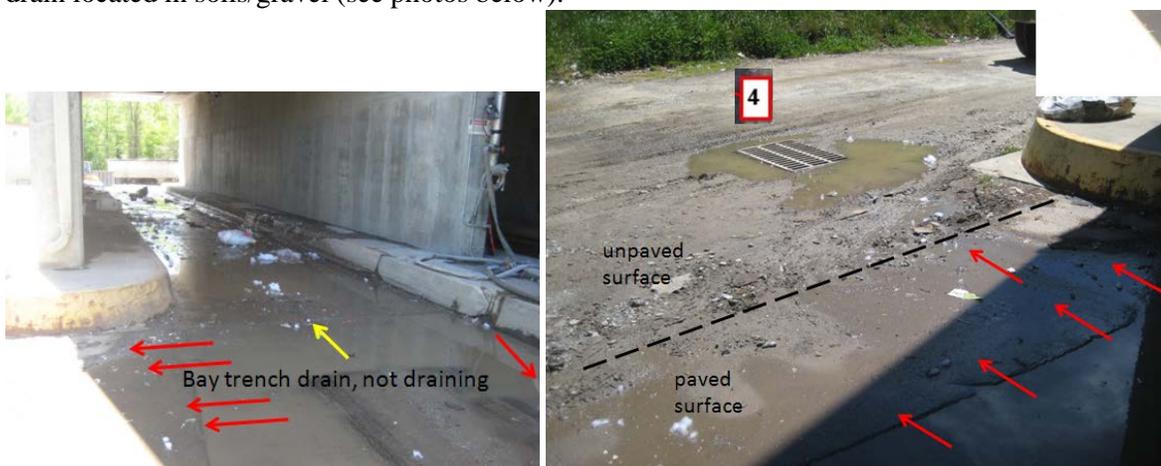
On May 6, 2013, the leachate collection system (trench drains) were not operational in the lower loading bays, contained standing water, and was not operating as designed. Leachate from the trench drains was observed reaching two surface water drains which discharge to an on-site surface water body. On May 6, 2013, two transfer trucks were observed releasing leachate to the environment (leaking).

- e. Area 4: Loading bay trench drain was not functional (overflow) had visible impact on stormwater drain located in soils/gravel (see photos below).

- b) Submit a Plan to the Section for review and approval that details maintenance and cleanout schedules, tracking, or documentation of maintenance of the leachate collection system, and/or re-structuring of on-site flow in order to restrict all leachate from reaching surface water drains and impervious surfaces; and
