**FACILITY COMPLIANCE INSPECTION REPORT**  
**Division of Waste Management**  
**Solid Waste Section**

**Date of Site Inspection:** October 4, 2012

Hertford County Closed MSW Landfill  
 227 Mount Moriah Road  
 Winton, NC 27986

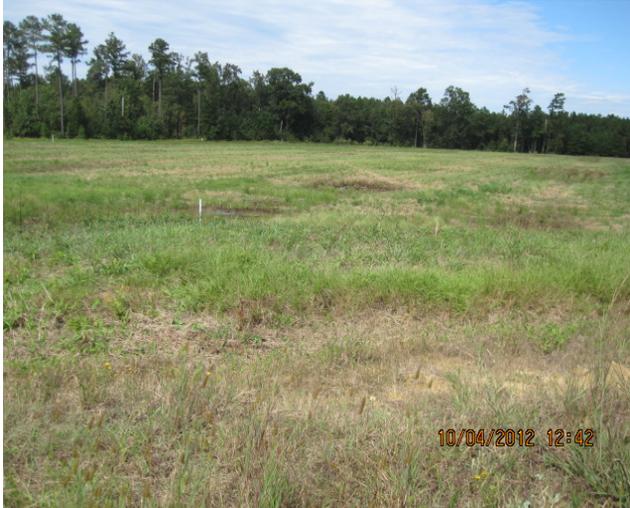
4. **There were many areas of ponding water over waste, in the landfill to the north side of the access road. These areas need to be filled with soil and the landfill should be graded to prevent any further ponding of water.** It is suggested that a regular schedule be maintained for the monitoring of any future subsidences at the closed landfill, in order to repair the areas and prevent any ponding of water over waste.

Closed MSW Landfill with areas of ponding water

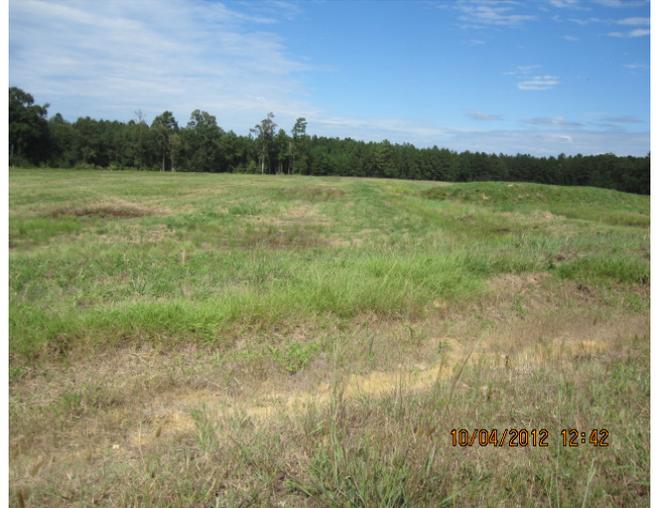
Closed MSW Landfill with areas of ponded water

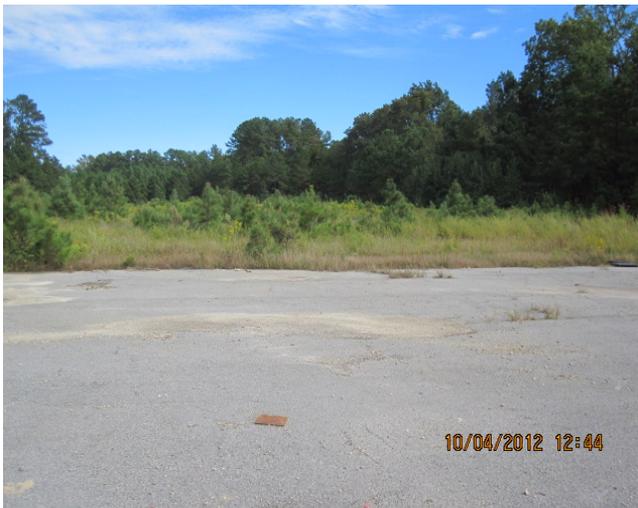
Old borrow area. This area is approved for vegetative disaster debris

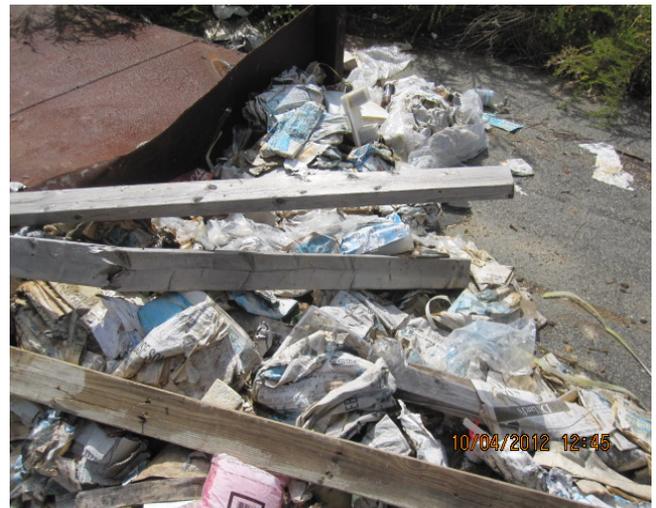
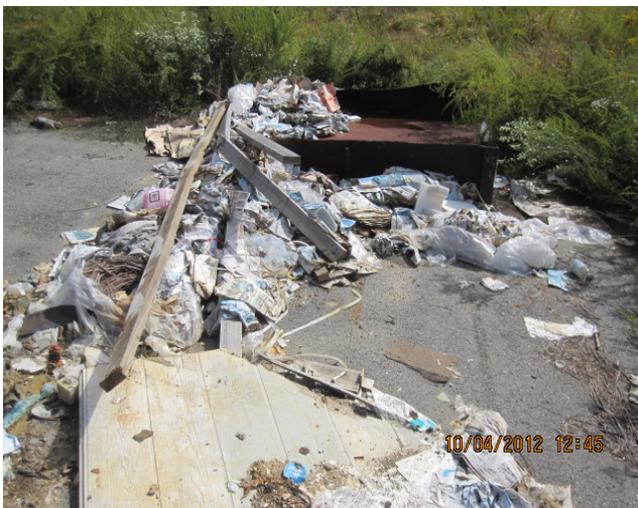
10. There is a load of waste that has been dumped on the paved area at the old borrow area. **This needs to be removed and disposed of properly.**

Load of waste at the old borrow area.

Load of waste at the old borrow area
