FACILITY COMPLIANCE INSPECTION REPORT

Division of Waste Management Solid Waste Section

Jones County Landfill
 Landfill Rd (NC SR#1343)
 Trenton, NC

5201-20130130INSP

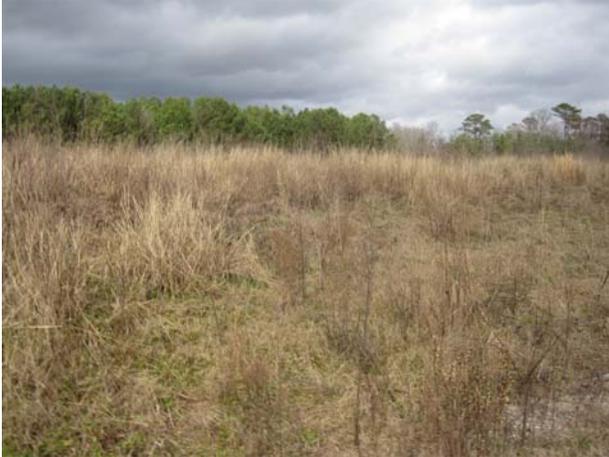
- 10) A cover crop of native warm season grasses has been established throughout the landfill. Overall, the cover crop has been well established; however, small areas of sparse cover were noted throughout the landfill. *Please grade, seed, and mulch these areas to establish a groundcover suitable to prevent erosion of your landfill cap system. All repaired areas should be graded at a slope not greater than 3:1.
