**CORRECTIVE ACTION REPORT
OWL'S DEN LANDFILL
PERMIT NO. 55-02
LINCOLNTON, NORTH CAROLINA
S&ME Project No. 1356-10-033**

Reference: Corrective Action Report
Owl's Den Landfill, Permit No. 55-02
Lincolnton, North Carolina
S&ME Project No. 1356-10-033

S&ME, Inc. (S&ME), on behalf of Lincoln County, submits this Corrective Action Report for the Owl's Den Landfill. This report is in response to the issuance of your letter dated May 20, 2010 titled "October 2009 Semiannual Monitoring of Groundwater, Surface Water, and Methane" requiring Corrective Actions for the above referenced site.

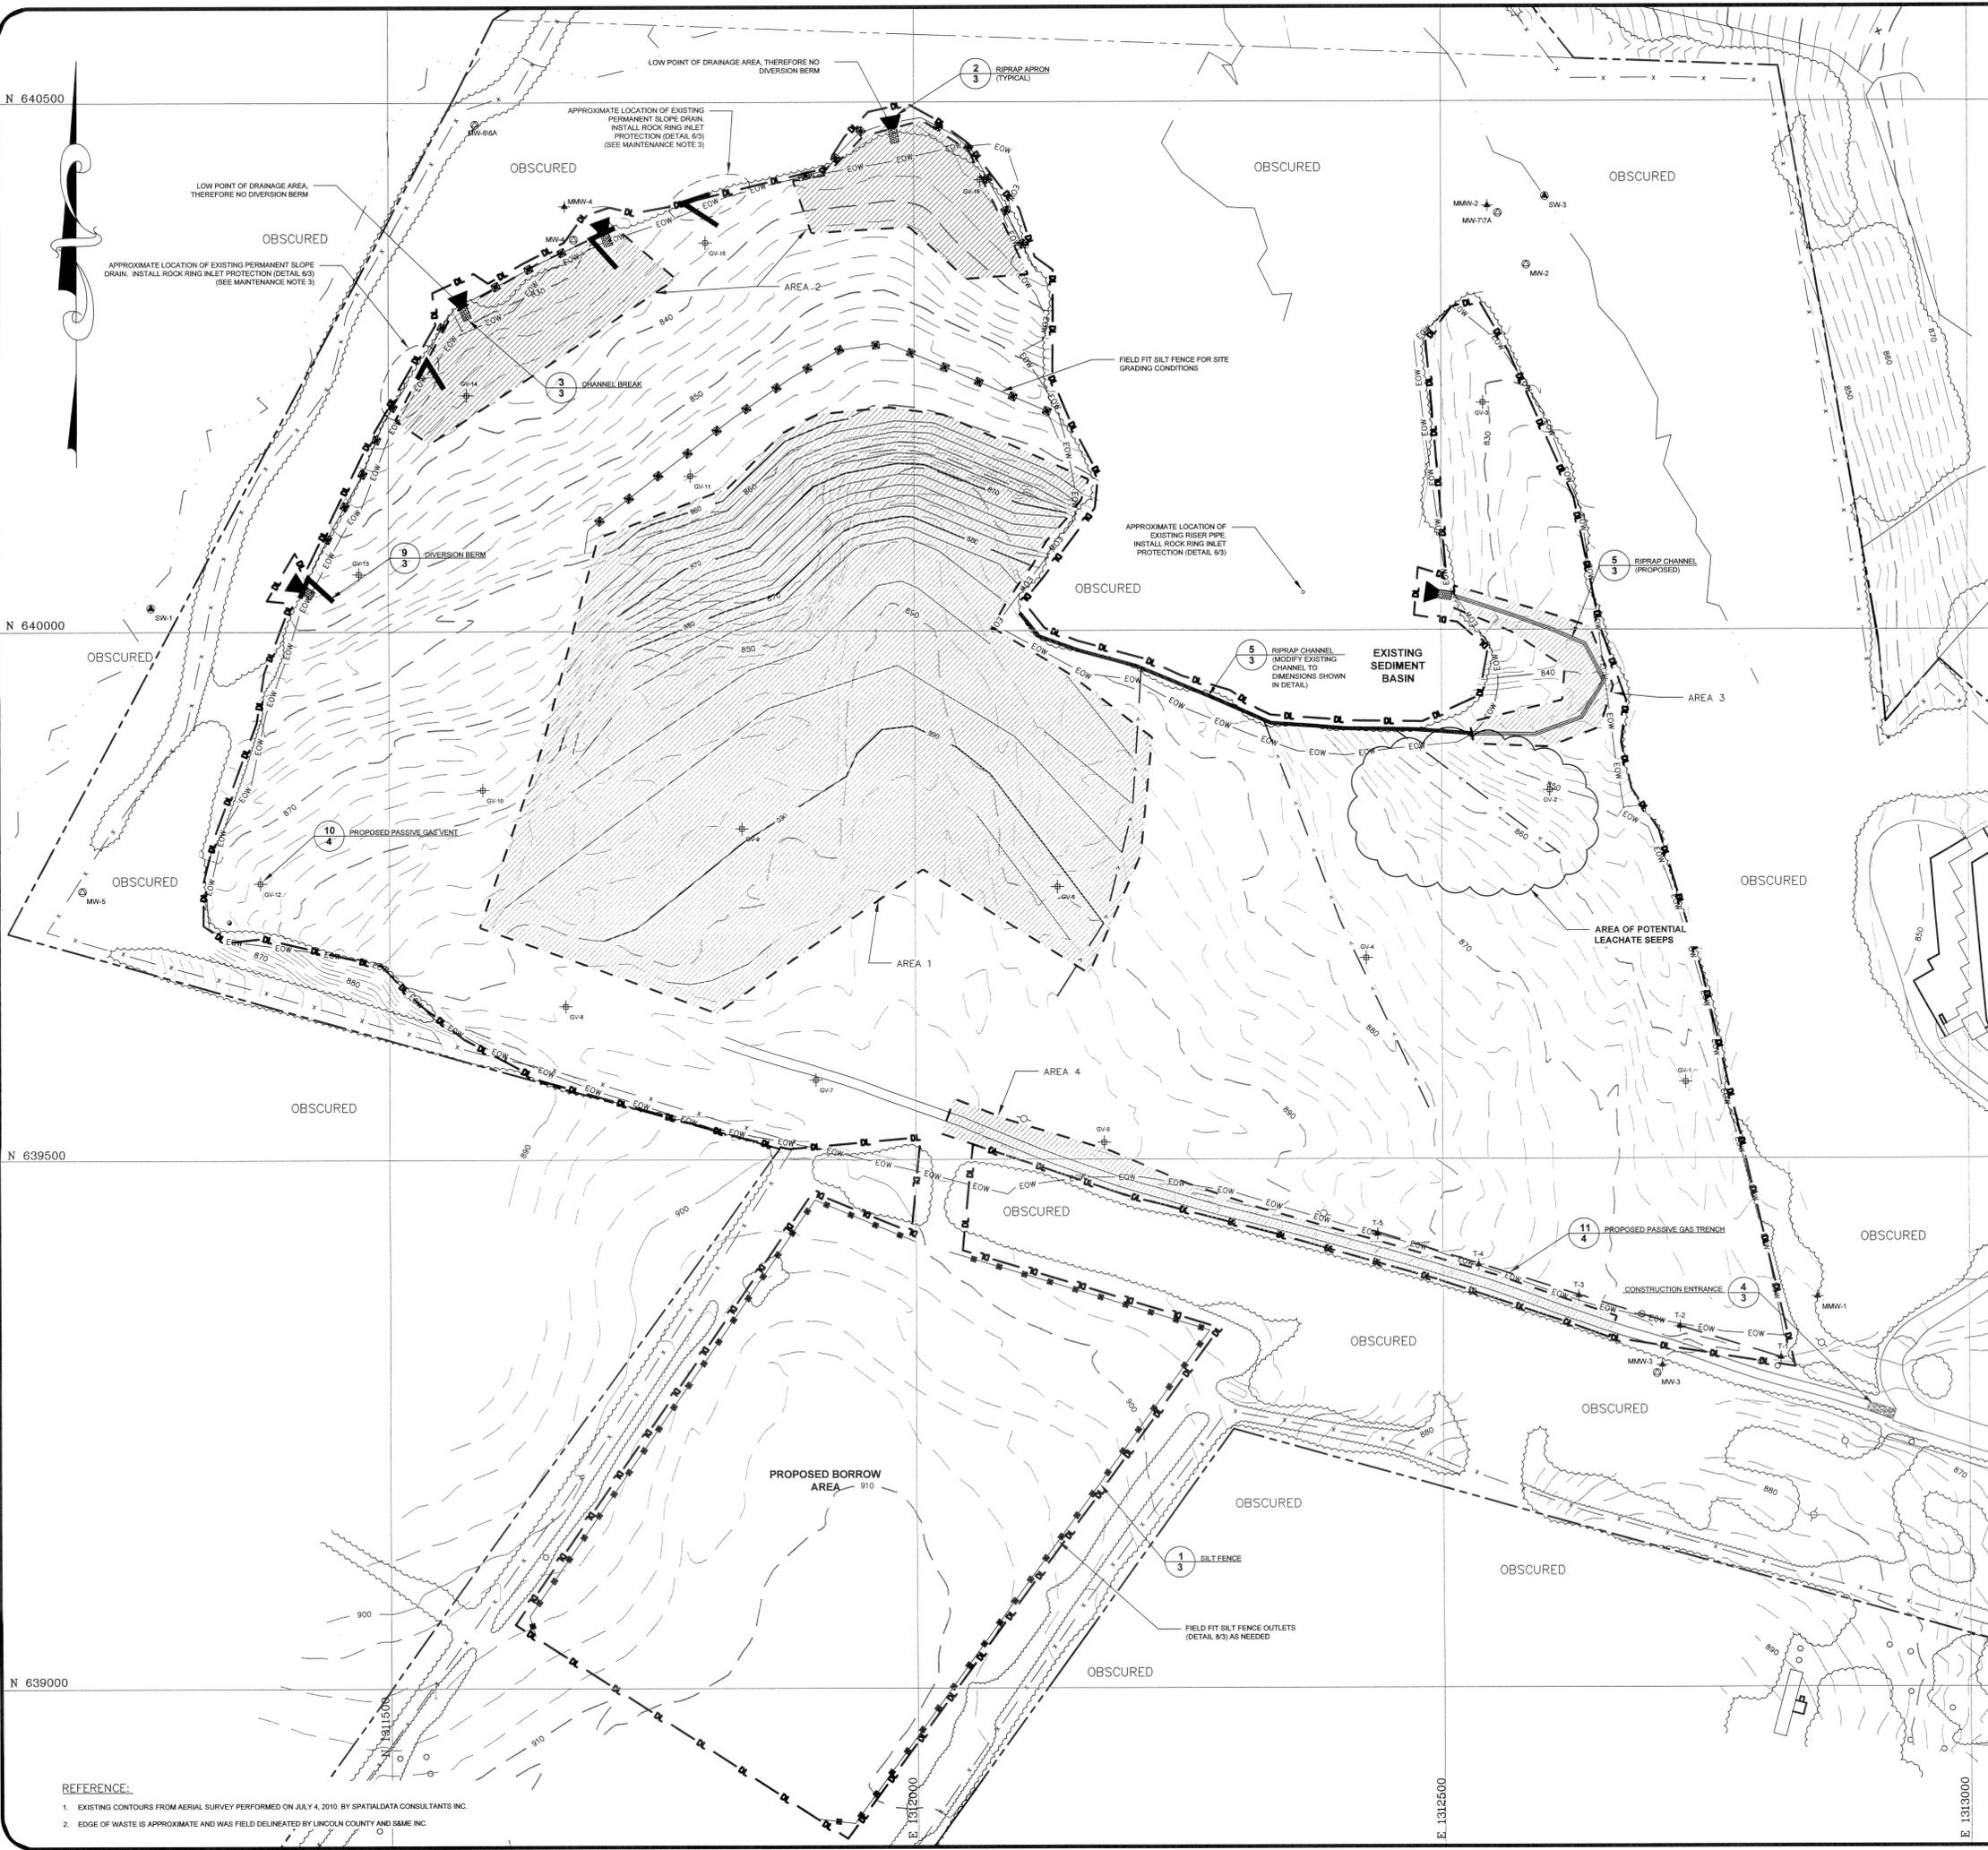
PROJECT DESCRIPTION
 THE AREA PROPOSED IS FOR THE OWL'S DEN LANDFILL PROJECT. THE PROPOSED DISTURBED AREA IS APPROXIMATELY 1.27 ACRES.

EXISTING SITE CONDITIONS
 THE SITE IS COMPRISED OF THE OWL'S DEN LANDFILL AND AN ADJACENT BORROW AREA. OWL'S DEN LANDFILL HAS RECENTLY BEEN CLEARED OF WOODY VEGETATION AND SHRUBS AND CURRENTLY CONSISTS PREDOMINATELY OF SPARSELY TO MODERATELY GRASSED AREA. THE BORROW AREA CONSISTS OF A GRASSED FIELD.

Due to the localized extent of the poorly draining areas, S&ME recommended that the localized poorly draining areas be filled and graded as a “field fit” to improve drainage. These areas received borrow material from the soil stockpile and were re-graded to the elevations shown on *Drawing 3*, Grading Plan As-Built, in *Appendix I*.

Exposed waste on the eastern portion of the landfill had been uncovered by erosion caused by concentrated stormwater flow. S&ME provided recommendations to reduce concentrated stormwater flow in this area by cleaning out and repairing the rip rap channel, as well as extending the channel and constructing an outlet apron as detailed on *Drawing 1* in *Appendix I*. Repairs and modifications to the rip rap channel and outlet apron were performed in accordance with the approved specifications detailed on *Drawing 2* in *Appendix I*.

The newly extended rip rap channel terminates at an existing stormwater detention basin. Based on our previous visual observations, the riser pipe and outlet pipe appeared to be in working condition and were not clogged, the plunge pool was in good condition, and the downstream area appeared stable. S&ME did not recommend modifications or repairs to the basin. However, the basin was reconditioned by removing trees and shrubs within the basin, as well as constructing a rock ring inlet protector for the riser pipe. “As-Built” of this area are shown on *Drawing 3* in *Appendix I*.

Sections of the access road along the southern portion of the landfill were exhibiting erosion rills caused by concentrated stormwater flow. A ditch exists on the north side of the access road to the west; however, the ditch diminishes towards the east and stormwater was allowed to flow over the road causing erosion. Repair of the road included re-grading the road to drain to the south with a maximum 2 percent slope. “As-Built” of this area are shown on *Drawing 3* in *Appendix I*.

Slope breaks consisting of soil berms were observed on the eastern portion of the landfill. The slope breaks appeared washed out and eroded in areas and were generally discontinuous. The slope breaks were repaired and reconditioned to the elevations shown on *Drawing 3*, Grading Plan As-Built, in *Appendix I*.

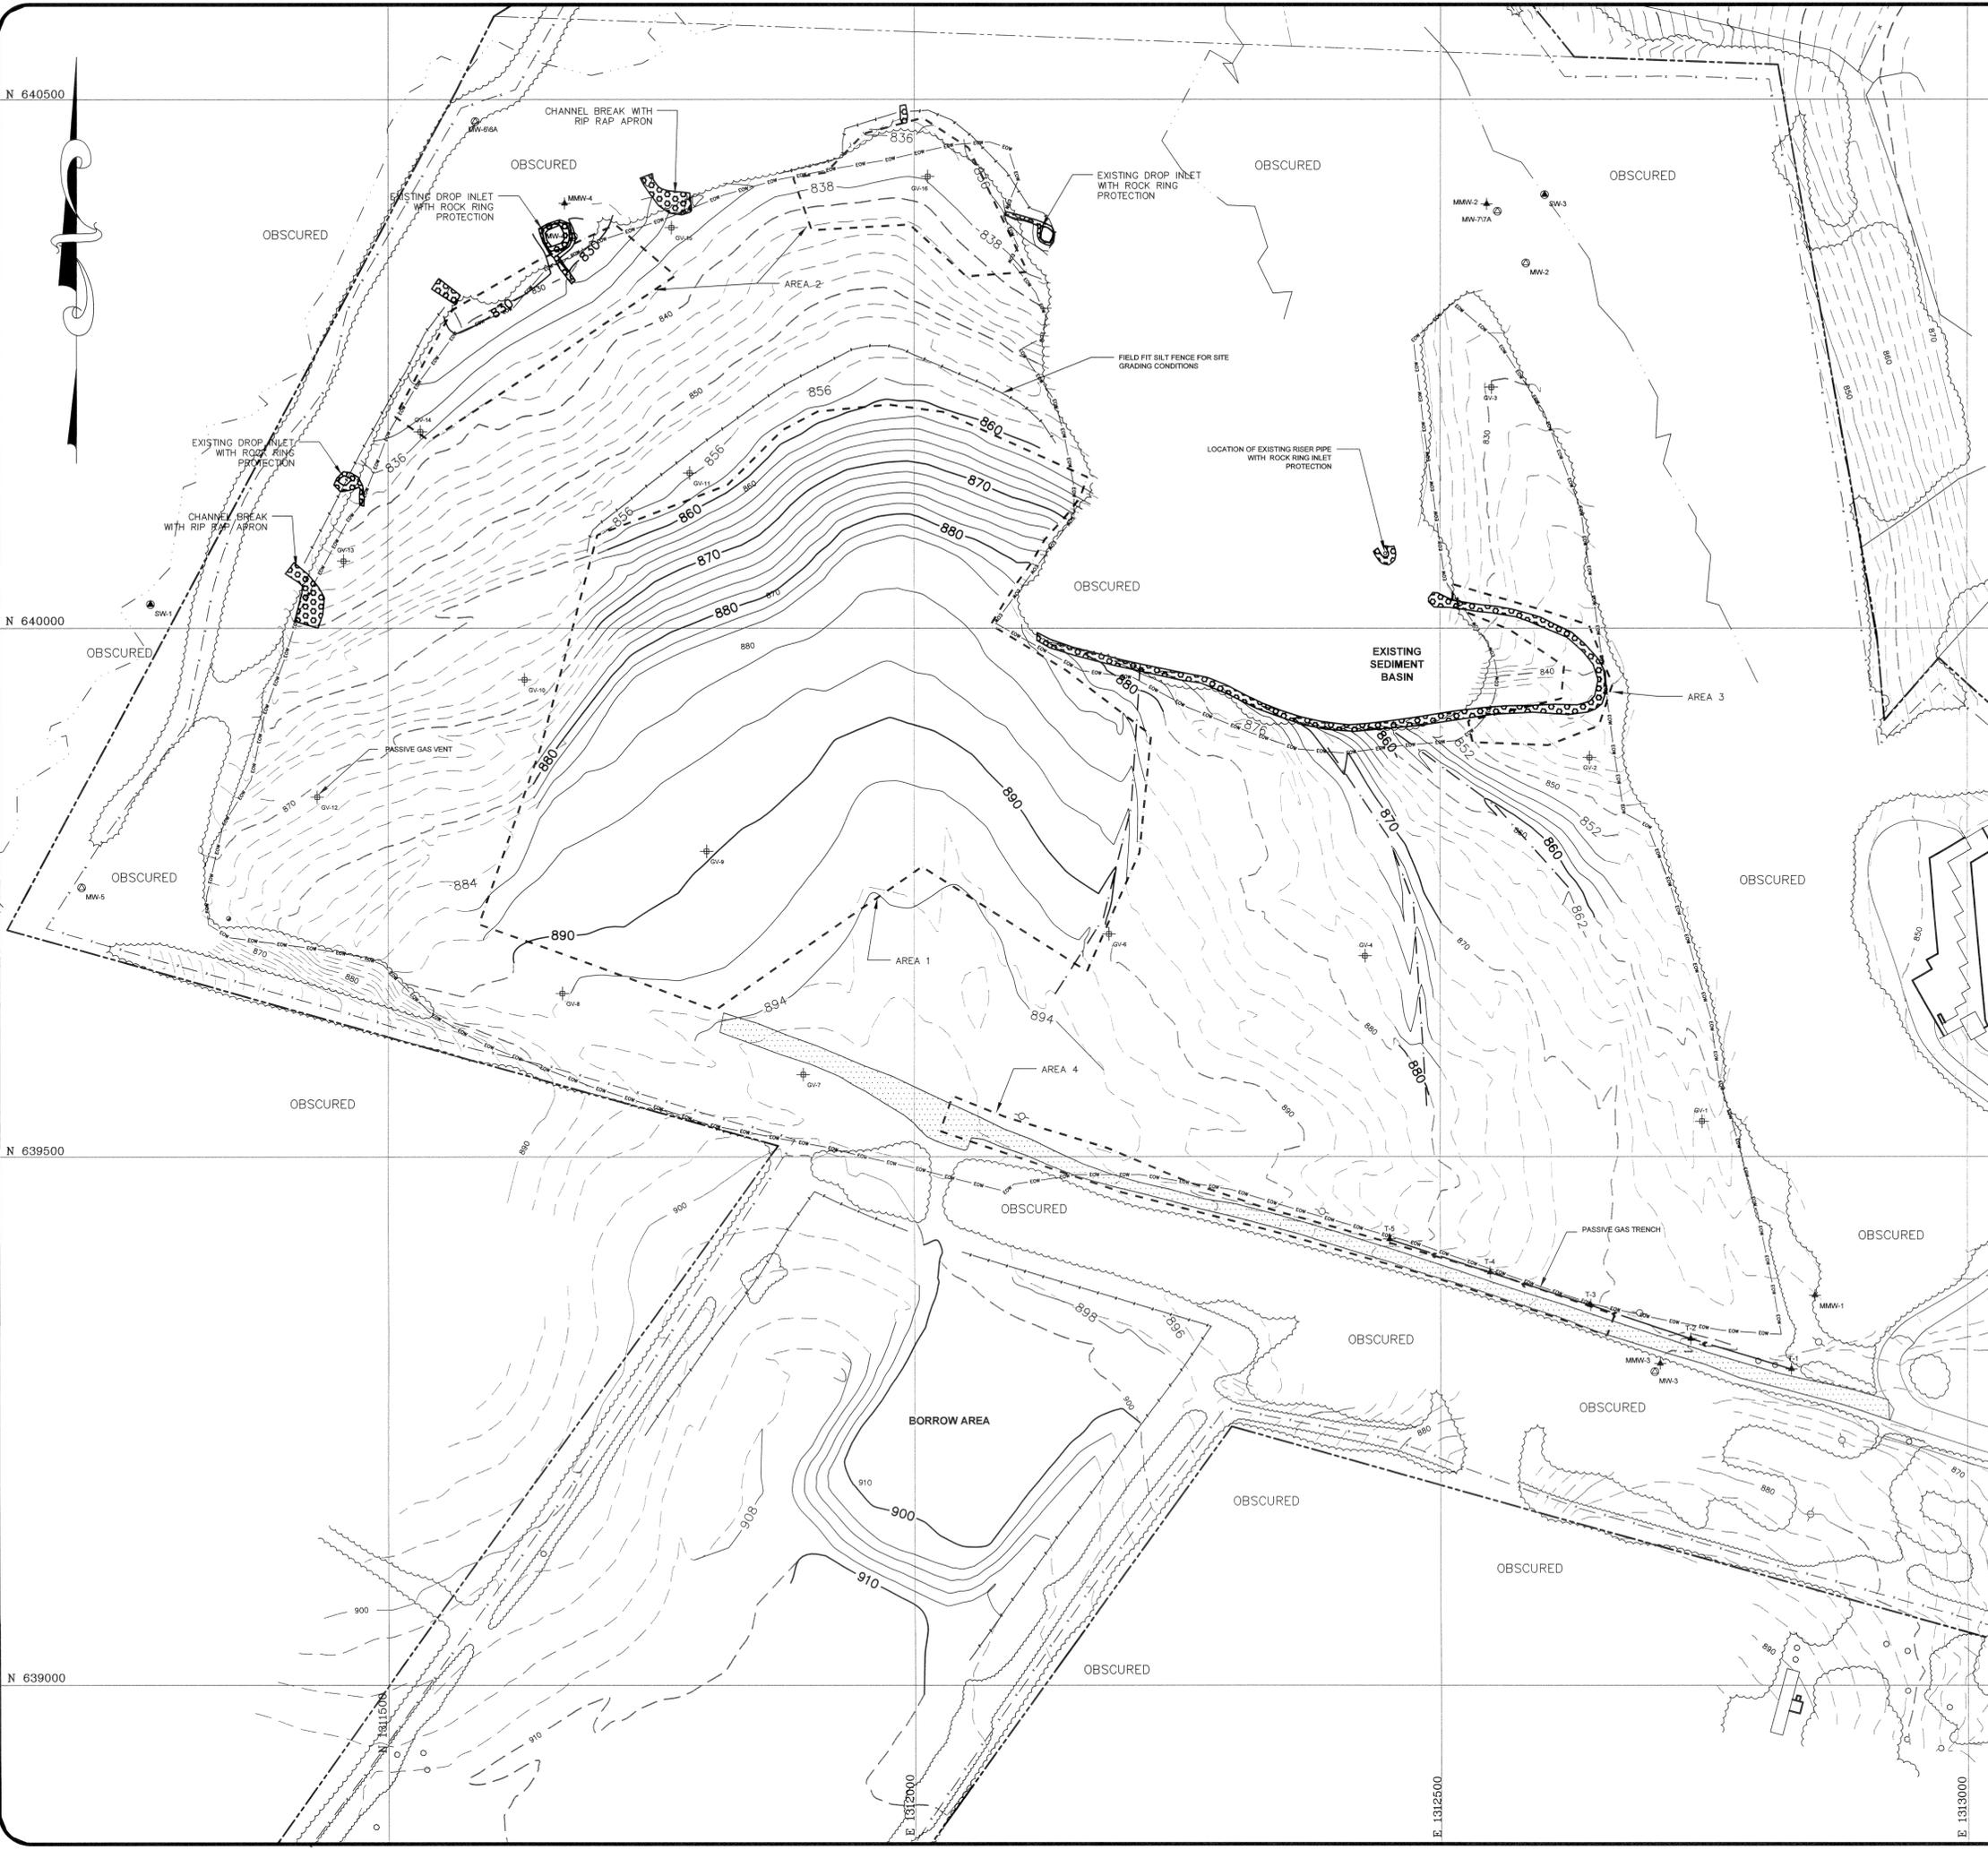
S&ME ENGINEERING LICENSE NO. F-0176
DRAWN BY: CLD CHECKED BY: JRP
DESIGNED BY: JRP APPROVED BY: JSR
PROJECT NUMBER: 1356-10-033
SCALE: 1" = 60' DATE: 8-29-12
DRAWING: 3 OF 5

During re-grading of this area, landfilled waste was not encountered in the suspected “non-disposal” area, which verified the assumptions made from the historical site drawings. In-place soils, borrow soils and investigative derived waste (IDW) from the passive gas vent installation were used to re-grade the area to the elevations shown on **Drawing 3**, Grading Plan As-Builts, in **Appendix I**.

To control the stormwater flow within the perimeter grass-lined ditches, periodic channel breaks were installed. Rip rap outlet aprons were also installed downstream of channel breaks to decrease flow velocity and depth before discharging to the receiving area. The channel breaks and rip rap aprons were constructed in accordance with the designs shown on *Drawings 1 and 2* in *Appendix I*. “As-Built” of this area are shown on *Drawing 3* in *Appendix I*.

S&ME proposed to install 16 passive gas vents (GV-1 through GV-16) across the site as illustrated on **Drawing 1** in **Appendix I**. However, only 15 passive gas vents were constructed. Passive gas vent GV-5 was omitted during construction due to no waste being encountered in the area. GV-5 was off-set 4 times in approximate 50-foot increments in a northeasterly direction toward the rip rap channel. The boring and offset borings were advanced 5 to 10 feet with no evidence of waste placement. The location of the surveyed vent locations are shown on **Drawing 3** in **Appendix I**.

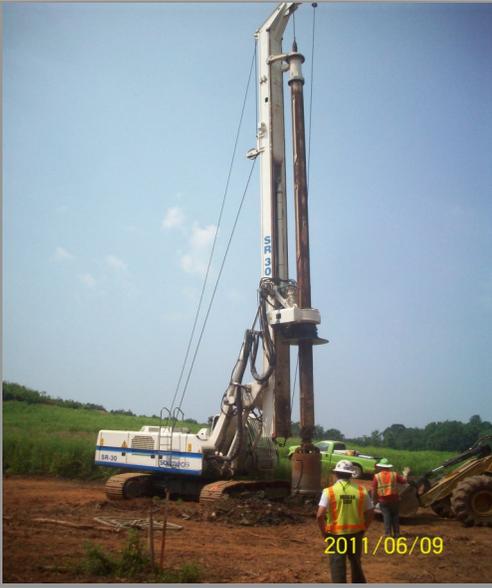
Photo 1

Date: 6/9/2011
		Photographer: J. Addis
Activity	Passive Gas Vent Installation	
Remarks	Bucket auger rig drilling for passive gas vents.

The passive gas vents were constructed as shown on **Drawing 4** in **Appendix I**. The vents were installed using a bucket auger drill rig capable of creating a 36-inch diameter borehole through the soil cover and waste. Because the depth to waste was not known, borings were advanced through the waste and into residual soils (approximately 2 feet). The borehole was then backfilled with bentonite within the residual material.

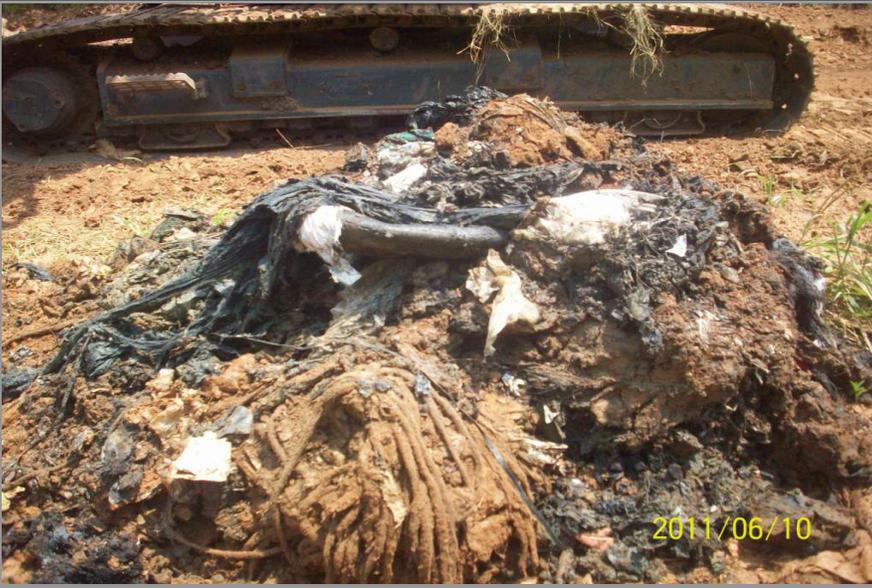
Photo 2

Date: 6/10/2011
		Photographer: J. Addis
Activity	Passive Gas Vent Installation	
Remarks	Typical waste excavated from borehole.

In an effort to minimize the amount of soil required to re-grade the cover, waste generated during installation of the passive gas vents and trench was re-buried in the waste area. Initially, the cover soils in the repair area were removed and stockpiled. Waste was then placed in compacted lifts until the desired grade was achieved, followed by re-placement of the cover soils.

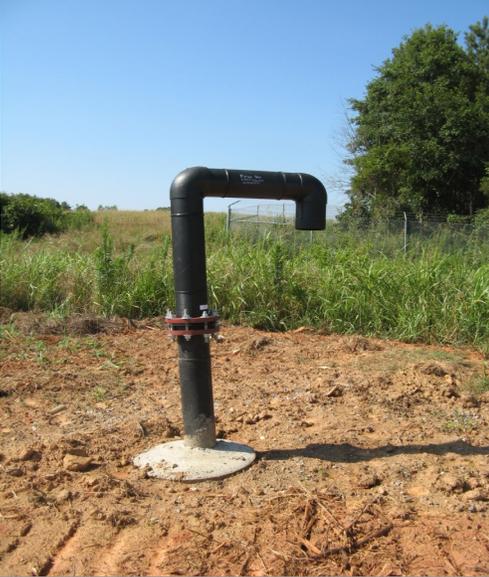
Photo 5

Date: 6/30/2011
		Photographer: J. Petersen
Activity	Passive Gas Vent Installation	
Remarks	Completed passive gas vent installation with goose neck.

The vent screen was constructed of 6-inch diameter perforated high density polyethylene (HDPE) that typically extended from 2 feet above the bentonite seal to 5 to 10 feet below land surface. The vent casing was constructed of 6-inch diameter non-perforated HDPE pipe that typically extended from 5 to 10 feet below land surface to 5 feet above land surface. The end of the perforated screen was capped, and the vent completed at the surface with a "gooseneck" style elbow (180 degree sweep). The top end of each vent was covered with a protective screen to allow the free flow of LFG out of the vent and to prevent animals, insects and material from entering.

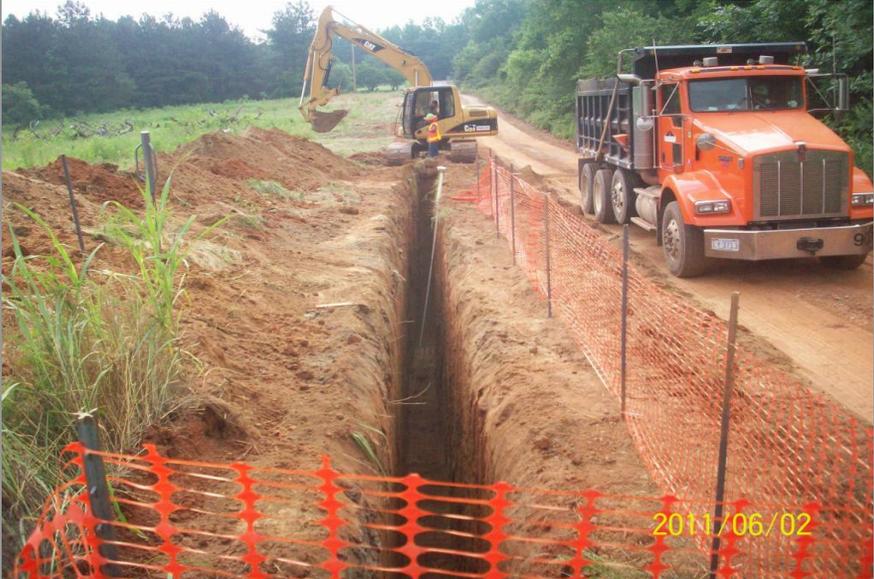
Photo 6

Date: 6/2/2011
		Photographer: J. Addis
Activity	Passive Gas Trench Installation	
Remarks	Excavation of trench.

The passive gas trench was constructed as shown on *Drawing 5* in *Appendix I*. The trench dimensions are generally 400 feet long, by 24 inches wide, by 15 feet deep. The trench was installed along the edge of waste boundary, adjacent to the waste mass. Five passive gas vents were spaced at 100-foot intervals along the trench (T-1 through T-5) and were connected by a horizontal perforated pipe.

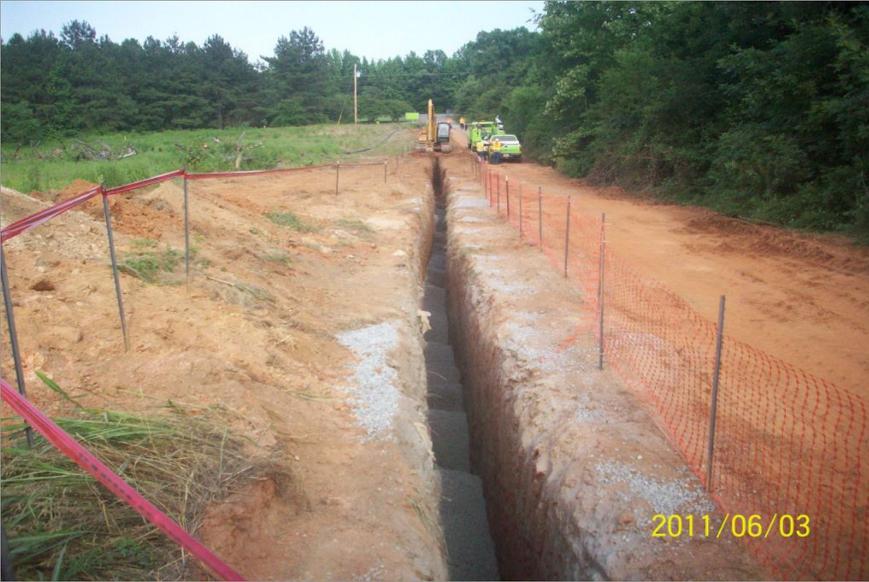
Photo 7

Date: 6/3/2011
		Photographer: J. Addis
Activity	Passive Gas Trench Installation	
Remarks	Stone backfill prior to vent pipe installation.

After excavation, the trench was backfilled with #57 aggregate (washed stone) to a depth of 8 feet below land surface. A 6-inch diameter perforated HDPE pipe was placed on top of the gravel pack and connected to the vertical vent pipes. The vertical vent pipe extends from the horizontal screen to 5 feet above land surface where each vent terminates into a gooseneck. After the HDPE pipe was installed and stabilized in-place, the remainder of the trench was backfilled with gravel to 2 feet below land surface.

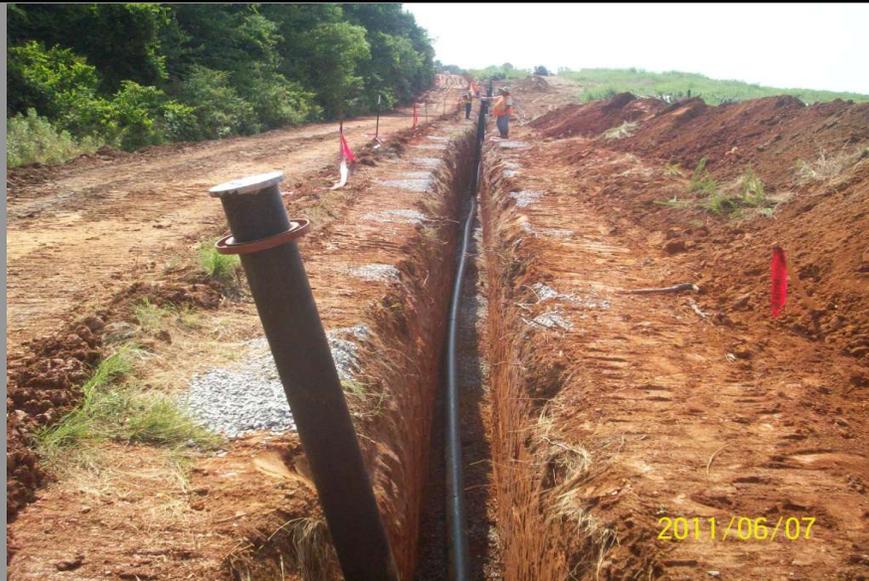
Photo 8

Date: 6/7/2011
		Photographer: J. Addis
Activity	Passive Gas Trench Installation	
Remarks	Installation of the vent piping.

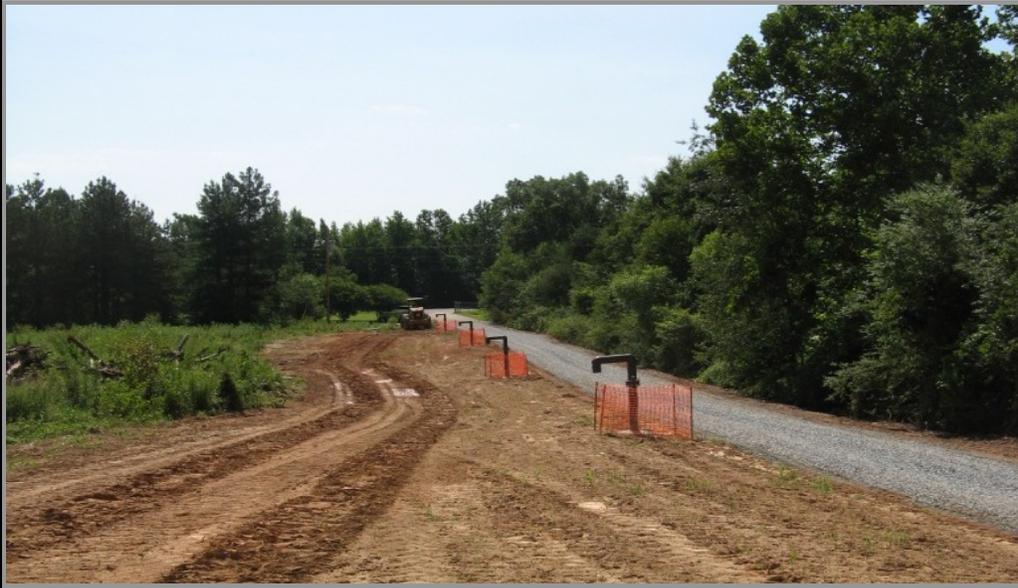
Photo 9

Date: 6/30/2011
		Photographer: J. Petersen
Activity	Passive Gas Trench Installation	
Remarks	Completed passive gas trench.

Twelve-inch diameter sonatubes were placed around the vertical vent pipes for later filling with concrete. A non-woven geotextile fabric was then placed around the vent pipes and on top of the gravel pack. The remainder of the trench was backfilled with compacted soil to ground surface. The vertical vent pipes were completed by backfilling the sonatubes with concrete to create a collar.

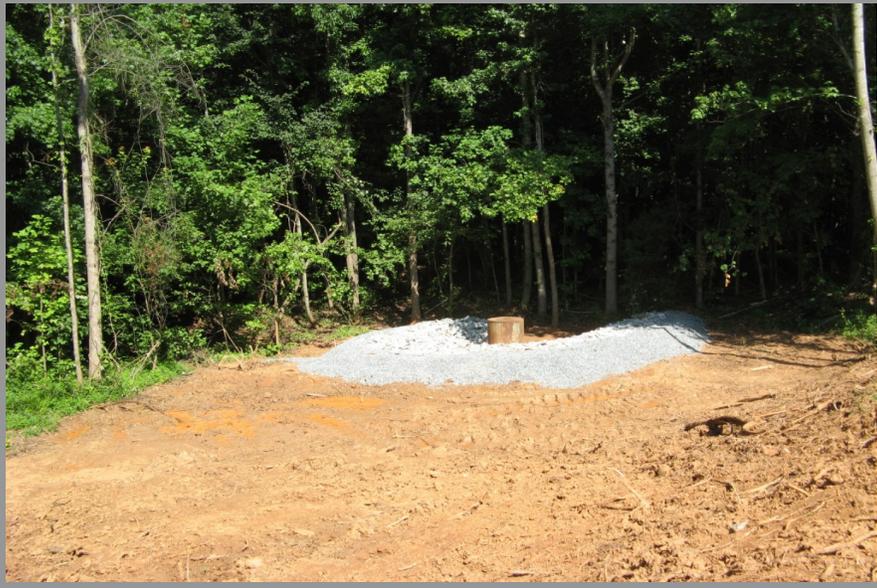
Photo 10

Date: 6/30/2011
		Photographer: J. Petersen
Activity	Construction and Rehabilitation of Stormwater Features	
Remarks	Cleaned-out sediment basin and rock ring inlet protection.

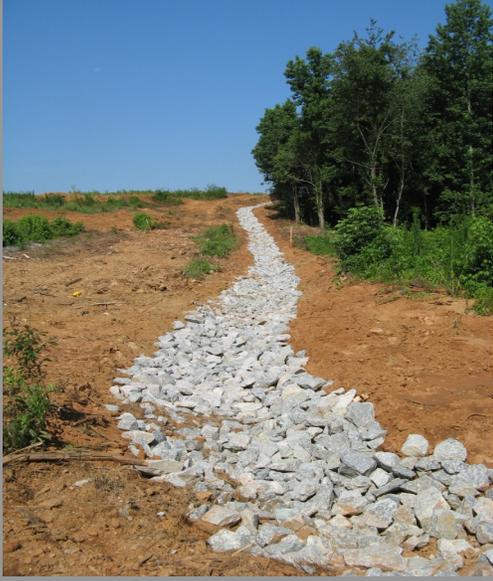
Photo 11

Date: 6/30/2011
			Photographer: J. Petersen
Activity	Construction and Rehabilitation of Stormwater Features		
Remarks	Rehabilitation of rip rap channel.

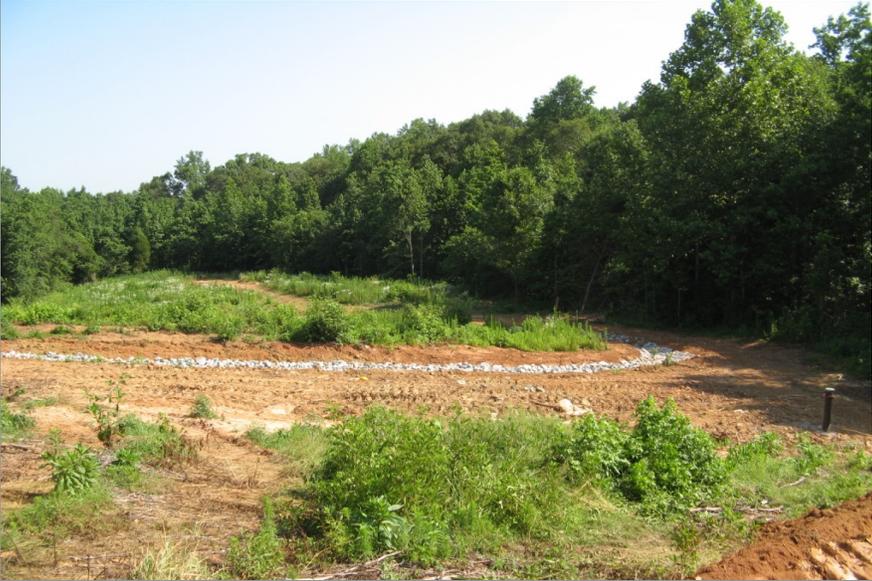
Photo 12

Date: 6/30/2011
			Photographer: J. Petersen
Activity	Construction and Rehabilitation of Stormwater Features		
Remarks	Extension of rip rap channel to sediment basin.

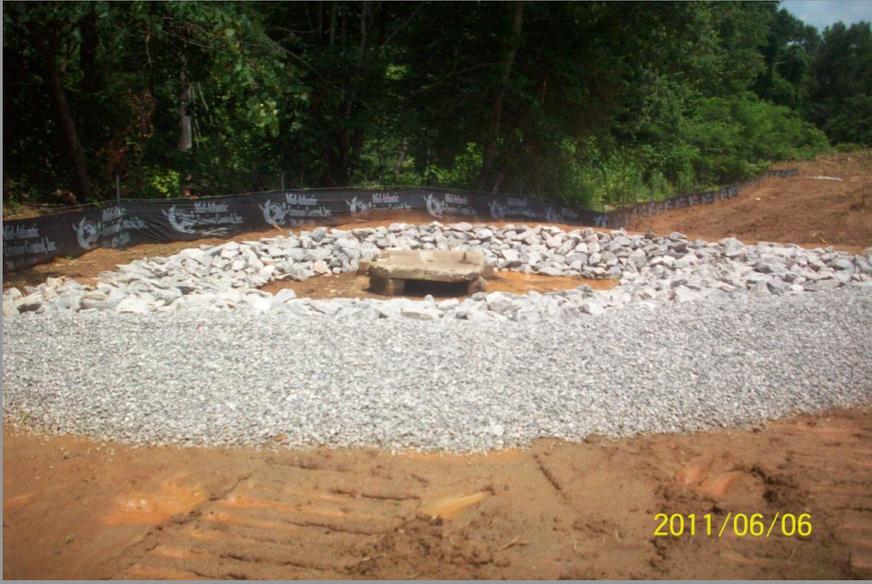
Photo 13

Date: 6/6/2011
		Photographer: J. Addis
Activity	Construction and Rehabilitation of Stormwater Features	
Remarks	Rock ring inlet protection around existing drop inlets.

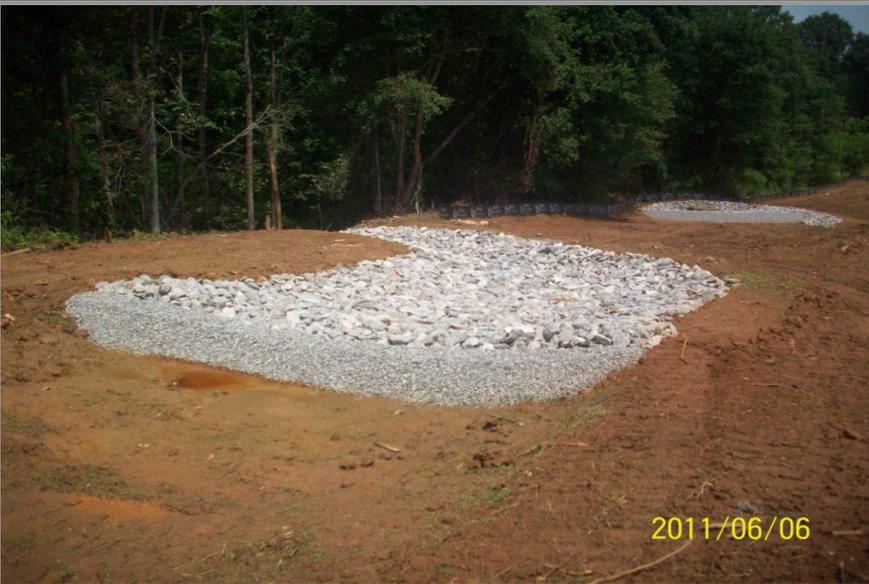
Photo 14

Date: 6/6/2011
		Photographer: J. Addis
Activity	Construction and Rehabilitation of Stormwater Features	
Remarks	Diversion berm and rip rap apron.

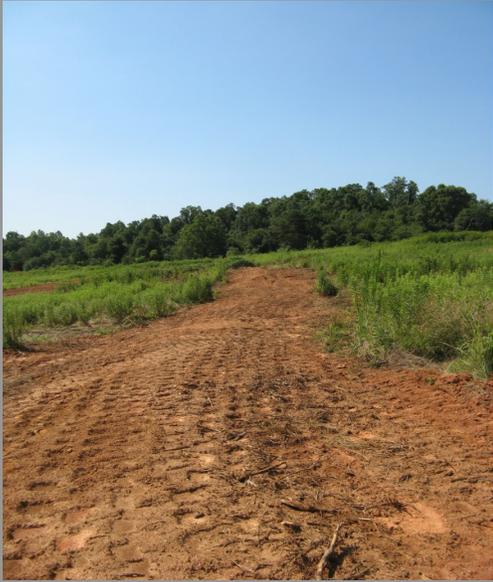
Photo 15

<p>Date: 6/30/2011</p> <p>Photographer: J. Petersen</p>	
Activity	Construction and Rehabilitation of Stormwater Features	
Remarks	Rehabilitation of slope breaks.

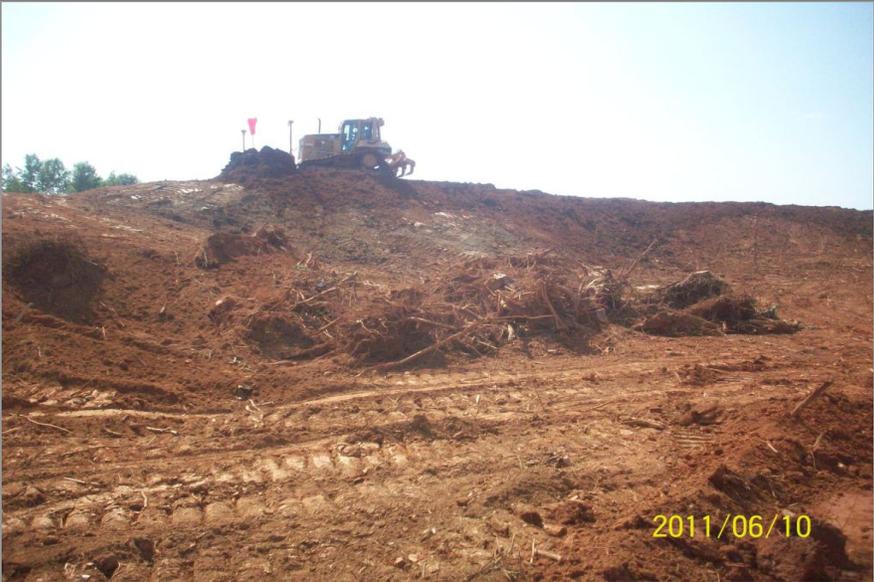
Photo 16

<p>Date: 6/10/2011</p> <p>Photographer: J. Addis</p>	
Activity	Re-Grading of Soil Cover	
Remarks	Re-shaping of Area 1.

A localized area of steeply sloping grades was identified in the central portion of the landfill in the vicinity of a suspected “non-disposal” area. S&ME proposed re-grading this area as detailed on the Grading Plan, **Drawing 1** in **Appendix I** to promote positive drainage across the site and decrease the likelihood of erosion on the slope face.

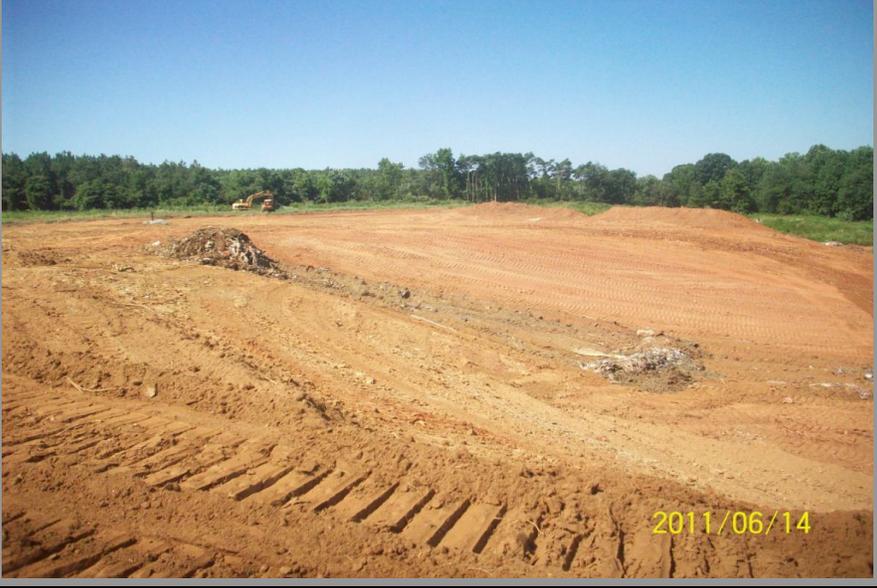
Photo 17

Date: 6/14/2011	
Photographer: J. Addis	
Activity	Re-Grading of Soil Cover
Remarks	Burial of investigative derived waste.

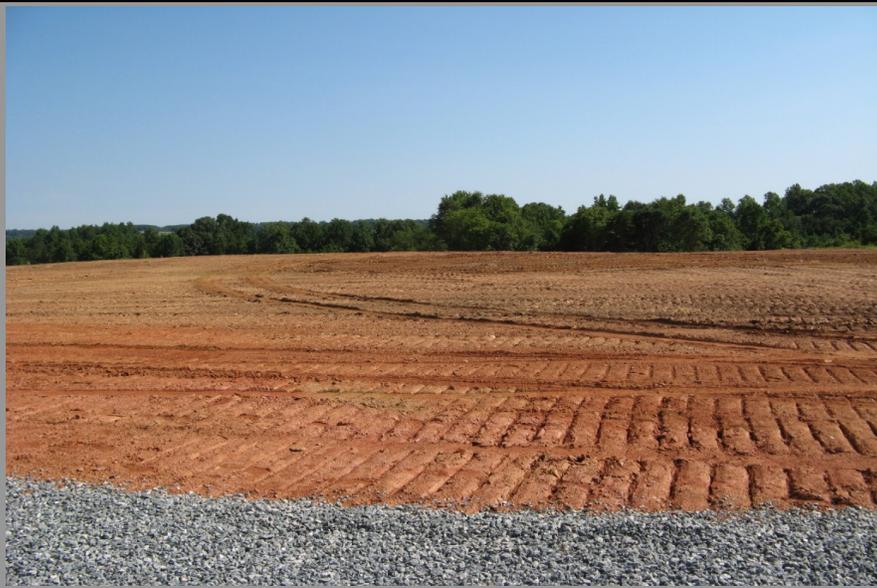
Photo 18

Date: 6/30/2011	
Photographer: J. Petersen	
Activity	Re-Grading of Soil Cover
Remarks	Re-graded Area 1 prior to final seed and mulch.
