**FACILITY COMPLIANCE INSPECTION REPORT**  
**Division of Waste Management**  
**Solid Waste Section**

**Date of Site Inspection: April 9, 2013      Date of Last Inspection: April 24, 2012**

**FACILITY NAME AND ADDRESS:**  
 Macon County Municipal Solid Waste Facility  
 1448 Lakeside Drive  
 Franklin, NC 28724

**PURPOSE OF SITE VISIT:**  
 Comprehensive Audit of MSW Landfill

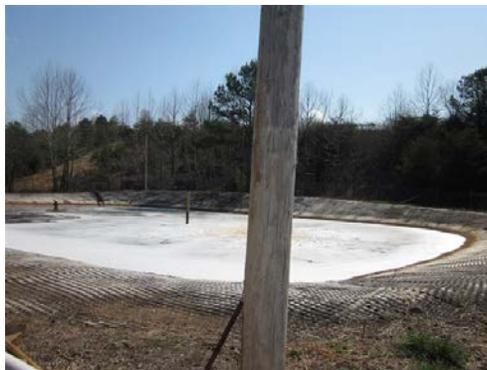
6. Methane detection forms were correctly filled out as a percentage of the LEL. The most recent Monitoring was done on 3/28/13. Monitoring is done on a quarterly basis. Monitoring for methane is also done in facility structures.
7. Waste screening forms were reviewed and appeared to be filled out correctly. The forms also report how the items were disposed or recycled.
8. The facility samples groundwater, surface water and leachate on a semi-annual basis. The most current reports available were of the sampling done on October 17, 2012. Each groundwater monitoring well was observed in good condition.
9. Leachate is pumped to a collection pond for pretreatment before being sent to the Town of Franklin Wastewater Treatment Plant located next to the facility. The pond appeared to be in good condition. The leachate collection pipes were last inspected with a camera on 5/29/12.

Leachate Collection Pond

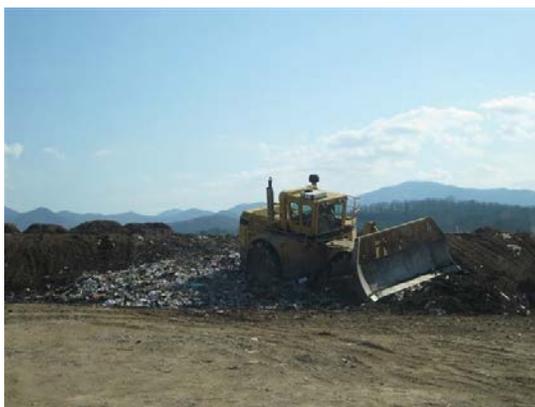
14. The MSW landfill was operating in Phase 2(active since 1998).
15. The facility is permitted to use a mixture of 50% soil and 50% mulch as an alternate daily cover (ADC). This activity is noted in the operations plan (Section 4.2). Mulch and soil is mixed before application. The facility also uses a fabric tarp as an alternate daily cover as approved in the permit.
16. The working face area was observed being confined to a small area. There was no banned material observed with the exception of incidental amounts. **The daily cover area was well maintained and appeared to have adequate cover.**

Working Face

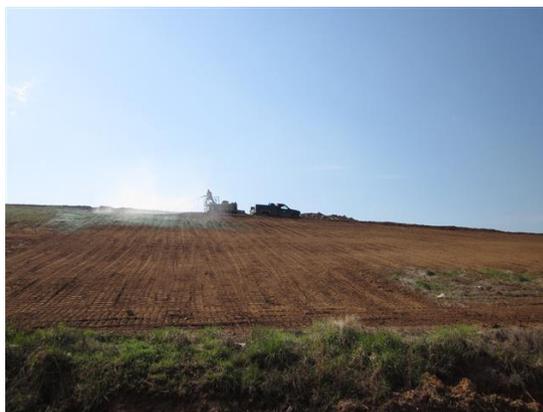
17. The intermediate cover was in excellent condition and seeded with little to no erosion. Very little windblown debris was observed.

Looking South at Phase 2 Intermediate Cover & hydro-seeding activity

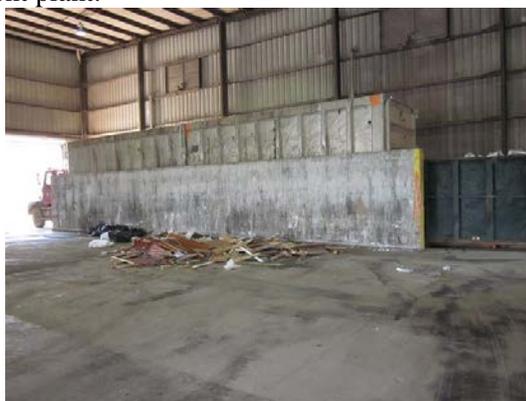
18. The MSW Treatment and Processing (T & P) Facility is located in a covered building and was observed in operation. This facility is permitted to receive all waste allowed for disposal in the MSW Landfill and is used by the general public. Waste is placed on the floor and recyclables are removed by Staff. Material that cannot be recycled is loaded into a semi-trailer and transported to the MSW Landfill. The area was very clean and well staffed. There are drains in the floor to catch any incidental liquids (leachate) and connects to the Franklin wastewater treatment plant.

T&P Facility

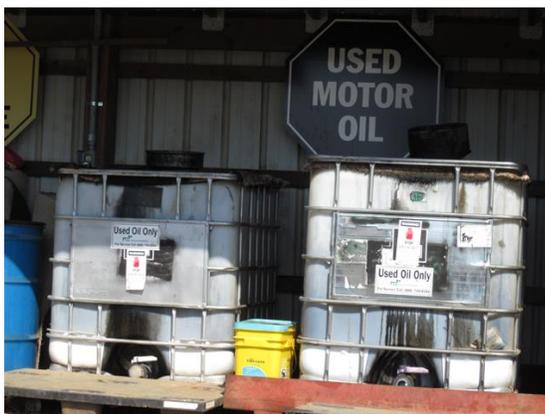
- 24. Macon County accepts materials to recycle that are dropped off at the facility and from collections sites located throughout the county. Recycled materials are baled and sent to appropriate recycling companies. The area was well maintained.
- 25. There were separate areas for metals, aluminum, steel cans, clothes, cardboard, paper and plastics. Glass was being separated into brown, clear and green.
- 26. The White Goods Area is located in the recycling area. Freon is removed by the facility.
- 27. An area to collect used motor oil and filters, cooking oil, anti-freeze and batteries were observed in good condition

Used Motor Oil Collection Area
