**FACILITY COMPLIANCE INSPECTION REPORT**  
**Division of Waste Management**  
**Solid Waste Section**

**Date of Site Inspection:** February 27, 2013      **Date of Last Inspection:** November 29, 2012

Waste Management of Raleigh-Durham Transfer Station  
 10411 Globe Road  
 Morrisville, NC 27560

Complaint Investigation. Partial.

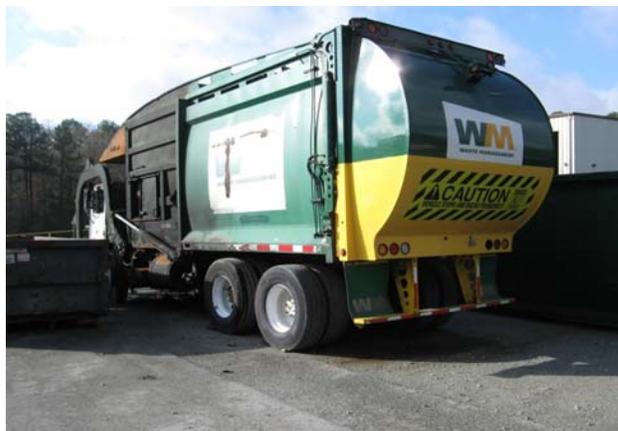
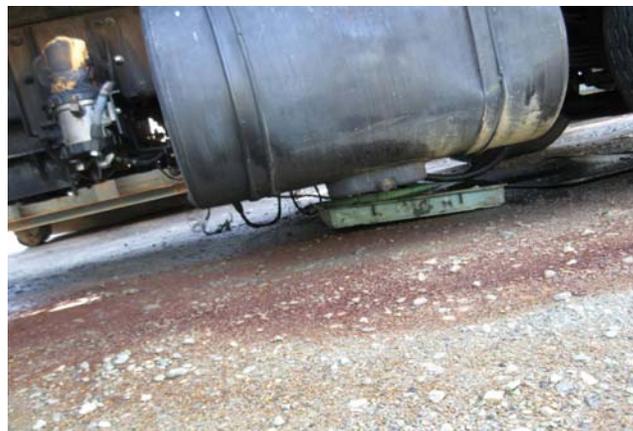
5. Conditions at the site were dry and sunny during the inspection, but heavy rain had occurred during the previous 24-hours.
6. A truck with a cab which had caught on fire was located onsite. Mr. Chappell stated that the forward part of the truck had caught fire during its recycling collection route and had been towed to the facility. Because the rear of the truck had not been damaged in the fire and was salvageable for parts, Waste Management had been asked by their insurance company to refrain from unloading the truck or dismantling the truck in any way until the insurance adjuster had made a determination. Mr. Chappell stated that the tailgate was new and had been installed only 3 weeks prior to the fire. The cab and front of the truck showed evidence of the fire but the rear did not.

7. A tray and a pan with absorbent material had been placed under the truck to catch oil leaks. Rain from the previous day had filled the pan. Although staining was evident under the truck, it appeared to be from the soot from exterior of the burned portion of the truck. The cab of the vehicle was pointed downhill on an incline and no leaking was evident at the time of the inspection.

12. The perimeter walls of the transfer station need to be maintained in a clean, sanitary condition. Waste that has perched above the loading bay must be removed at the end of every day.
13. No windblown litter was observed during this inspection.
14. In a follow-up call to the facility on March 15, 2013, James Woodard stated that the contents of the truck had been unloaded on March 14, 2013; he stated that most of the contents of the truck were sent to the MSWLF but some of the cardboard was salvageable. Mr. Woodard also stated that parts would be salvaged from the truck during the following weeks and that they anticipated any unusable parts of the truck would be sent to an offsite salvage yard by the beginning of April 2013.

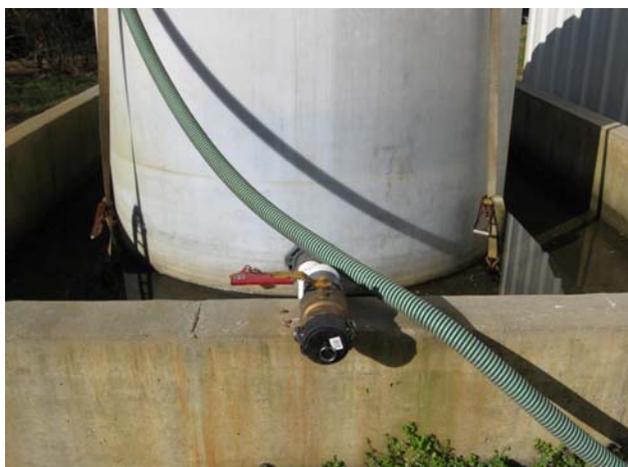
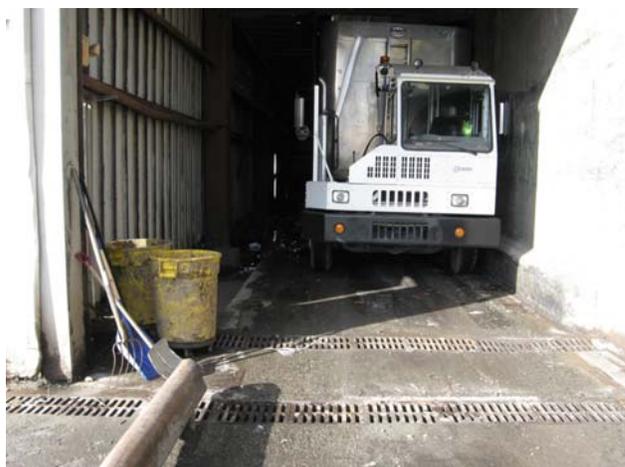
8. The facility has a leachate collection system for the transfer station with drains into a 3000-gallon above ground tank. The liquid is hauled as needed by a contractor. The cap on the outflow from the tank had been recently replaced.

9. Continue to frequently clean out sumps and drains in the loading bay to keep them free of excess waste and debris to ensure good flow of leachate into the holding tank. The grating for the sump in the loading bay had been repaired but not replaced at the time of the inspection. Replacing the repaired grate over the sump should reduce the quantity of waste falling into the sump.
10. Waste on the tipping floor was being well managed.
11. Continue to remind staff to clean the area behind the push wall on a routine basis. The area adjacent to the door was being well maintained but the less accessible area behind the wall is not being cleaned as thoroughly.
