**FACILITY COMPLIANCE INSPECTION REPORT**  
**Division of Waste Management**  
**Solid Waste Section**

Washington County C&D Landfill  
 718 Landfill Rd  
 Mackeys, NC 27970

Comprehensive Facility Compliance Inspection

9404-20130312INSP

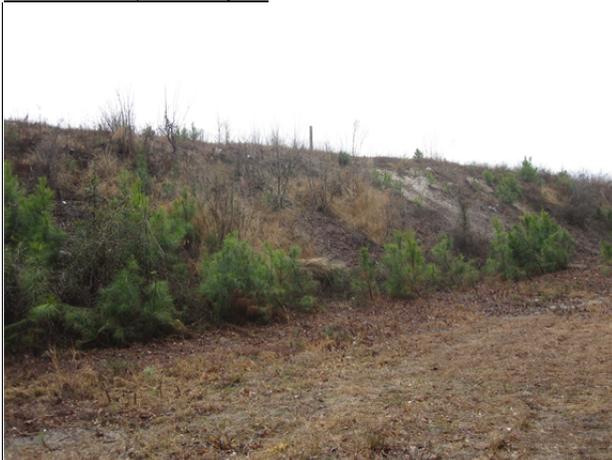
- 15) Brush and woody vegetation were noted on the landfill sideslopes. \*Please remove all brush and woody vegetation and work establish a permanent groundcover suitable to preserve site stability and prevent erosion of your landfill cap system on all facility sideslopes.

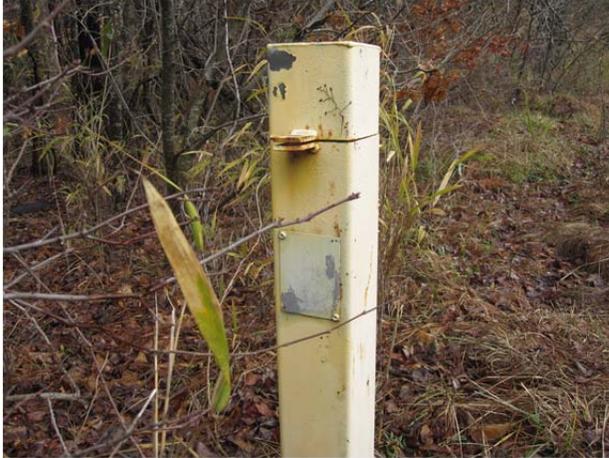
- 28) The groundwater monitoring wells were observed during this Facility Compliance Inspection. All the wells were readily accessible, painted with high visibility paint, properly labeled, and secured with functional locks. With the exception of Groundwater Monitoring Well #2 which was lacking a functional lock. \*As soon as possible, to prevent unauthorized

access to this well, please secure this well with a functioning lock.
