FACILITY COMPLIANCE INSPECTION REPORT
Division of Waste Management
Solid Waste Section

UNIT TYPE:											
Lined MSWLF		LCID		YW		Transfer		Compost	<input checked="" type="checkbox"/>	SLAS	COUNTY: WATAUGA PERMIT NO.: SWC-95-04 FILE TYPE: COMPLIANCE
Closed MSWLF		HHW		White goods		Incineration		T&P		FIRM	
CDLF		Tire T&P / Collection		Tire Monofill		Industrial Landfill		DEMO		SDTF

Appalachian State University [ASU]
 Physical Plant – Dale Street
 P.O. Box 32105
 Boone, NC 28608-2105

Comprehensive Inspection.

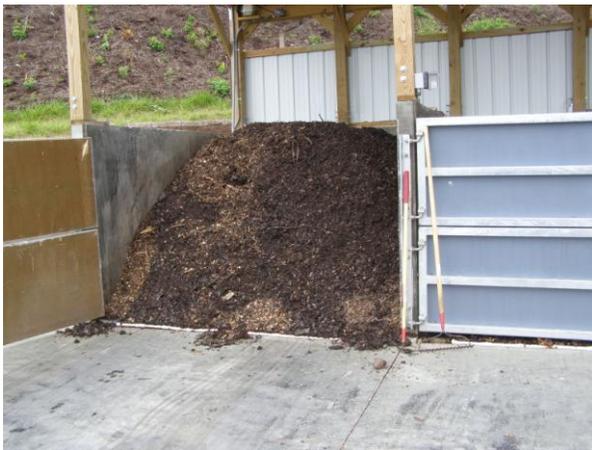
1. A pre-operations meeting was conducted on August 25, 2011, prior to the issue of the permit. A training session was conducted and the facility first accepted waste on October 24, 2011. This was the first inspection of the active facility.
2. The facility utilizes a forced aerated bin system consisting of 4 covered bins and a covered curing area.
3. At the time of the inspection the bins were in use as follows:
 - a. Bin 1 – contained mix / cover for in process compost in Bins 2, 3, and 4.
 - b. Bin 2 – filled, covered, in process.
 - c. Bin 3 – started on July 11, 2012, in process.
 - d. Bin 4 – started on August 1, 2012, in process.

View of Bin 1.

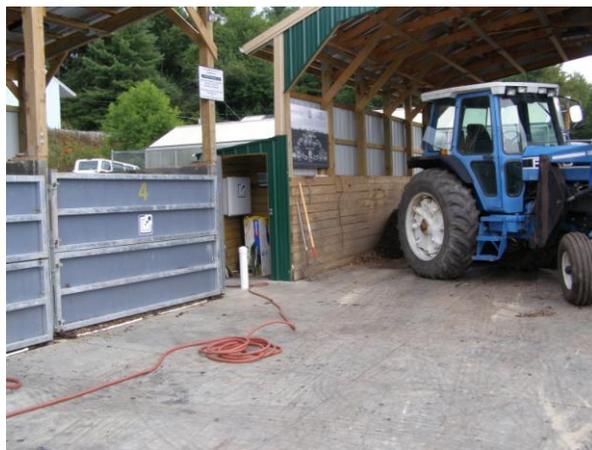
View of Bin 4, Control Room, and Curing Area.

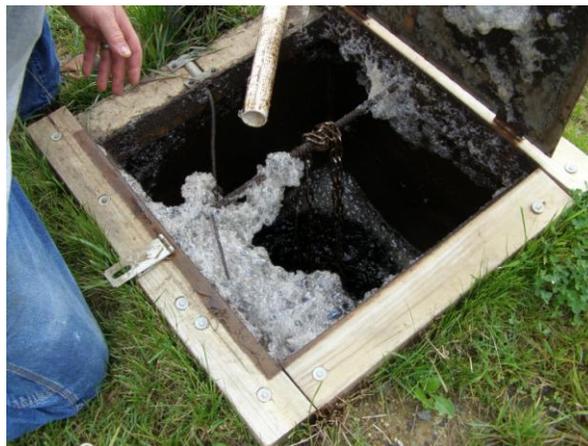
8. The leachate tank was inspected. The tank appeared to be maintained and functioning as designed. The leachate is stored and aerated to be used as the primary source of moisture during the composting process.

View of Leachate Storage Tank.

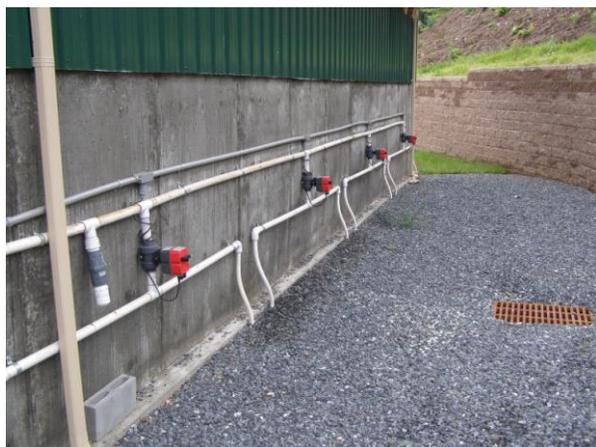
9. The retaining wall behind the facility was wet in places (see top of wall in upper right of photograph below). It was stated that during recent rain events that surface water seeped from behind the wall, and collected and flowed around the leachate storage tank cover but did not flow into the tank. The facility took immediate measures to redirect the flow to a storm drain downgradient of the tank. Additional measures are planned to prevent surface water from collecting behind the wall.

**View behind the building with covered Bins.
Note the wet areas at the top of the retaining wall.**

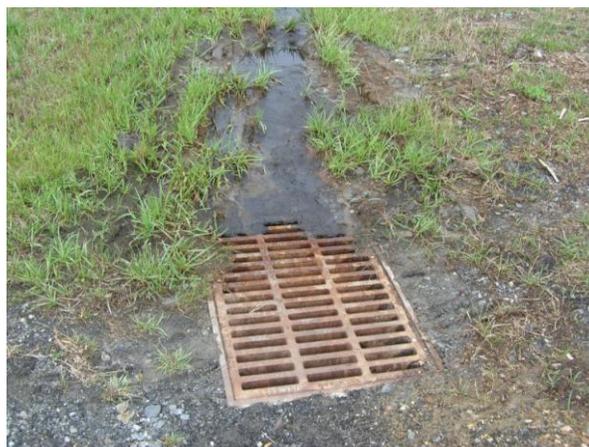
View of storm drain with flow of surface water, apparently originating from behind the retaining wall.

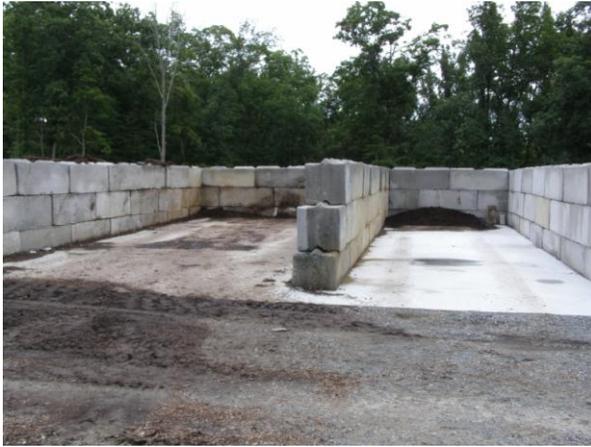
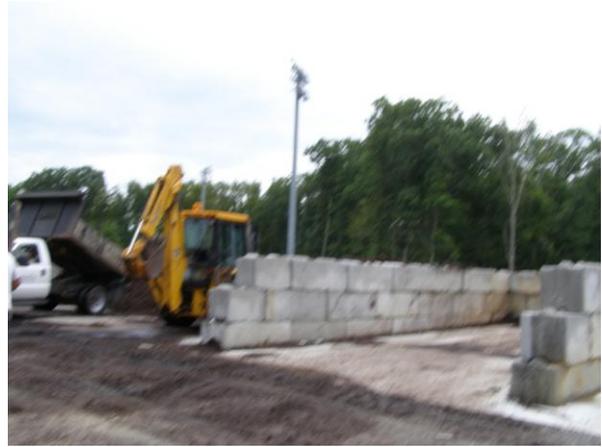
14. The facility appears to be well maintained and operated.
15. The facility requested that an additional curing area on-campus, located off of Bodenheimer Drive near the baseball stadium. This area was inspected. Two large concrete pads are proposed (adjacent to the Landscape Services mulch storage). The curing would take place on one pad and when finished be moved to the second pad for distribution. To pursue adding this location as a curing area to the permit, please provide in writing to Tony Gallagher, Composting and Land Application Branch Supervisor (tony.gallagher@ncdenr.gov), the following information: the location and map, setbacks, proposed volumes, storage times, feedstocks, and operations. Additional information may be required.

Views of the proposed additional curing area adjacent to mulch storage area.
