**FACILITY COMPLIANCE INSPECTION REPORT**  
**Division of Waste Management**  
**Solid Waste Section**

<b>UNIT TYPE:</b>											
Lined MSWLF	<b>X</b>	LCID		YW		Transfer		Compost		SLAS	<b>COUNTY: WAYNE</b> <b>PERMIT NO.: 96-06</b> <b>FILE TYPE: COMPLIANCE</b>
Closed MSWLF		HHW		White goods	<b>X</b>	Incineration		T&P		FIRM	
CDLF		Tire T&P / Collection	<b>X</b>	Tire Monofill		Industrial Landfill		DEMO		SDTF

Wayne Co. MSWLF Landfill  
 460-B South Landfill Rd  
 Dudley, North Carolina 28333

Comprehensive Inspection

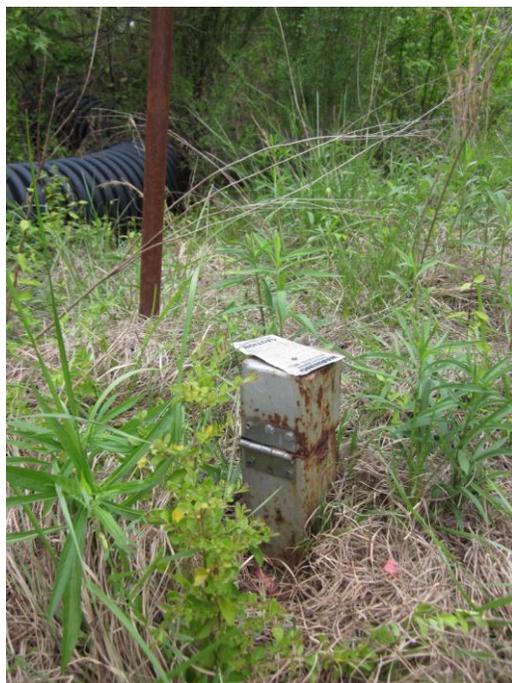
14. A total of sixteen groundwater monitoring wells comprise the approved groundwater monitoring system at the MSWLF and are labeled MW-1 through MW-16. Pads were not visible and/or buried at several of the wells, including MW-2, MW-12, and MW-13. One of the wells, believed to be MW-10, had a well ID tag on the steel casing but had no identifying well number imprinted on the well tag. The ID tag for MW-7 was not affixed to the steel casing and found buried in the grass adjacent to the well. For the protection of the monitoring wells and to prevent precipitation or run-off water from channeling down the sides of the casing, concrete pads must be installed or repaired at these wells. MW-3 was observed with one foot or less of stickup above the ground surface. It is apparent the steel well casing was hit and subsequently dented by machinery or mowing equipment. We recommend raising the stickup of well and/or steel casing to prevent further damage from machinery or equipment. Landfill gas monitoring wells MP-17 through MP-30 were observed with steel casings but without locks. Locks on the casings of the landfill gas monitoring wells are required; MP-26 was not labeled.

Soil build-up around monitoring well

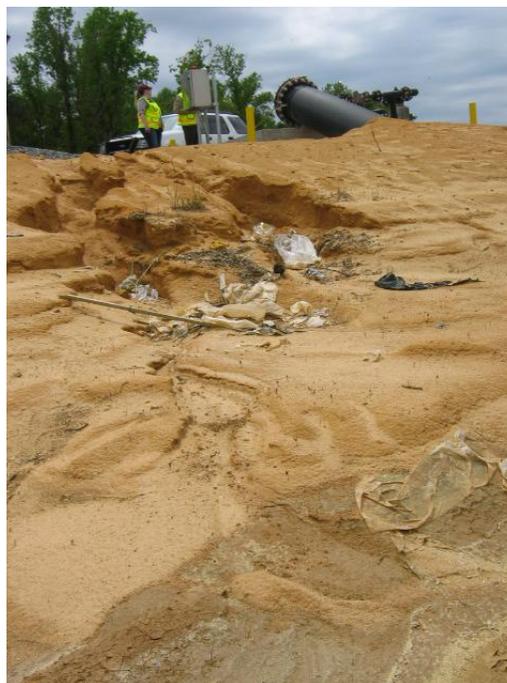
9. Soil erosion along the side slopes was observed at numerous locations in the Phase 3 area. These eroded areas must be properly backfilled and compacted prior to receiving waste. This repair activity must be documented and placed in the operating record.

Erosion in Phase 3 cell

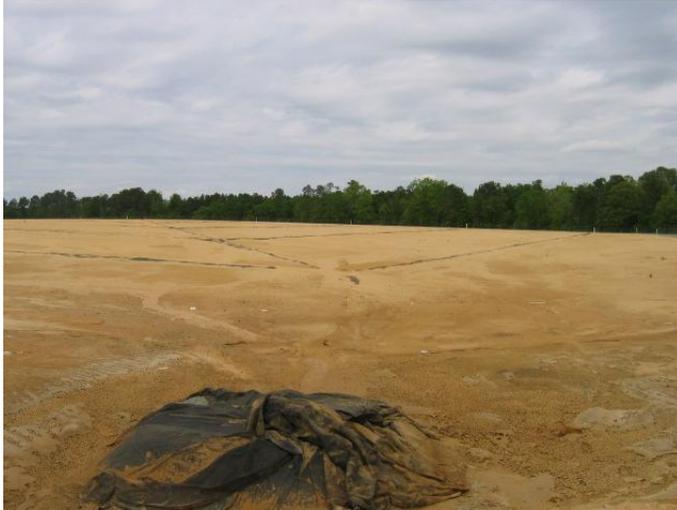
Phase 3 cell

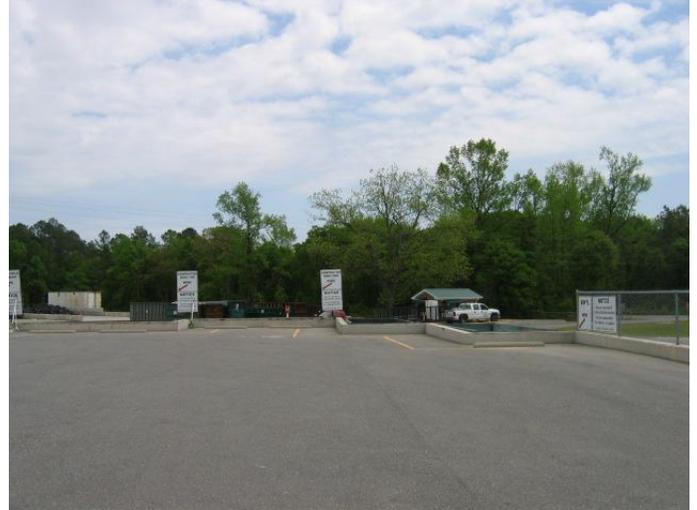
Waste/Recycling sorting and tire storage areas
