**FACILITY COMPLIANCE INSPECTION REPORT**  
**Division of Waste Management**  
**Solid Waste Section**

**Date of Site Inspection:** November 16, 2012

Waste Industries Black Creek Road Transfer Facility  
 3031 Black Creek Road  
 Wilson, NC 27893

Partial audit of a MSW Transfer Facility

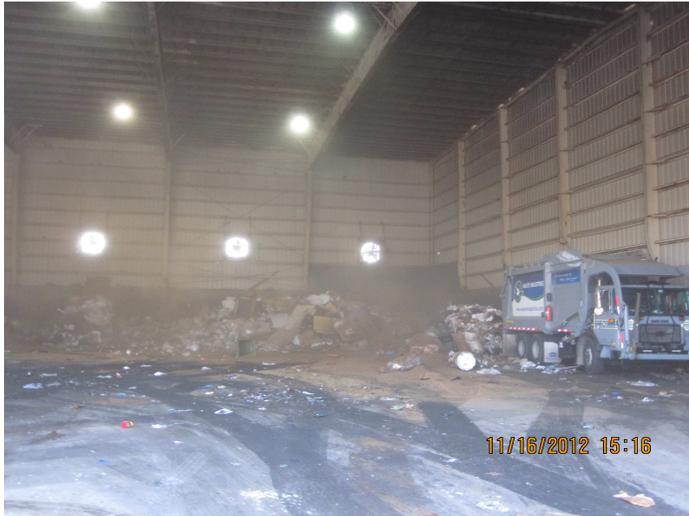
13. The sediment basin has been re configured and cleaned.
14. **Tobacco dust was being dumped during the inspection making conditions inside the building very dusty. The vent fans were not turned on until I suggested it. The generator might need to be contacted to either have the dust transported separately in covered containers or if transported in open containers wet down to minimize fugitive dust.**

The inside of the building illustrating the dusty conditions caused by the dumping of tobacco dust, fans were not turned on until I suggested it.

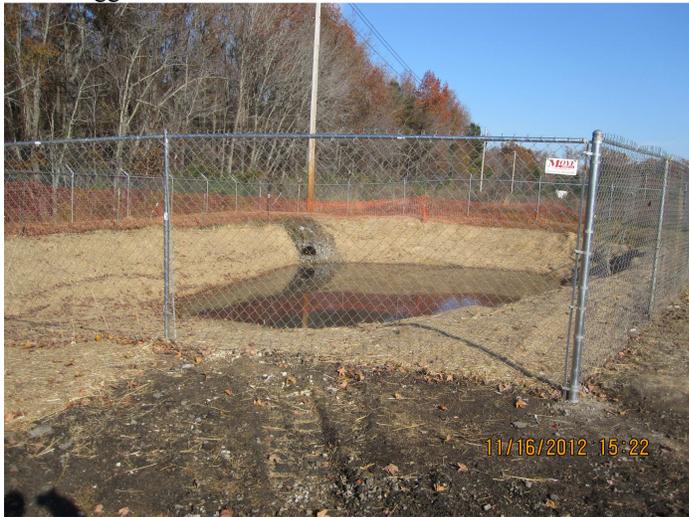
The reconfigured sedimentation basin illustrating improvements

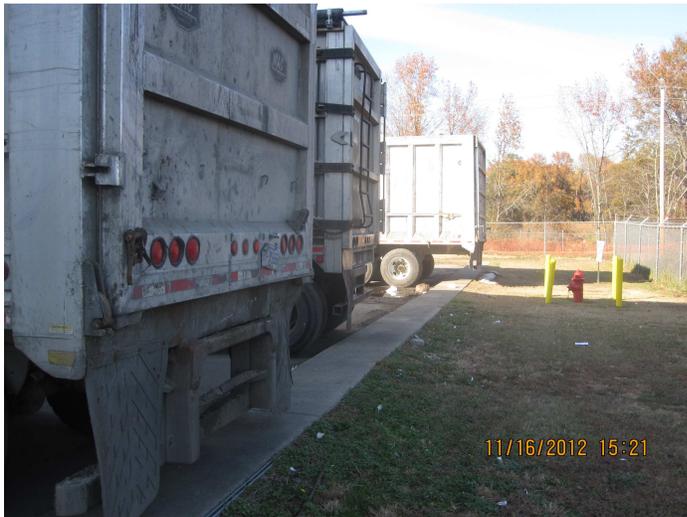
The rear gate of the haul trailers, no leachate was observed.

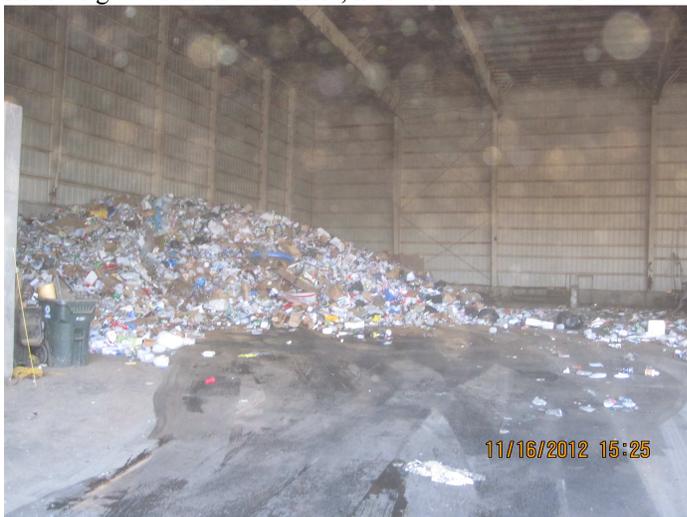
4. The operating hours are Monday thru Saturday, 6:00 AM to 8:00 PM.
5. The signage is according to the permit conditions.
6. Recyclables are stored in bay 1 as specified in the Ops Plan.

The recycling storage area in bay 1

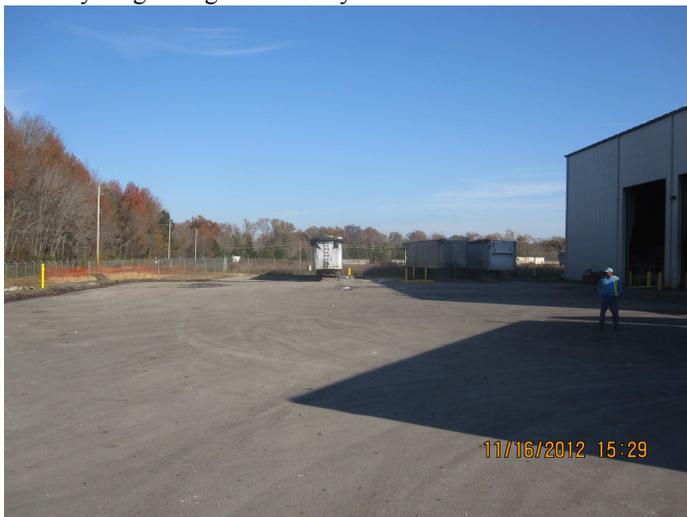
15. The grounds were very clean, not much windblown was observed.
16. A new floor has been installed within the past month and reconfigured to better direct leachate into the floor drain. A new floor drain was also installed.

The grounds, very little blown waste was observed
