FACILITY COMPLIANCE INSPECTION REPORT

Division of Waste Management Solid Waste Section

Miller Farm LCID Landfill
 Miller Farm Road
 Morehead City, NC 28557

N0190-20130116INSP

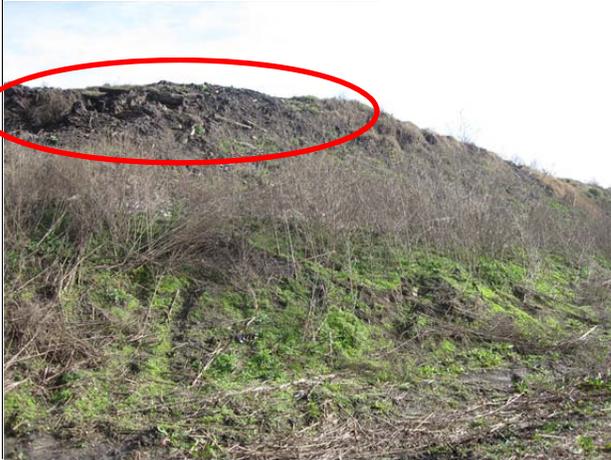
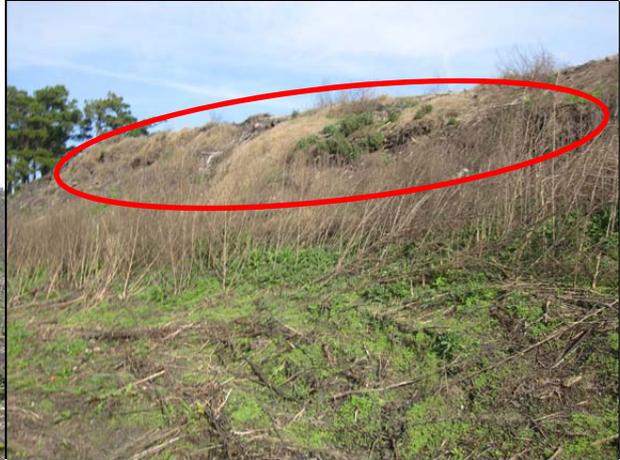
- 14) Areas of differential settlement were observed in several areas throughout the landfill. *Please, fill, compact, and cover all areas of differential settlement to provide for positive drainage of surface waters away from the landfill. All sideslopes and repaired areas should be graded at a slope not greater than 3:1 and seeded and mulched to establish a groundcover suitable to prevent erosion.

- 15) Many areas of the landfill cap were observed as having sparse cover and/or bare soil that is insufficient to prevent the erosion of your landfill cap system. *Please seed and mulch all bare areas to establish a cover crop suitable to prevent erosion of your landfill cap system.
