**FACILITY COMPLIANCE INSPECTION REPORT**  
**Division of Waste Management**  
**Solid Waste Section**

**Date of Site Inspection:** 31 January 2013      **Date of Last Inspection:** 28 November 2012

Garner LCID Site  
 Lake Road  
 Havelock, NC 28557

Comprehensive Facility Compliance Inspection

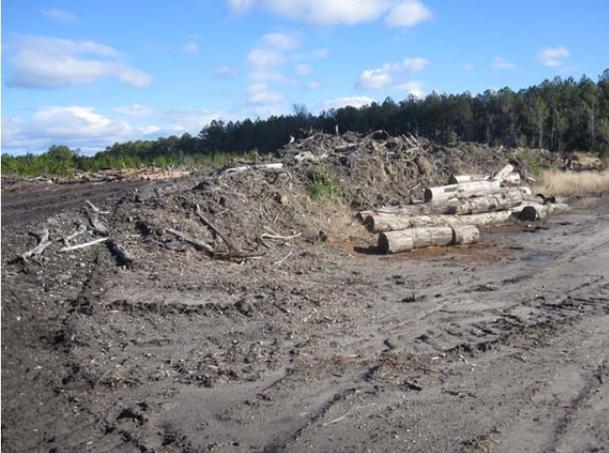
- 10) The waste type being disposed is LCID waste only; no unacceptable waste streams were observed during this Facility Compliance Inspection.
- 11) The landfill footprint boundaries have not been marked. \*Please install permanent markers delineating the landfill waste footprint boundaries and all required buffers as listed in 15A NCAC 13B .0564 (9) on your LCID notification form.
- 12) \*For effective Facility maintenance and inspection, please ensure the perimeter road around the footprint of the landfill is clear and well maintained, providing for stable access around the facility.
- 13) \*The outside slopes need to be compacted and graded at a slope not greater than 3:1. Please seed and mulch these areas to establish a groundcover suitable to prevent erosion of your landfill cap system.

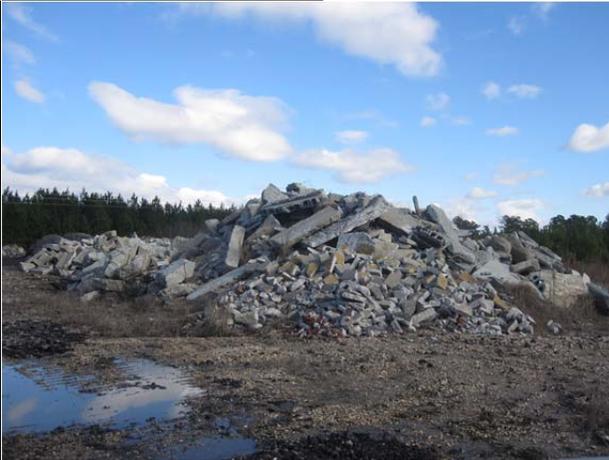
- 14) Soil has been stockpiled for use as cover in an area adjacent to the Facility access road.
- 15) \*Please ensure that all waste is covered monthly, or when the active working area reaches one acre in size, whichever occurs first.
- 16) Inert debris consisting of scrap concrete and asphalt is being stockpiled on the property in an area separate from, but adjacent to, the landfill for later crushing and re-use. \*Please note that the State Rules regarding recovered materials state that for a material to qualify as a recovered material, the majority of the material (51% or more) must be sold, used, or re-used within twelve months.

- 17) \*Corrective actions are required as a result of this Facility Compliance Inspection.
