FACILITY COMPLIANCE INSPECTION REPORT
Division of Waste Management
Solid Waste Section

Date of Site Inspection: April 10, 2013 **Date of Last Inspection:** November 3, 2011

Lowder Sandrock LCID Landfill
 5860 Sandrock Drive
 Burlington, NC 27217

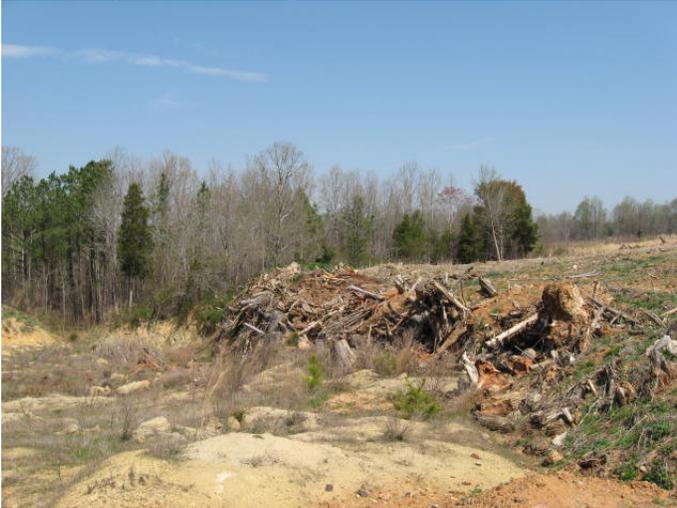
Remaining LCD/side slope to be covered

10. Mr. Bryant stated that remaining LCD will be covered with soil in the coming weeks. He is in the process of obtaining additional soil. If need be he will cover the material with inert debris.

11. Side slopes should be graded such that no indication of erosion or runoff is observed.
12. Logs segregated and placed in a pile will be given away for firewood.

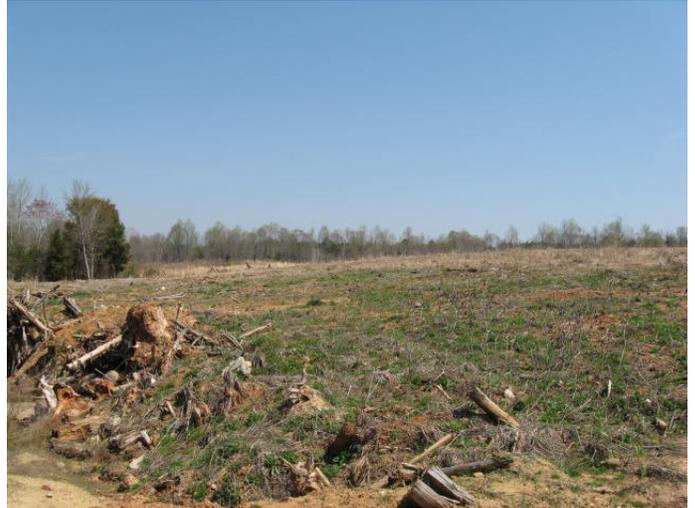
Recently covered area, sown with grass

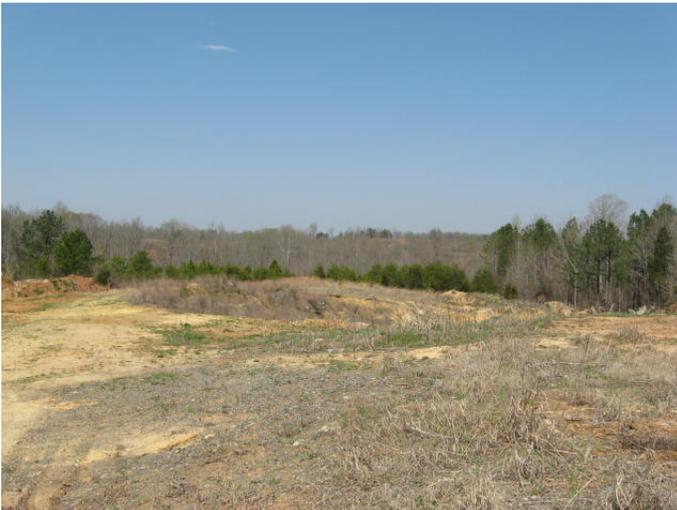
3. Schedule site inspection with Mr. Bryant to ensure access to the facility.
4. A portion of the landfill area has been used as a sandrock mine.
5. Mr. Bryant stated that in April 2011 the LCID landfill ceased accepting material and is no longer in operation. And that the sandrock mine also ceased operation in April 2011.

7. The LCID landfill is ~ 1 acre.
8. Land clearing debris (LCD) has been placed in the mine and surrounding area.
9. Numerous piles of inert debris (rock, brick, and concrete) are stored adjacent to the landfill area.

Mine area/LCID landfill area

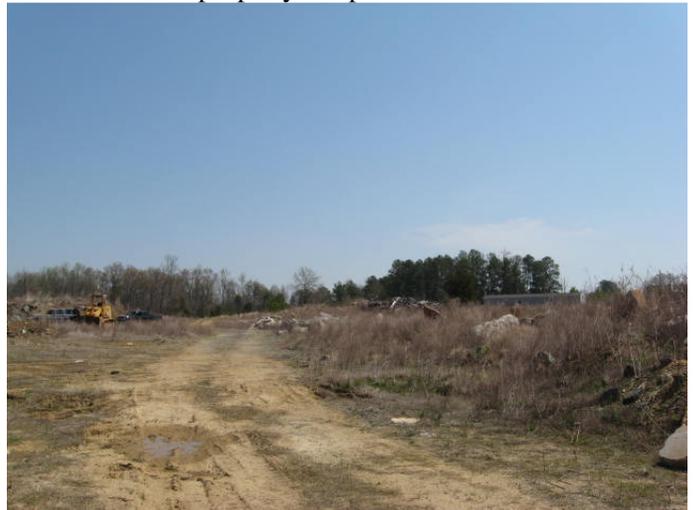
Inert debris on property – representative

13. Mr. Bryant stated that inert debris not placed in the fill area will be graded accordingly in-place and covered with soil.
14. The facility is secured by a locked gate at the entrance to the property.
