FACILITY COMPLIANCE INSPECTION REPORT
Division of Waste Management
Solid Waste Section

UNIT TYPE:												
Lined MSWLF		LCID		YW		Transfer		Compost		SLAS	X	COUNTY: CLEVELAND PERMIT NO.: SLAS-23-10 FILE TYPE: COMPLIANCE
Closed MSWLF		HHW		White goods		Incin		T&P		FIRM		
CDLF		Tire T&P / Collection		Tire Monofill		Industrial Landfill		DEMO		SDTF

Date of Site Inspection: 11/08/12

Wesson Septic Tank Services, Inc.
 707 Poplar Springs Church Rd. (SR-1151)
 Shelby, NC 28152

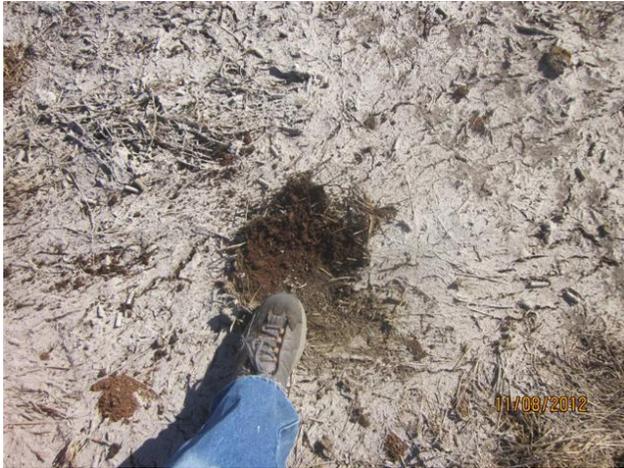
1. Both land application fields had multiple areas of matted vegetation caused by the heavy application of septage. (Photos #1 - #4)

1. Matted and dead vegetation due to the recent over application of septage.

Land application of septage should occur in a wide thin spray path. Please review your procedures for using a spreader attachment in conjunction with proper truck speed and pressure to obtain a good spray path. Heavy/improper land application results in crop damage as in dead/weedy patches. When necessary, you should manually rake loose any thick matted areas to prevent crop damage.

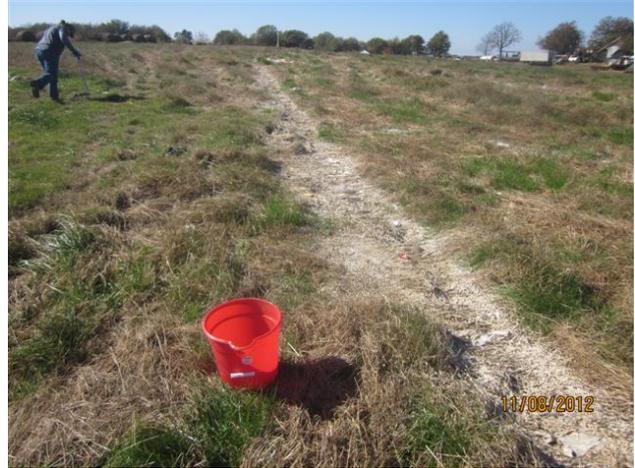
2. 15A NCAC 13B .0838(11) states that “All septage discharges shall be made at a location on the site consistent with the nutrient management plan.”
 - Item E. “Application Method” of the approved *Nutrient Management Plan* states that “The preceding information is based on septage being evenly applied over the entire permitted site by pump trucks with dispersion fins. Application width is 12’.”

2. Septage applied in a narrow strip.

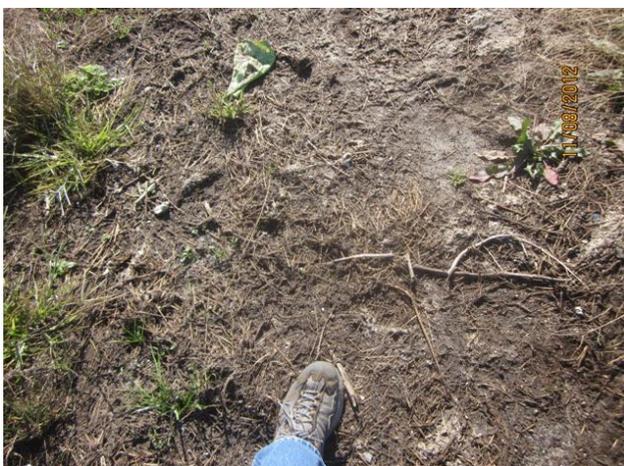
3. Area of dead vegetation due to the apparent over application of septage.

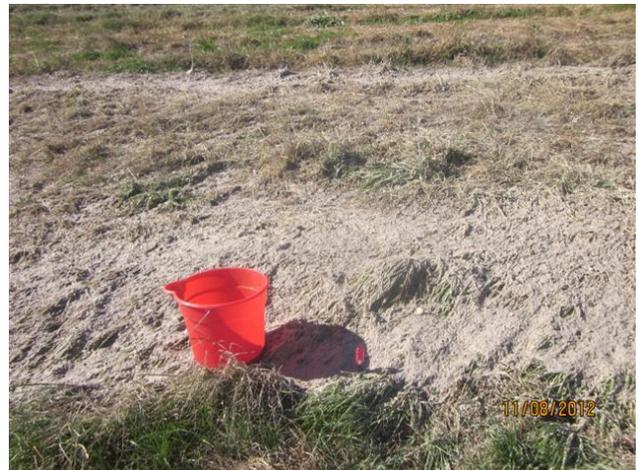
4. Swath of matted vegetation due to the recent over application of septage.
