**FACILITY COMPLIANCE INSPECTION REPORT**  
**Division of Waste Management**  
**Solid Waste Section**

Beaufort County Closed MSW Landfill  
 1342 Hawkins Beach Road  
 Bath, NC 27808

Partial Facility Compliance Inspection without records review

0702-20130718INSP

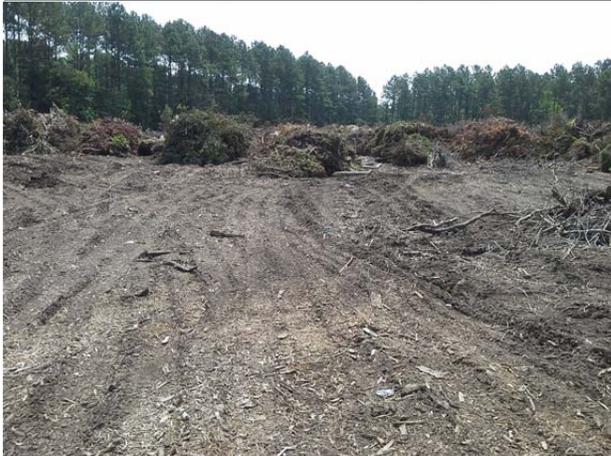
- 7) The vegetative waste stockpile is approaching the maximum allowable size. \*Vegetative waste on-site needs to be ground/chipped and processed for composting or removed from the site for use as boiler fuel.

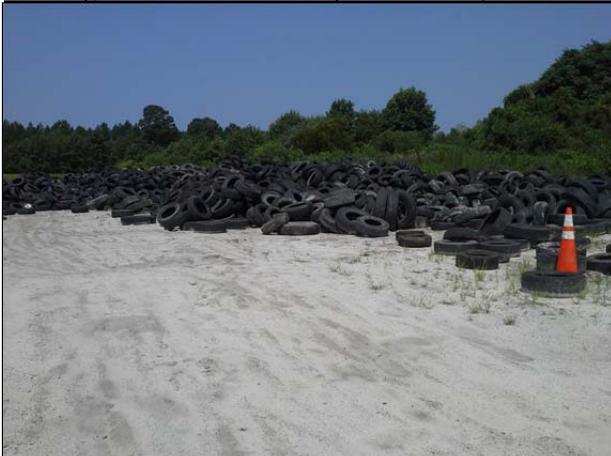
- 8) No ponding water was observed during this Facility Compliance Inspection.
- 9) The scrap tire management element was reviewed. \*This area of your Facility needs better management. Trailers should be brought on-site and all tires placed directly into the trailers for direct haul to the scrap tire management Facility.

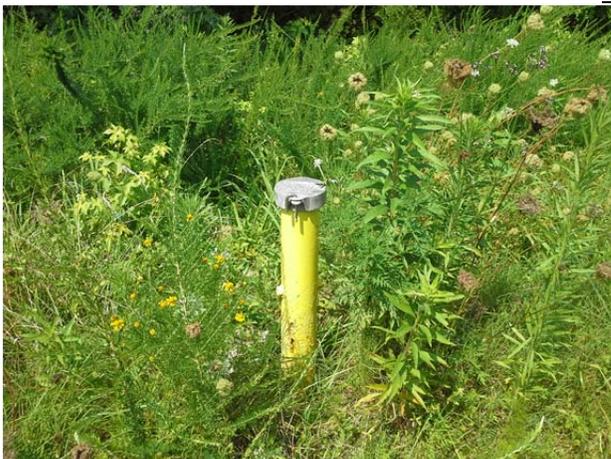
- 10) The perimeter surface water ditches were clear of brush and woody vegetation.
- 11) Facility monitoring wells were reviewed. All wells were readily accessible and secured with locks, with the exception of well #14. The lock from this well has been broken off. \*Please ensure that all wells are secured with functioning locks.
