**FACILITY COMPLIANCE INSPECTION REPORT**  
**Division of Waste Management**  
**Solid Waste Section**

Beaufort County Transfer Station  
 500 Flanders Filters Road  
 Washington, NC

Partial Facility Compliance Inspection without records review

0703T-20140623INSP

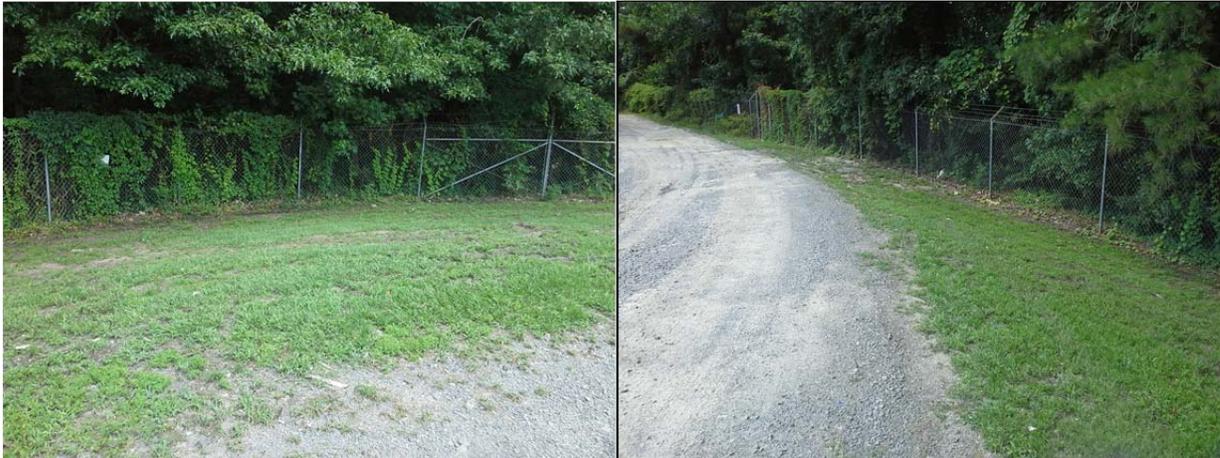
- 16) No windblown debris was observed outside of the Facility perimeter fence.
- 17) Windblown debris was minimal on-site during this Facility Compliance Inspection.

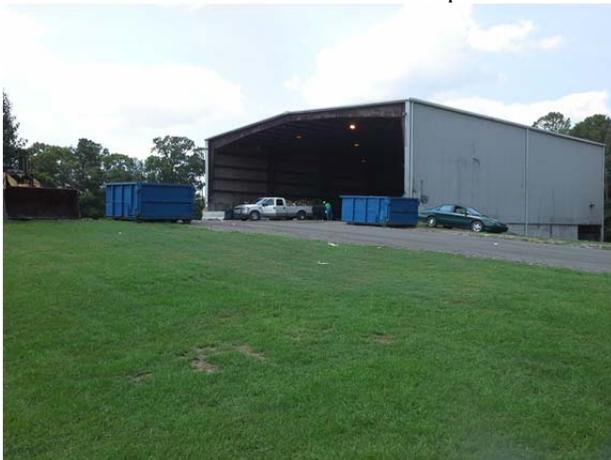
- 18) Scrap tires are placed in a roll-off container for direct haul to the tire management facility.
- 19) A roll-off container is maintained for scrap metal and white-goods removed from the waste stream.

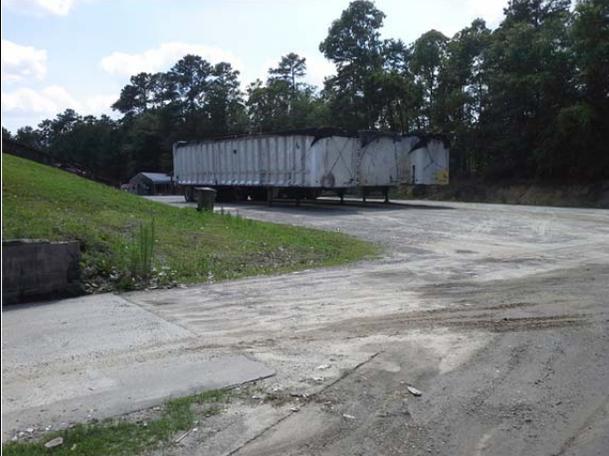
- 25) The Facility is protected by highly visible, safety bollards at the entrance to the tipping floor, and at the trailer loading bay entrance and exit.
- 26) Signage is maintained at the tipping floor turn around with operating instructions to increase Facility operations efficiency and customer safety.
- 27) This Facility maintains an adequate number of trailers on site to properly manage the volume of waste received during operating hours.

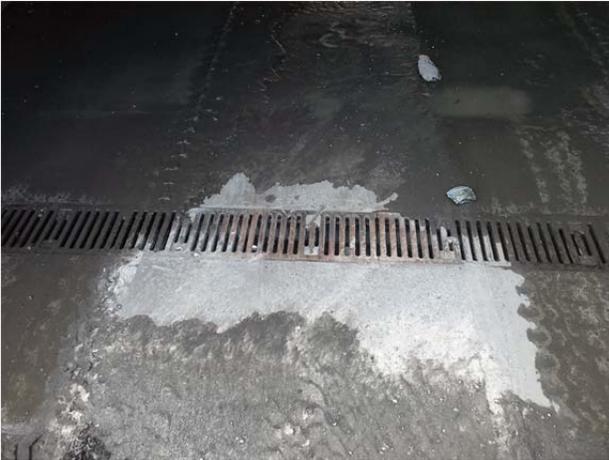
- 28) Waste received at the facility is loaded into the transport trailers in a timely manner.
- 29) The waste type was reviewed; no unpermitted wastes were noted during this Facility Compliance Inspection.
- 30) There is one manhole present in the tipping floor for access to the leachate collection system and to provide for additional drainage and collection as needed.
- 31) Leachate is restricted to the tipping floor and directed to the collection system by a small berm at the entryway edge of the tipping floor.
- 32) The Leachate collection drains were clear of debris and appear to be functioning as designed.
