FACILITY COMPLIANCE INSPECTION REPORT
Division of Waste Management
Solid Waste Section

Date of Site Inspection: 26 March 2014 **Date of Last Inspection:** 10 July 2013

Carteret County Closed MSW Landfill
 Landfill Road
 Newport, NC

Partial Facility Compliance Inspection without records review

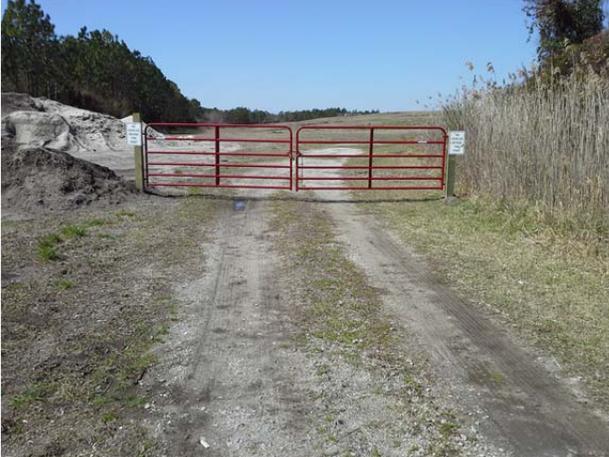
- 4) Soil has been stockpiled adjacent to the landfill access road for use in repair and maintenance of the landfill cap system.
- 5) An all-weather perimeter road is maintained around the landfill for access to the Facility monitoring wells and to perform Facility maintenance and inspections.

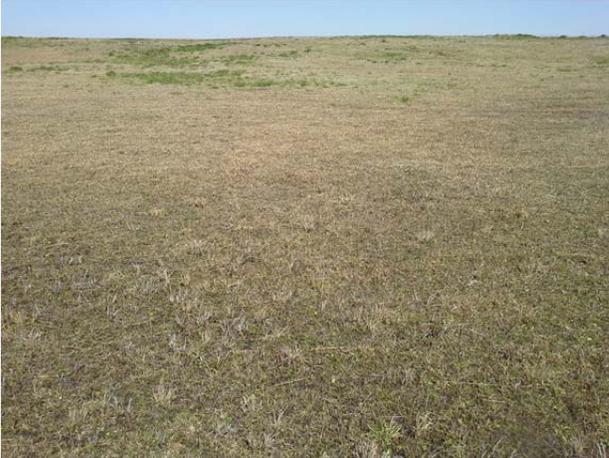
- 11) This Facility is mowed three times per year.
- 12) Several small areas of sparse cover crop were noted in various places around the top lift of the landfill. *Please repair these areas by seeding and mulching to establish a cover crop suitable to prevent erosion of your landfill cap system.
- 13) Areas of differential settlement were observed around the top lift of the landfill. Some of these areas were observed as retaining surface waters. *To prevent the ponding of water on the landfill, please fill and grade these areas at a slope not greater than 3:1. All filled and graded areas should be seeded and mulched to establish a groundcover suitable to prevent erosion of your landfill cap system.
