**FACILITY COMPLIANCE INSPECTION REPORT**  
**Division of Waste Management**  
**Solid Waste Section**

Caswell County Municipal Solid Waste Landfill - Closed  
 162 County Landfill Road  
 Yanceyville, NC 27379

Post Closure Site Visit

On September 10, 2013, John Patrone met with Keith Fuqua to conduct a post closure site visit to view recently installed landfill gas wells at the Caswell County Municipal Solid Waste Landfill - Closed on County Landfill Road in Yanceyville, Caswell County.

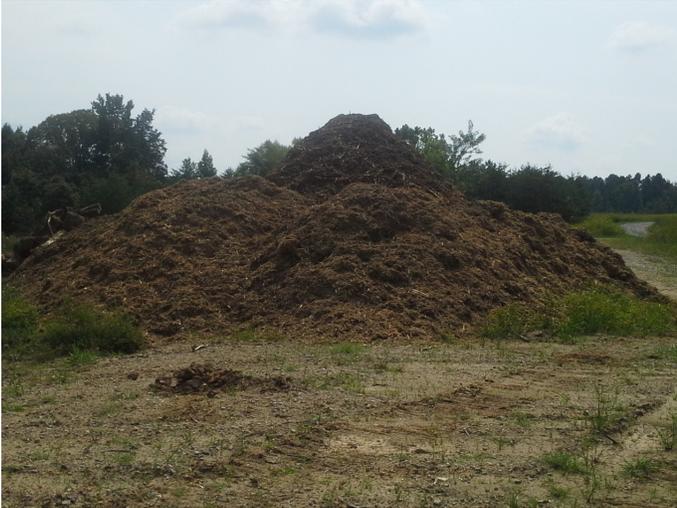
15. Mr. Fuqua stated that storm debris was brought to the TDDSS a few months ago. The material has been recently ground such that there is a pile of mulch on site.

Ground storm debris required to be removed

16. The mulch stored at the TDDSS shall be removed within 30 days of receipt of this report. The mulch may be relocated to the YWN site for public giveaway or used on site, etc.

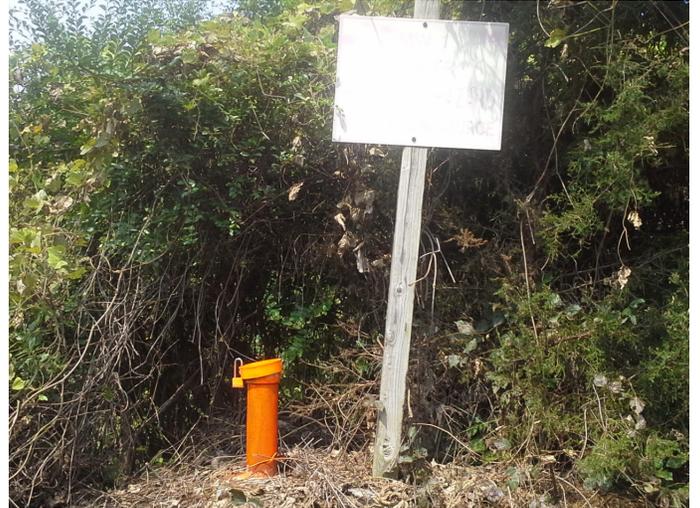
6. The landfill cap should be routinely mowed.
7. The facility has installed two landfill gas (LFG) monitoring wells and uses a low water level groundwater monitoring well (MW-1) to monitor for landfill gas.

8. The two methane gas wells were installed in April 2013.
9. Per Smith Gardner, Inc., the two landfill gas wells each have a stopcock valve and the groundwater monitoring well has a slip-cap stopcock valve.

Groundwater monitoring well MW-1/LFG monitoring well

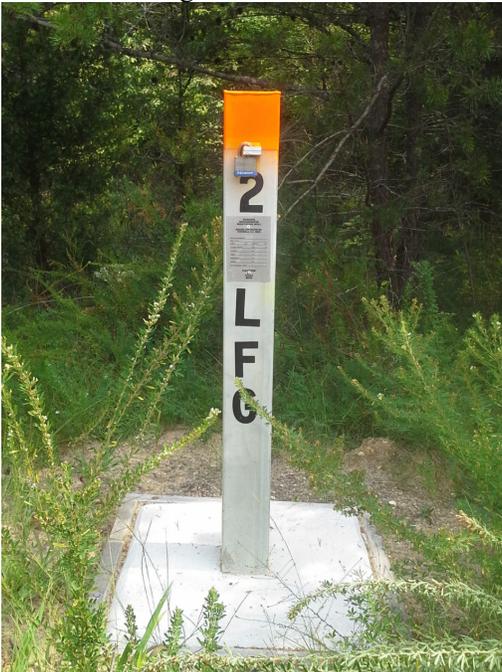
LFG monitoring well-2

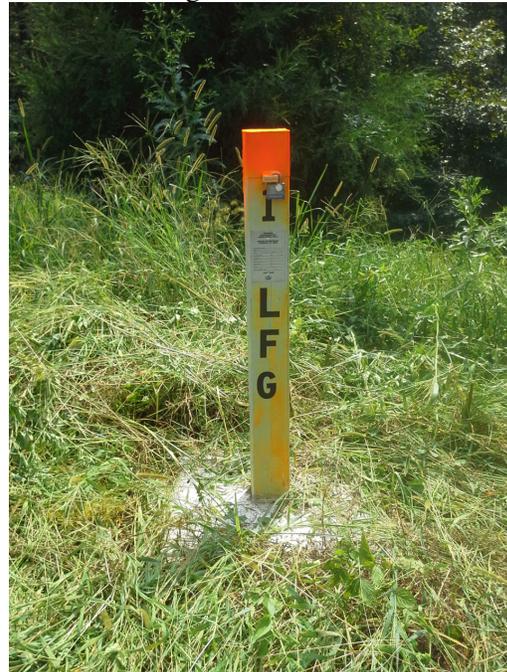
LFG monitoring well - 1
