FACILITY COMPLIANCE INSPECTION REPORT
Division of Waste Management
Solid Waste Section

Date of Site Inspection: February 24, 2014

M^cGill Environmental Systems of NC, Inc. – Merry Oaks Facility Large, Type 4 SWC Facility
 634 Christian Chapel Church Road
 New Hill, NC 27562

Comprehensive Inspection

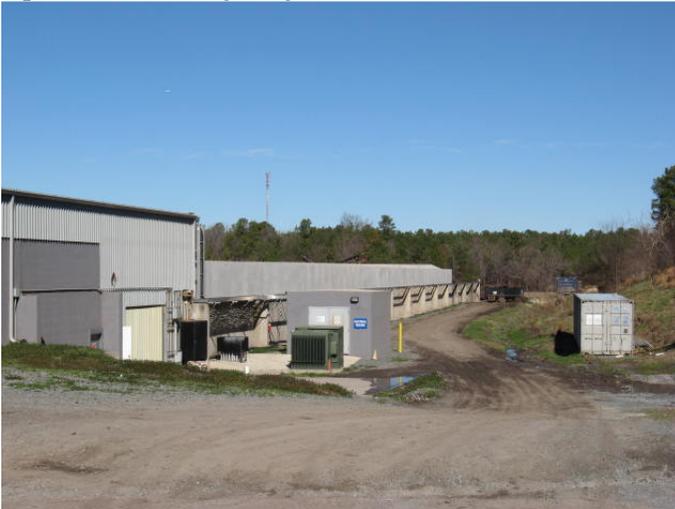
Operations building – right side view

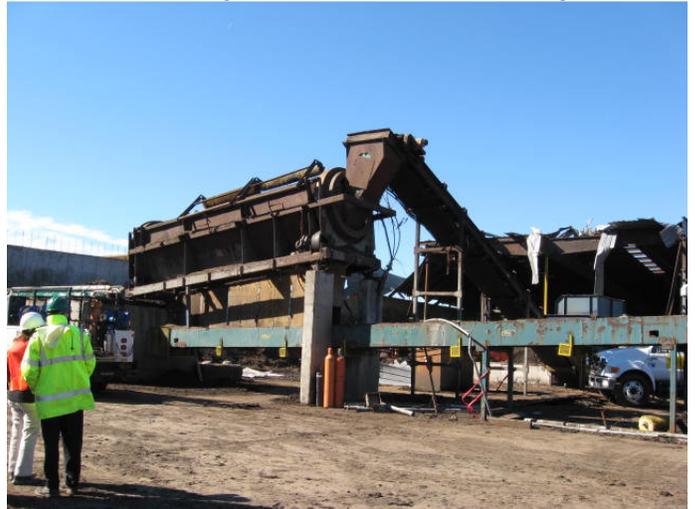
52. It is suggested that material awaiting VAR is sufficiently separated from cured compost.
53. The facility roof over the VAR screener collapsed and the roof over the VAR bays is in poor condition. The facility is conducting cleanup operations and plans to have a new roof constructed over the VAR bays and screener in 4 to 6 months.

Material awaiting VAR screener – roof damage/removed

56. Mr. Lyons stated that perhaps in 2015, the facility will amend the building such that the VAR screening operation and storage of material awaiting VAR will be conducted within the building itself.

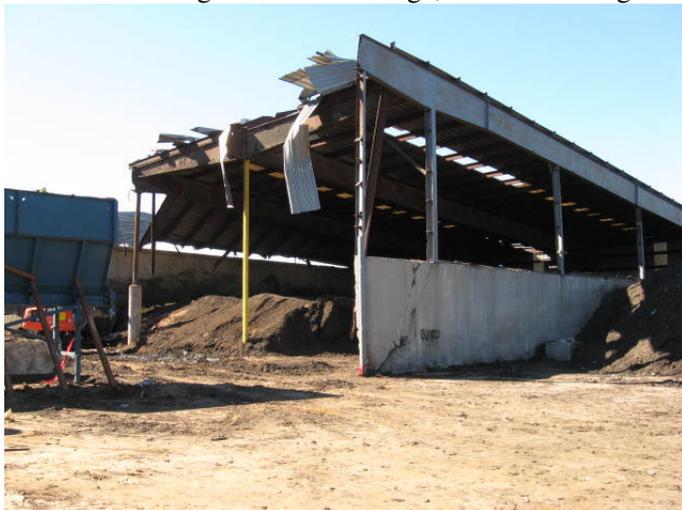
Material awaiting VAR roof damage, rear of building

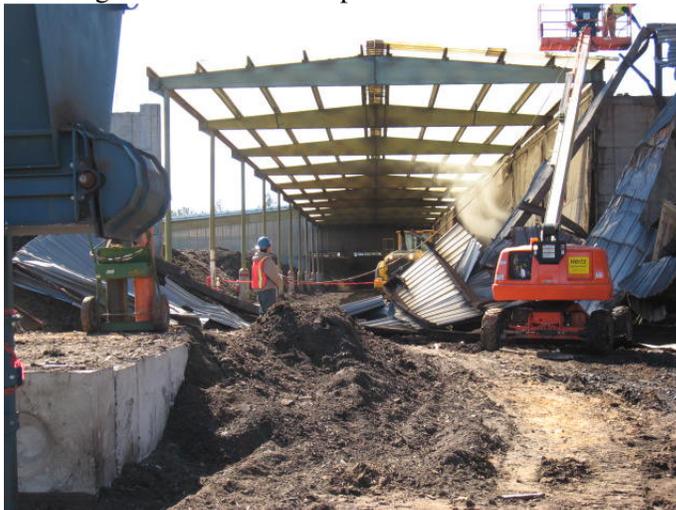
Damaged roof removal – operations corridor

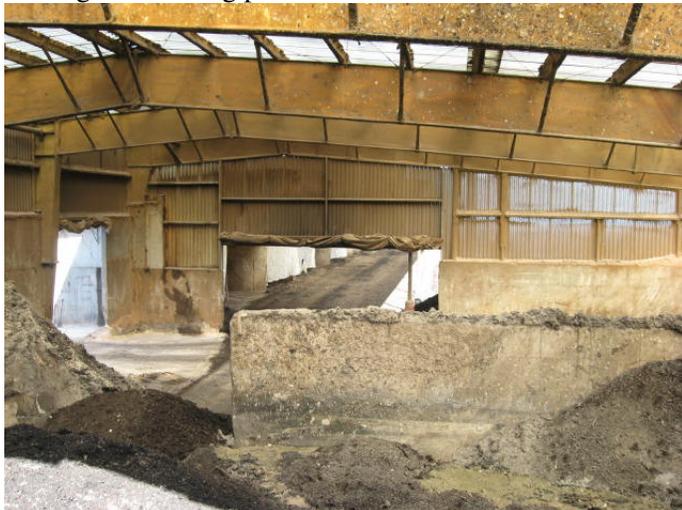
7. The facility is in operation Monday through Friday 8:00 am to 5:00 pm and Saturday 8:00 am to noon.
8. Active composting and curing operations are conducted within the facility building. Feedstocks are off-loaded into a mixing and bulking pit. Bulking material is brought into the pit from outside via adjacent bay door. Mixed material is stockpiled within the pit area until enough is on-hand to create an active compost row. The material is placed into positive aeration active compost bays to meet process for further reducing pathogens (PFRP). Afterwards, material is screened via dedicated screener (conveyor located in building, material deposited outside of building) and placed in a triple-wide bay (maximum pile height: 10') to meet vector attraction reduction (VAR).

Mixing and bulking pit

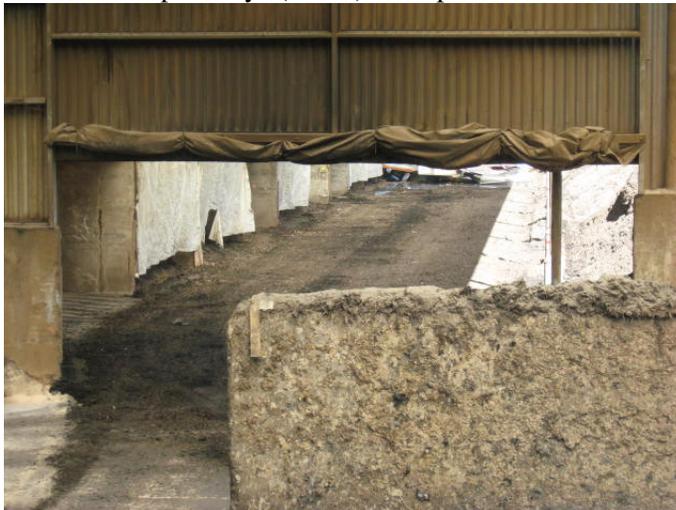
11. The facility has 10 individual active compost bays (Nos.: 1,3,5,7,9,11,13,15,17, and 19) and a curing area constituting what would be three bays (Nos.: 21, 23, and 25).

16. Each active compost bay is enclosed on three sides and has a reinforced polyethylene laminate tarp that remains in-place across the open portion of the bay. The mixing and bulking pit bay door and entranceway to the corridor, from the mixing and bulking pit to the active compost bays, have the same reinforced polyethylene laminate tarps; which are raised-up during facility operation and drawn-down afterhours.

Active compost bays (PFRP) and operations corridor

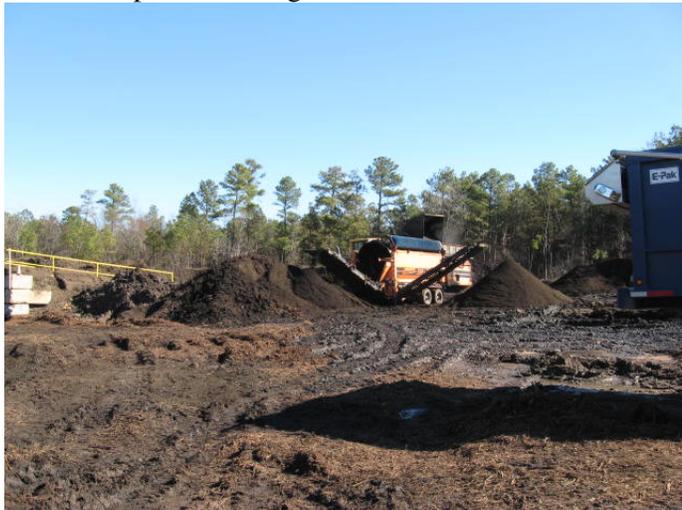
10. Material is considered cured after achieving VAR. Cured product is screened outside (via dedicated screener). The screened compost is finished product. Finished product is stockpiled outside in storage bays constructed of large cement block.

Cured compost screening

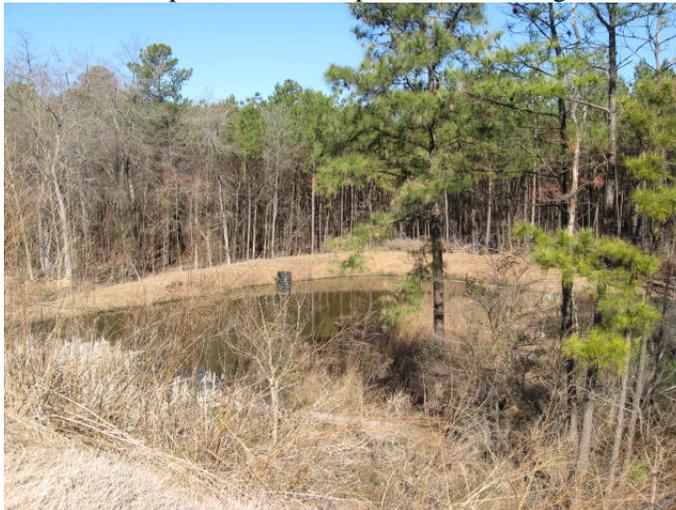
48. The facility has three stormwater ponds. The stormwater ponds appeared in good order.
49. There was no indication of erosion or runoff.
50. Mr. Cockman stated that material awaiting VAR - stored outside absorbs water. And that runoff from the pile(s) of material awaiting VAR is directed to the stormwater pond.

Stormwater pond – rear of operations building

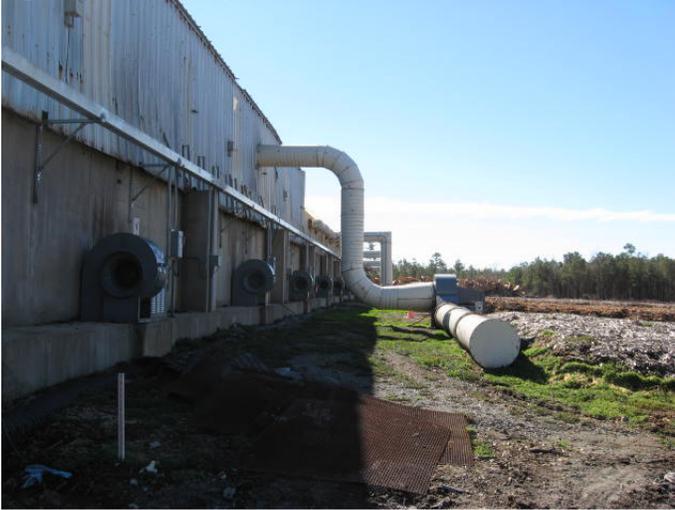
Operations building – left side view

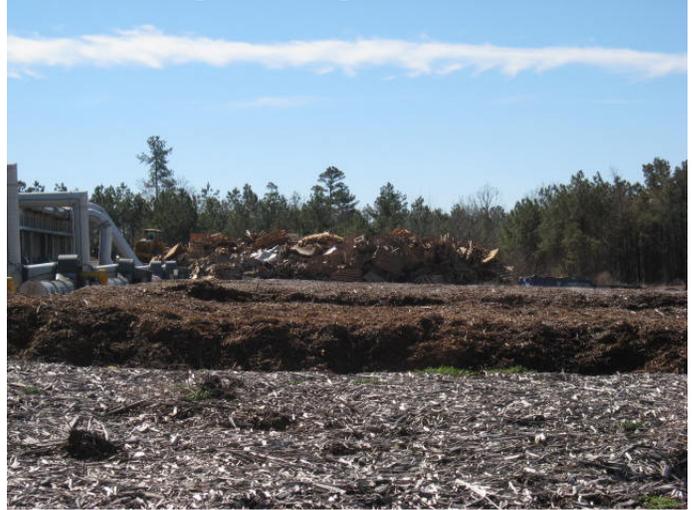
19. There are six biofilters, each containing five twelve-inch perforated plastic pipes. The biofilters are constructed atop a clay ash pad followed by an initial layer of wood chip, perforated pipe, a layer of compost, and a second layer of wood chip. The area allotted for the biofilter is ~ 400' x 110' x 3.5'.

20. Maintenance pathways (ground layer/no filter material) stretch throughout the biofilter. Each biofilter is ~ 40' wide and each maintenance pathway is ~ 40' wide. The total biofilter area is ~ 26,400 ft² and the total maintenance pathway area is ~ 17,600 ft². The biofilter volume is ~ 92,400 ft³ or 3,422.2 yd³.

Biofilters and pallet/wood pile

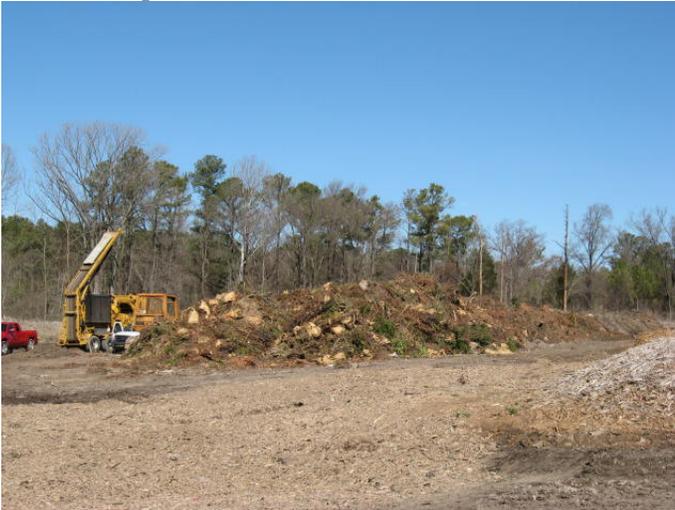
23. There are a total of 19 fans: 13 positive aeration fans and 6 biofilter fans.
24. High carbon bulking material is stored outside, behind the building. Wood and yard waste are ground routinely. A portable grinder unit is brought on site to grind material. During the inspection the portable grinder was being readied to grind material.

Yard waste pile

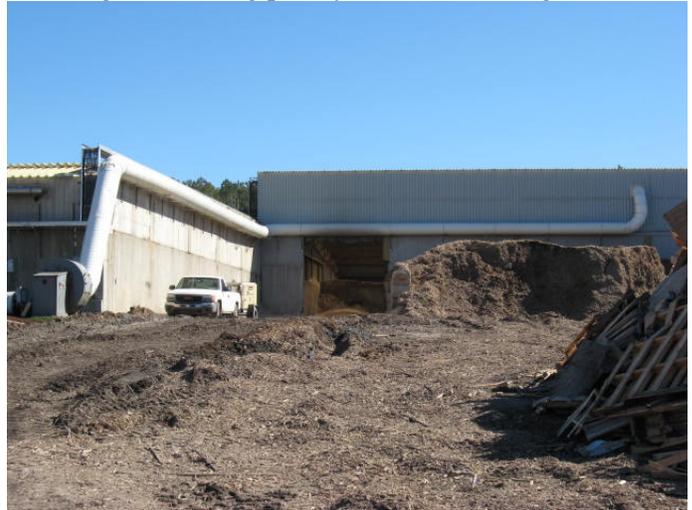
Mixing and bulking pit bay door and bulking material

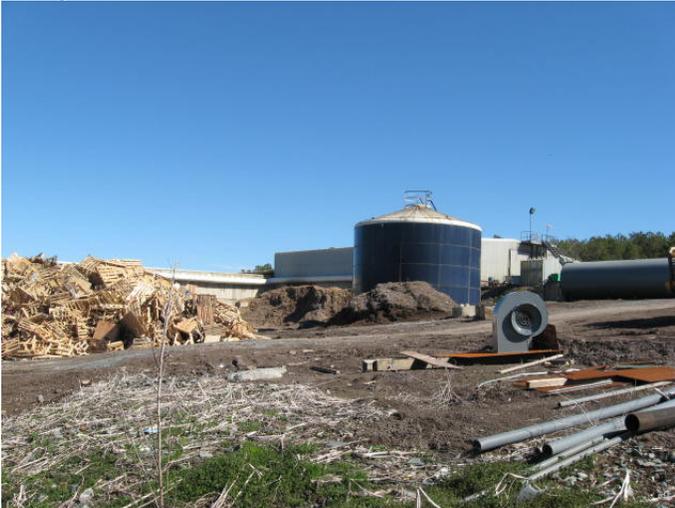
26. The facility has a 110,000 gallon sludge aboveground storage tank (AST). Absorbent material is on-hand in case of emergency. Mr. Cockman stated that bagged sand and hydrated lime is kept in a shipping container stored on site. And that the facility no longer pumps sludge into the AST, it only removes it. He estimates that the AST will be empty in ~ 1.5 years. At that time the AST will no longer be used. Sludge is off-loaded directly into the mixing and bulking pit.

Sludge AST

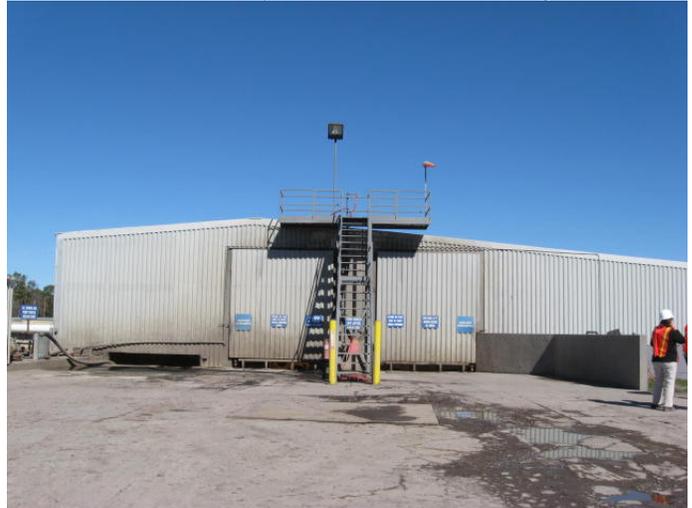
Material off load bay door - front of building
