FACILITY COMPLIANCE INSPECTION REPORT
Division of Waste Management
Solid Waste Section

Date of Site Inspection: August 5, 2013 **Date of Last Inspection:** January 23, 2013

Town of Edenton Transfer Station
 118 West Hicks Street
 Edenton, North Carolina 27932

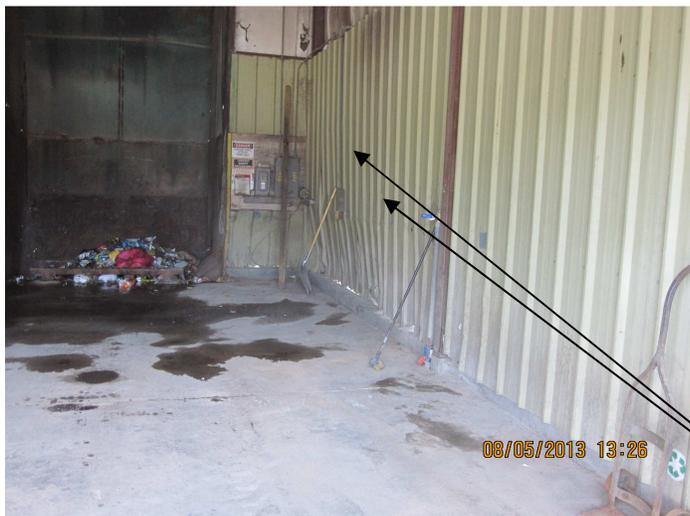
- 9) Fire suppression is handled by two freeze proof fire hydrants and a single fire extinguisher mounted on the wall. The extinguisher as charged.
- 10) Repairs have been conducted to part of the walls but more are needed. **The walls need repair in several areas of the building.**

Tipping floor showing damaged walls

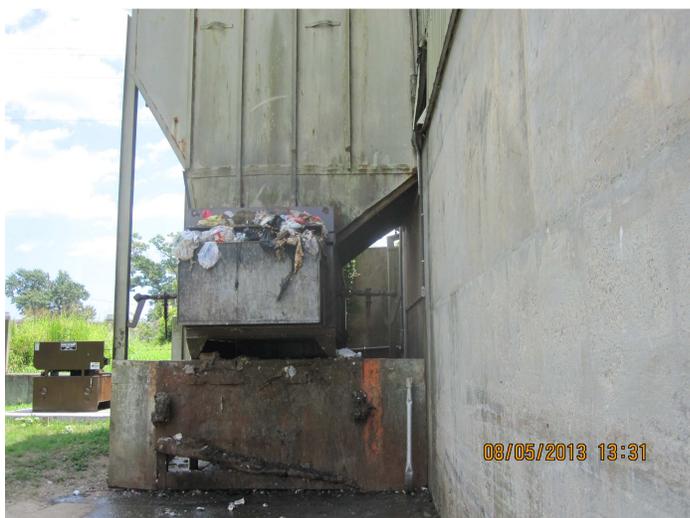
- 11) The tipping floor is in good condition.
- 12) Waste is direct dumped into a compactor, a new compactor has been installed. The compactor was not fully closed and waste was spilling on the concrete. **The compactor and the area around it need cleaning.**

Compactor, partially open allowing waste to spill on the haul ramp

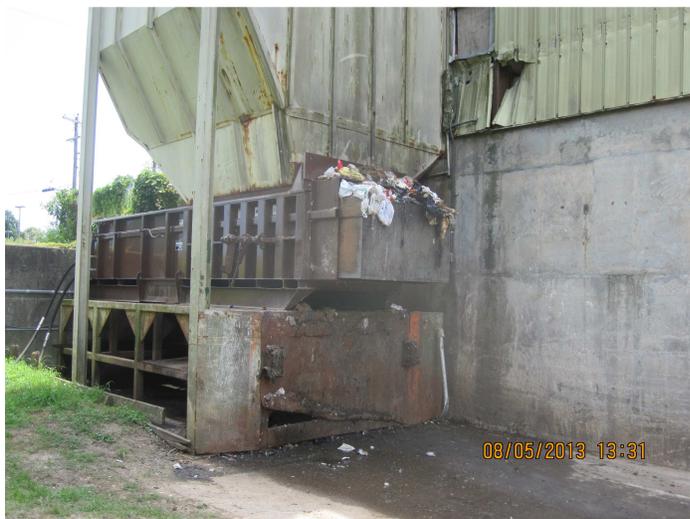
Compactor, partially open allowing waste to spill on the haul ramp.
