FACILITY COMPLIANCE INSPECTION REPORT
Division of Waste Management
Solid Waste Section

Date of Site Inspection: 12/30/13

JMN / Cleveland Container Industrial Landfill
 345 Roseborough Rd. (SR-2212)
 Grover, NC 28073

Partial inspection of closed landfill.

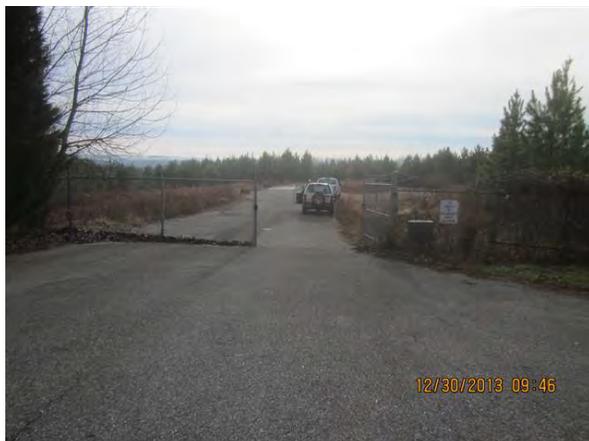
- a) Access is on the SW corner of the landfill, off of Roseborough Road. This access is controlled by a locked gate. (Photo #1)
- b) Proper landfill signage is displayed at the Roseborough Road access gate.
- c) The perimeter access road around the landfill was passable but in need of grading in several places at the time of the inspection. Please ensure that all access roads are maintained and are passable at all times.

1. Looking (SE) from Roseborough Rd. at the entrance gate to the landfill.

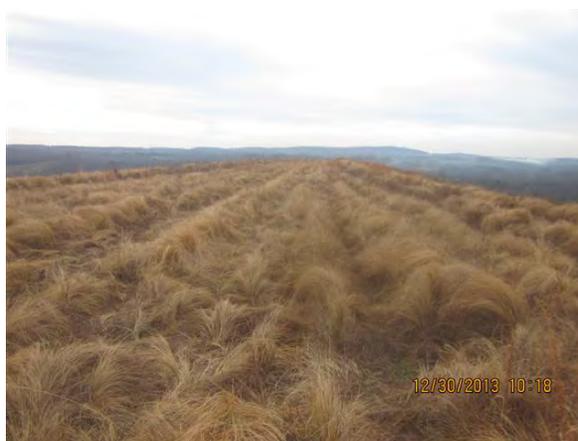
2. Looking (N) down the top of the landfill.

- a) The cap of the landfill has a well-established vegetative cover and is free of trees and woody vegetation. (Photos #2 & #3)
- b) No seeps of leachate from the landfill, or excessive erosion of the cap or were observed.
- c) Edge-of-waste markers are in place. (Photo #3)

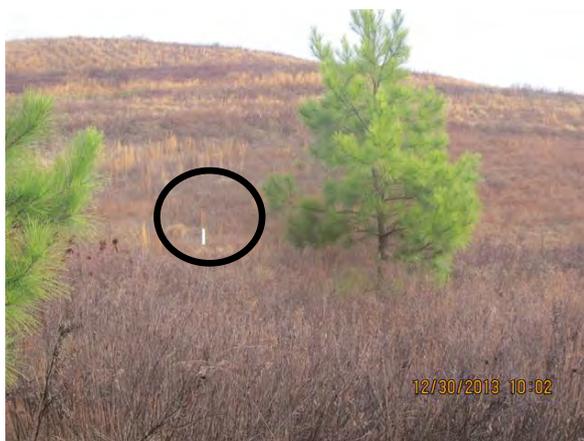
3. Looking at the southern slopes of the landfill. (Note the white edge-of-waste marker.)

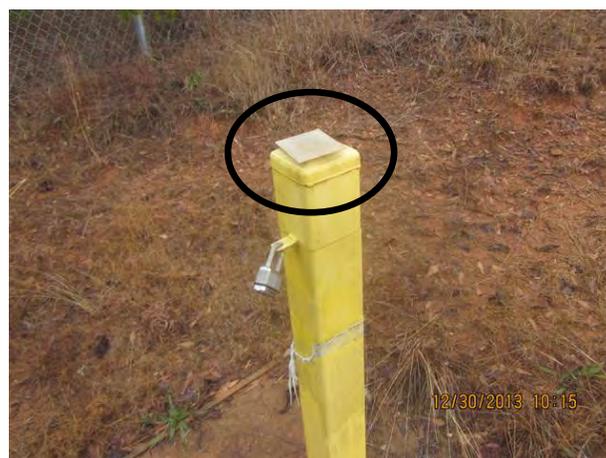
4. Groundwater monitoring well (believed to be MW-8). Note the 'well tag' placed on the top of the casing that should be re-attached to the well casing.

- b) While all of the inspected wells were and labeled with IDs, the ‘well tag’ one well (believed to be MW-8) had fallen off. (Photo #4). **Please ensure that all wells are properly secured and label in accordance with the requirements in 15A NCAC 2C .0108(o).**
