FACILITY COMPLIANCE INSPECTION REPORT
Division of Waste Management
Solid Waste Section

Date of Site Inspection: 5 September 2013

Weyerhaeuser Industrial Landfill
 Washington Post Road
 Vanceboro, NC

2502-20130905INSP

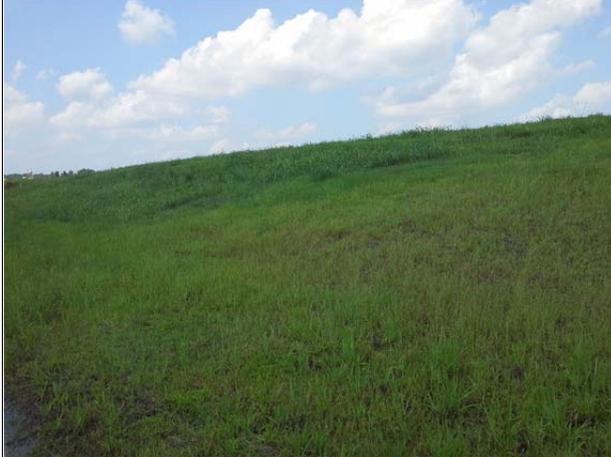
- 11) Some areas of sparse cover were observed throughout the landfill. *Please continue working to ensure that these areas are graded, seeded, and mulched to establish a cover crop suitable to prevent erosion and that the cover is maintained throughout the landfill to protect the integrity of your landfill cap system.

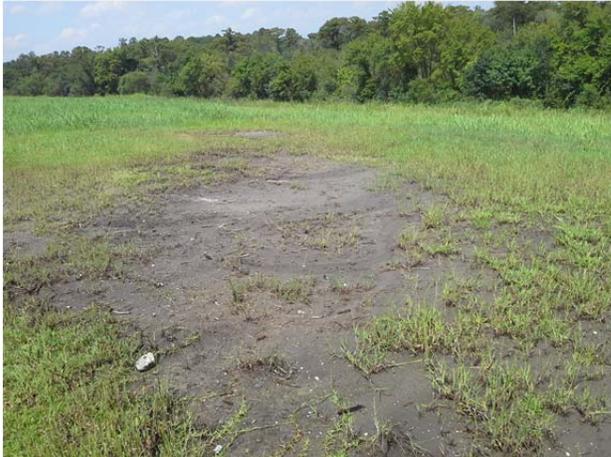
- 12) The sinkhole that was noted near the top lift at the southeastern end of the landfill has been repaired. The repaired area has been filled, compacted, and graded and a groundcover suitable to prevent erosion of the landfill cap system has been established in this area.

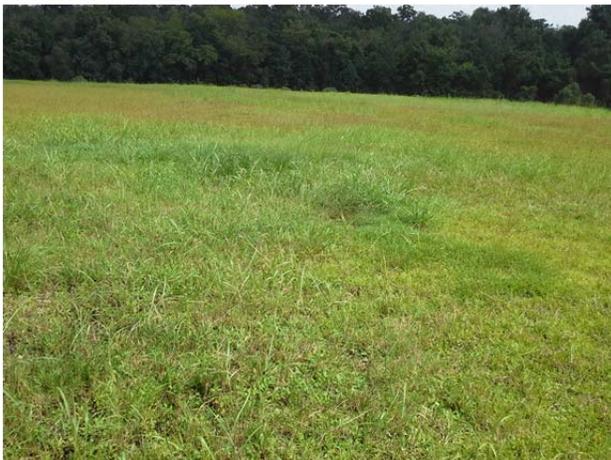
- 13) Grading work has been completed in the area on the top lift of the landfill, approximately 500' from the northwestern sideslope that was noted in the previous Facility Compliance Inspection Report as retaining surface waters. No ponding of surface waters was observed in this area.
- 14) Small areas of ponding surface waters were observed on the top lift of the landfill. *Within thirty days of receipt of this Report, please fill and grade these areas to promote the positive, controlled flow of all surface waters from the landfill. All filled areas should be seeded and mulched to establish a groundcover suitable to prevent erosion of your landfill cap system.
