**FACILITY COMPLIANCE INSPECTION REPORT**  
**Division of Waste Management**  
**Solid Waste Section**

**Date of Site Inspection:** 12 May 2014

Craven County Landfill  
 7400 Old Highway 70  
 New Bern, NC

2503-20140512INSP

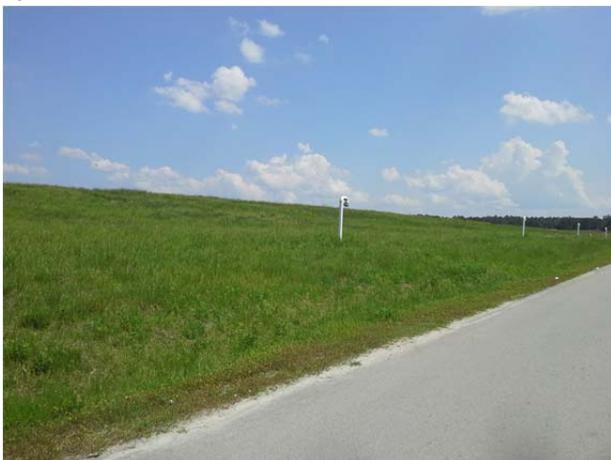
- 5) Edge-of-waste markers have been installed at the corners of the disposal footprint and are being maintained as required.
- 6) Soil has been brought on site and is being staged for use in settlement and cap repair projects. Two stockpiles are being maintained; one stockpile on the lower lift and one stockpile on the uppermost lift.

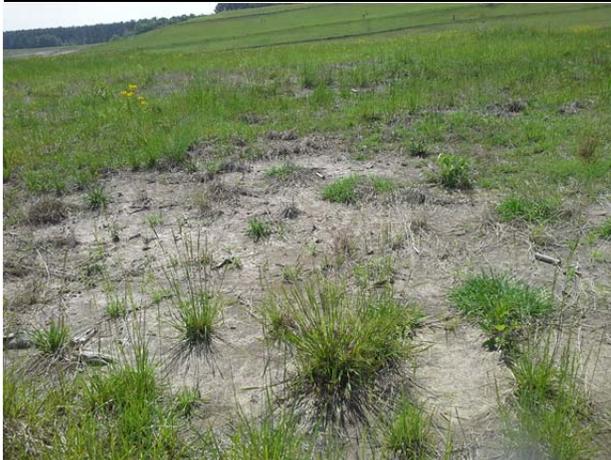
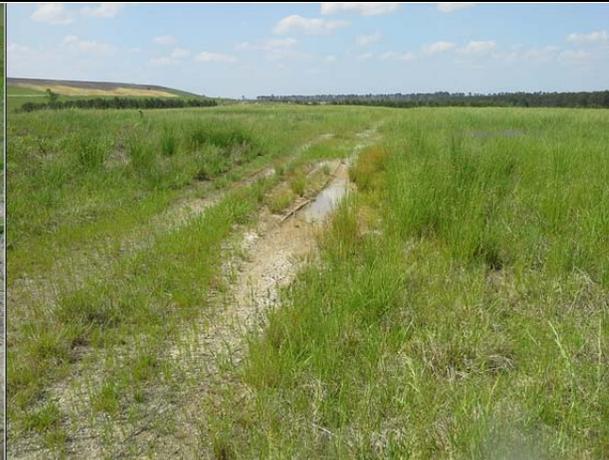
- 9) Areas of differential settlement were observed in several areas around the landfill. Some of these areas are restricting the positive flow of surface waters from the landfill during and following rain events. \*Please fill and grade these areas to promote positive drainage of all surface waters away from the landfill. All filled areas should be graded at a slope not greater than 3:1 and seeded and mulched to establish a cover crop suitable to prevent erosion of your landfill cap system.

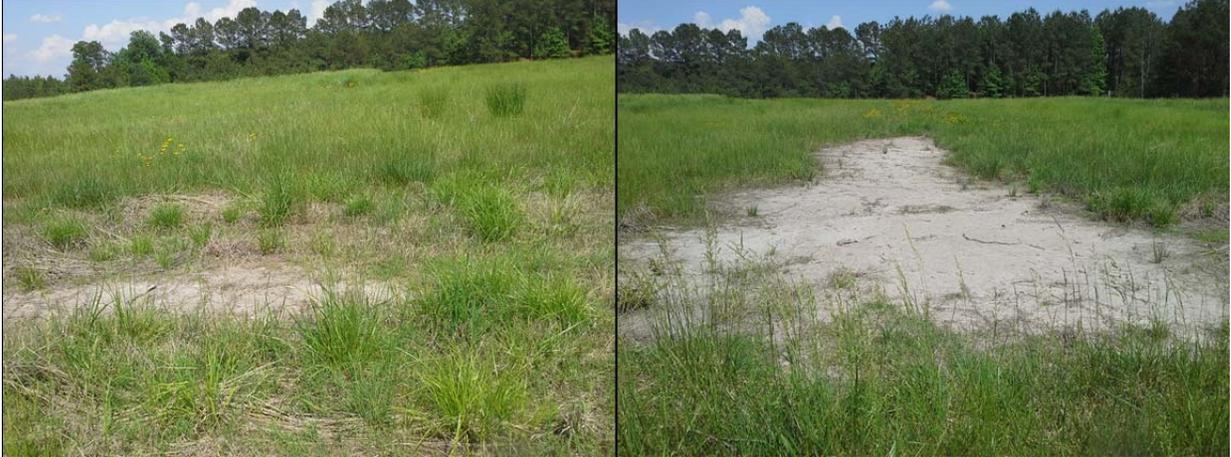
- 10) The Facility monitoring wells were reviewed. All wells were locked and labeled with permanently affixed tags. Access to the wells was stable and clear of brush.
- 11) Overall this facility has a well-established and maintained cover crop of native warm season grasses. However, some areas throughout the landfill were noted as having sparse cover. \*Please re-seed and mulch these areas to establish a groundcover suitable to prevent erosion of your landfill cap system.

12) \*Corrective measures are required as a result of this Facility Compliance Inspection.
